Cwm Ivy

climate change and the historic landscape – loss, damage or opportunity? Judith Doyle MCIFA (6639), Archaeologic

Judith Doyle MClfA (6639), Archaeological Planning Officer, Glamorgan Gwent Archaeological Trust Ltd

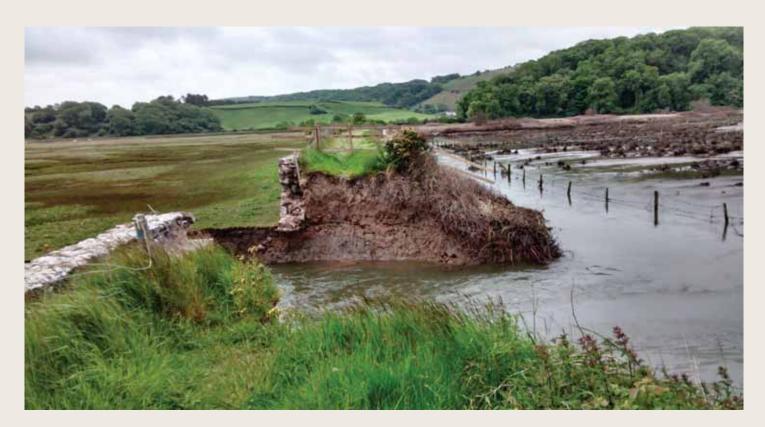
A breach occurred in late 2013 during a storm, adversely affecting the outer late medieval/early post-medieval bank at the point where the sluice drained water from the management system into the Burry Estuary. The resulting physical impact on the bank was not immediately addressed, as various options were considered for rebuilding, retaining the sluice, or expanding, consolidating and bridging the gap. Natural Resources Wales (NRW) and the landowner, the National Trust, had concerns regarding the long-term safety of the bank, and in relation to water movement.

Photograph showing the breach in the bank and where the phases of construction can be seen. Credit: Judith Doyle

circular walk. Formal local consultation came in 2015, local concerns raised previously with both the National Trust and NRW having gone unanswered. Between 2013 and 2015, tidal surges, especially at very high and very low tides, created more erosion of the sea bank and widened the breach. It was 2015 before the historic environment impact was formally considered, and a desk-based assessment was recommended to consider the impact on the physical remains, as well as the setting within the Registered Landscape, in relation to the options for repair. During a scoping visit for the consultation, the construction phases of the bank were visible in section in the breach. Three dumps of material formed the base, covered with at least four more phases of material, including a sloping stone toe towards the estuary, with the wall to the seaward side forming the most recent phase. Regular flooding with sea water has destroyed the vegetation, as in the photograph. Because of both tidal and financial situations, the current situation is static, and local concern continues.

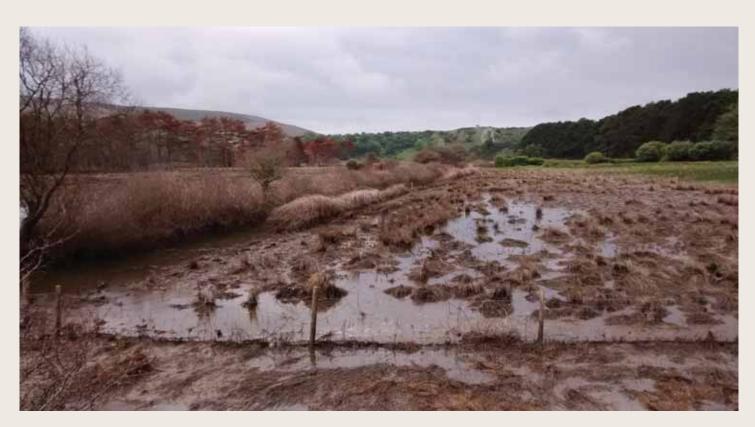
Photograph showing the effect of sea water on the vegetation of the character area. Credit: Judith Doyle
