Wangduephodrang Dzong Seriously Damaged by Fire

**Survey for Remaining Structure of
Wangduephodrang Dzong
After June 24, 2012 fire**

15 October 2012

Division for Conservation of Heritage Sites
Department of Culture
Ministry of Home & Cultural Affairs
Royal Government of Bhutan

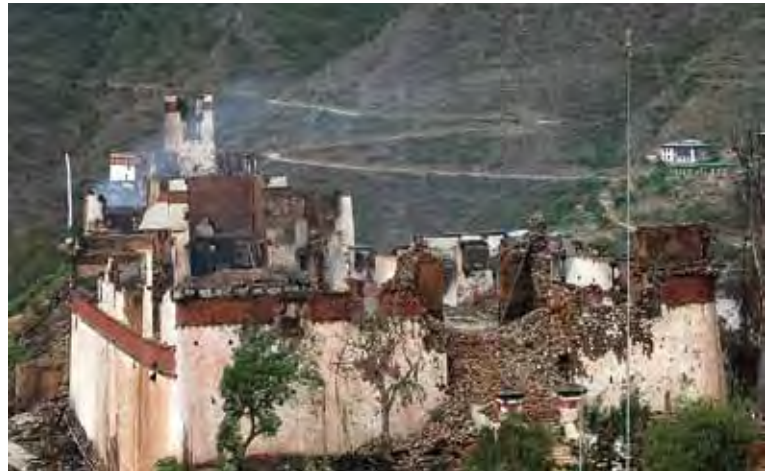
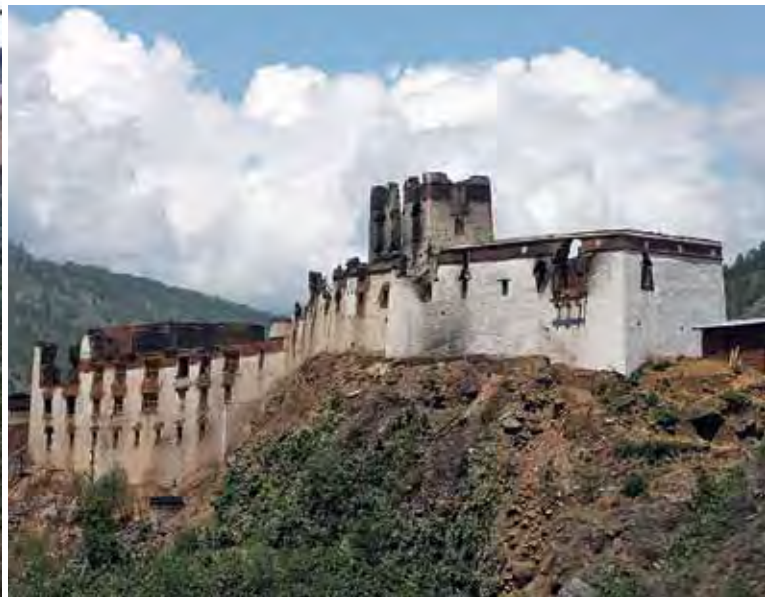
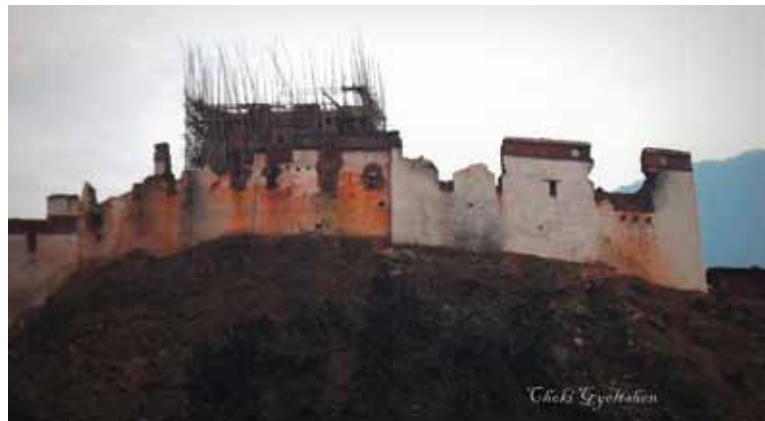
The ruins of Wangduephodrang Dzong after the fire
(photos: Yeshey Dorji, Choki Gyeltshen)

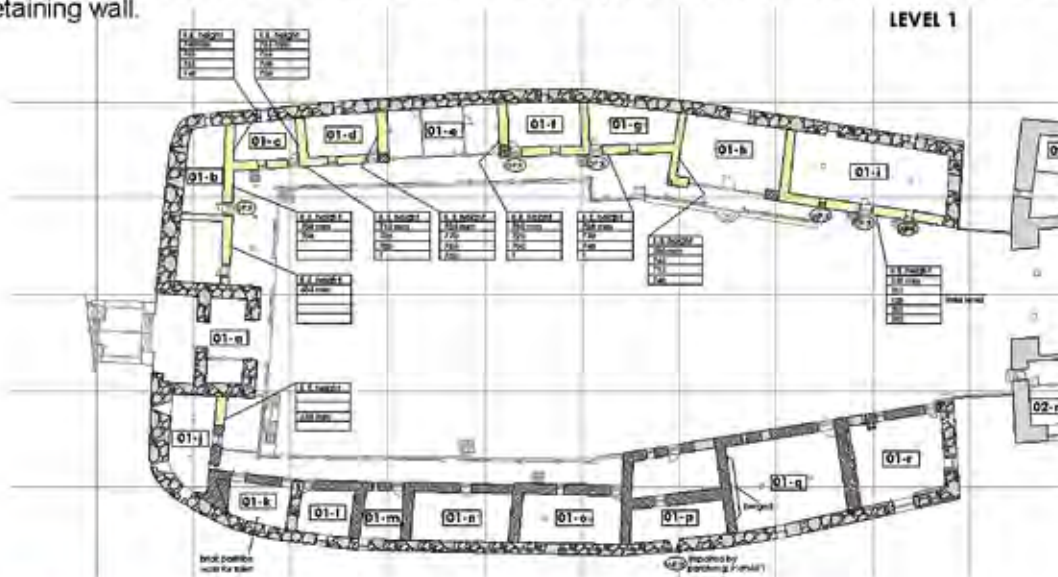
Although the walls of this Dzong are mainly of stone masonry, significant amount of rammed earth walls can be found at the eastern *shabkhor* (facing Dangchu River) of the first courtyard area, which is part of the original extension work undertaken by Gyalsay Tenzin Rabgay.

Rammed earth wall (indicated in yellow) and stone masonry wall at the Level-1

Rammed earth wall at the first courtyard area is expected of the extension work in 1683. As it will be served for a future study on medieval construction especially when compared with other Dzongs and buildings which were built of a mixture of construction materials, it is highly recommended to retain these rammed earth walls. Although the walls of the Level-1 have been deteriorated by fire-fighting water and subsequent rain, the rammed earth walls on the Level-B1, which is in good condition, should be maintained.

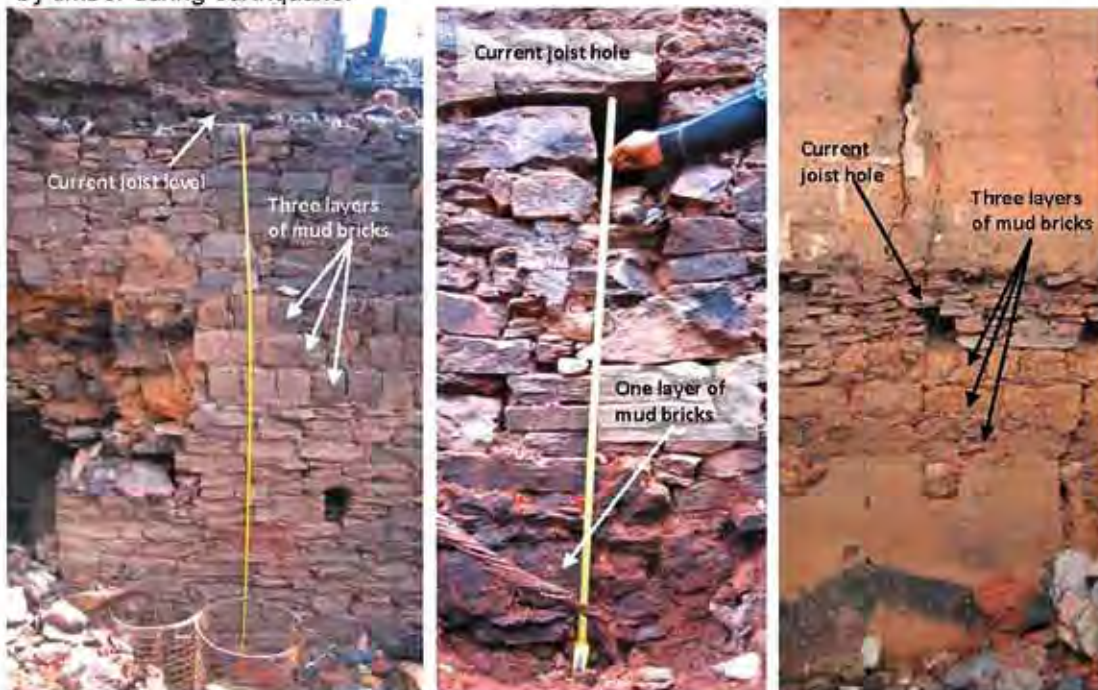
The inner surfaces of the front façade walls of the first courtyard, which are of stone masonry are observed with a few vertical layers of mud bricks (*parchung*). Since the front façade walls are part of the original construction (as mentioned earlier in page 2), these *parchung* must have existed since the original construction. It has been observed that *parchung* layers are mainly around the area where the earlier joists were inserted. This insertion of *parchung* is assumed to make it easy to replace chams, or to reduce damage on the stone wall caused by timber during earthquake.

(Left) Inner surface of the front façade stone wall for Area01j
 (Middle) Inner surface of the front façade stone wall for Area01b
 (Right) The rammed earth wall on the opposite side of the wall in pic40

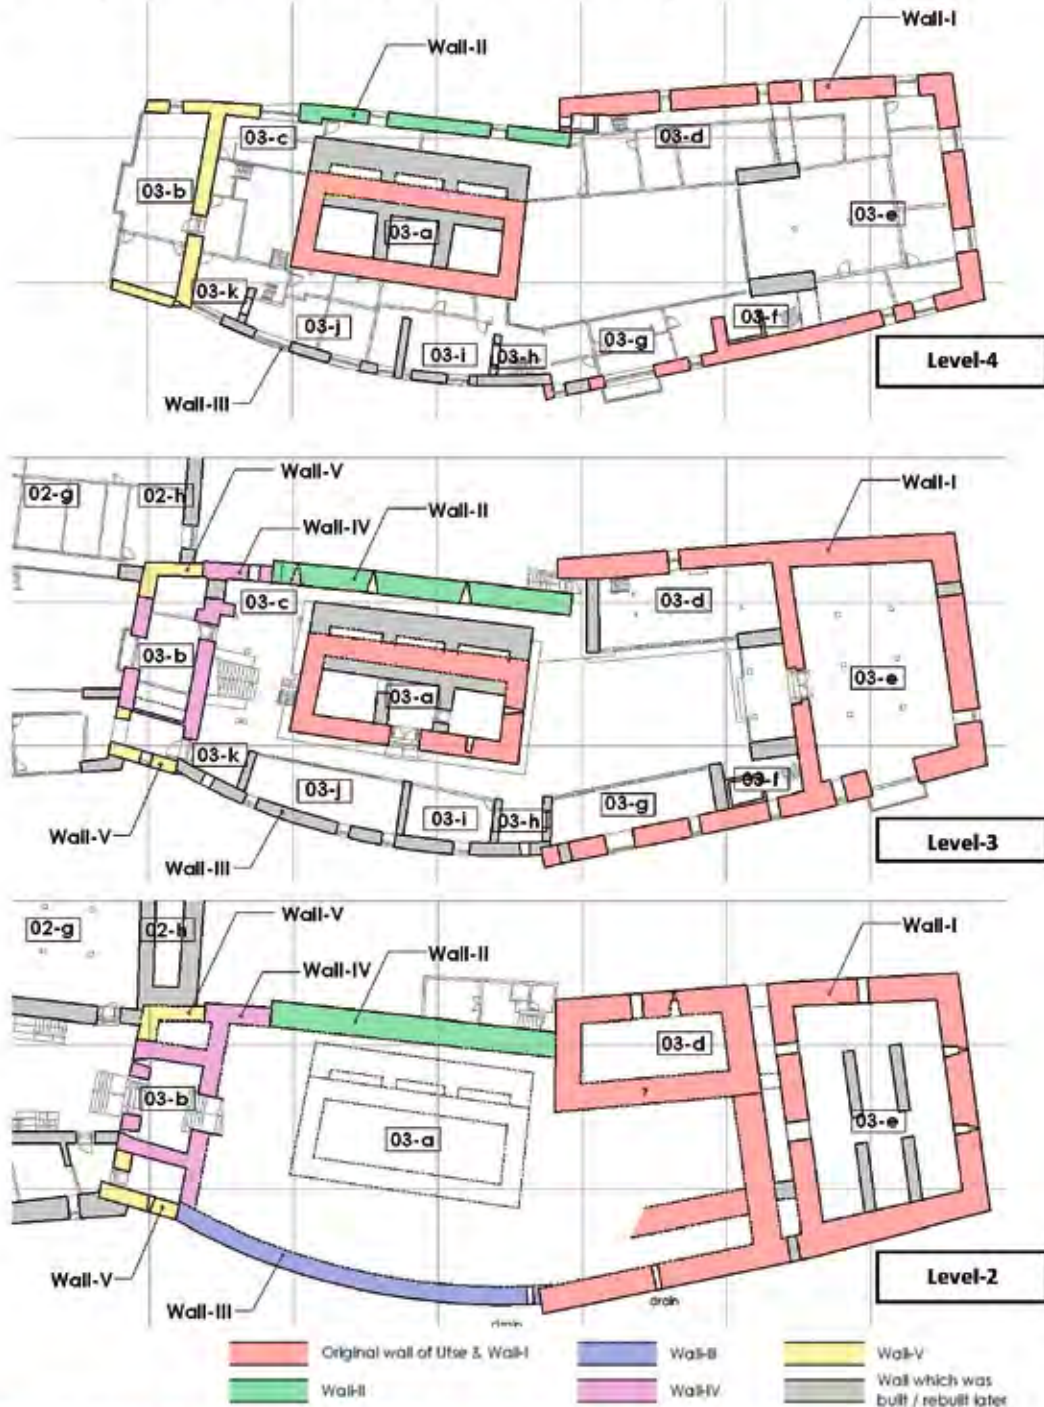
The *shabkhor* building around the third courtyard provides evidence to assume that parts of the *shabkhor* building were constructed at least in three different phases or period, which has taken place from 1638 to 1683, as shown in the drawing below.

Different phases of wall construction (Wall-I to Wall-V) at the third courtyard area

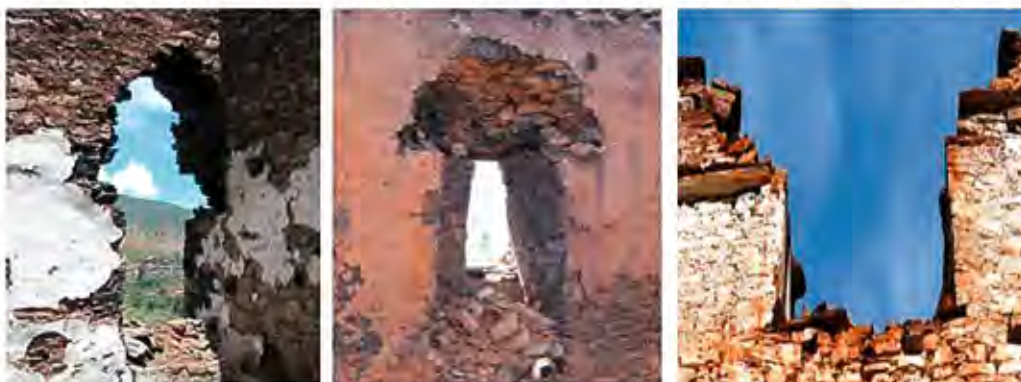
The majority of the damage to the walls was caused by failure of the wooden lintels over windows and doors, these lintels were severely burnt and therefore provided very little support to walls above. Such damages are common in all the three courtyard areas. In most cases, where lintels located on the upper wall were completely burnt, the entire wall above the lintel collapsed, this usually triggered further collapse of nearby walls. On the other hand, where lintels located on the lower wall were completely burnt, the collapse of stone wall above the lintel were generally partial with formation of an arch or semi-dome shape damage.

(Left) Collapse of stone wall above a lintel with formation of arch – Area01m at Level-1

(Middle) Collapse of stone wall above a lintel with formation of semi dome – Area01l at Level-1

(Right) Collapse of entire stone wall above a lintel – Area02c at Level-2

For instance, it is highly recommended that alternate non-flammable material be used for the construction of lintel for doors and windows in the light of reducing major damages that are caused by the failure of wooden lintel during and after a fire. However, it may not be required to extend the use non-flammable materials to the overall frames of door and window, as the amount of wood used for these frames does not cause considerable damage to the overall structure in case of a fire.

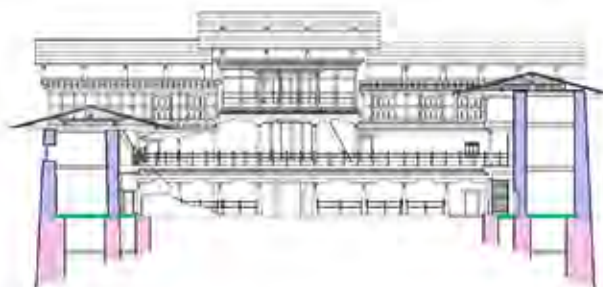
Estimate for amount of wall

Above the courtyard levels (blue):
 For the first courtyard area= 4,358 m³
 For the second courtyard area = 5,078 m³
 For the third courtyard area = 4,124 m³

Below the courtyard levels (red):
 For the first courtyard area= 6,057 m³
 For the second courtyard area = 4,336 m³
 For the third courtyard area = 3,569 m³

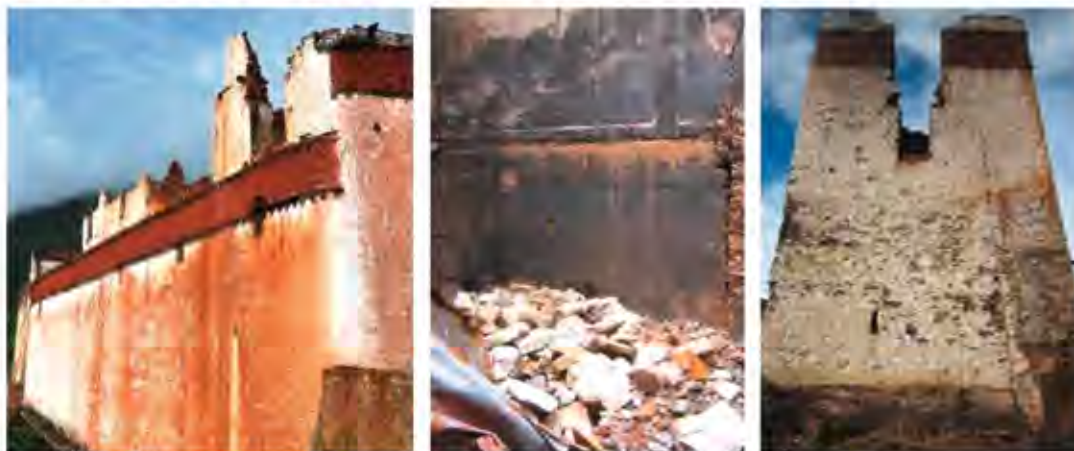
The external walls below the courtyard levels show no signs of bulging or major damages. The fire has minimally affected the walls located below the courtyards, as it is evident from the state of wooden floorings of the ground floors, most of which have remained after the fire. Reuse of the walls with minor repair at this level is also recommendable from financial aspect. The stone masonry work for the current walls below the courtyard levels is roughly estimated of 14,000 cubic-meters, which is almost equivalent with the walls above the courtyard levels.

As the original wall of Utse is the most significant part of this Dzong, appropriate measures should be taken to reuse this wall. Despite the sign of damage on stones which shows peeling off the surface of stone, it is expected that core of the wall is intact.

(Left) Eastern external wall of the first courtyard area: The ground floor level downward (below the khemar) is in good condition

(Middle) Rammed earth wall at Level – B1 located between Area01b & 01c

(Right) Utse
