# INDONESIA

## Borobudur Temple

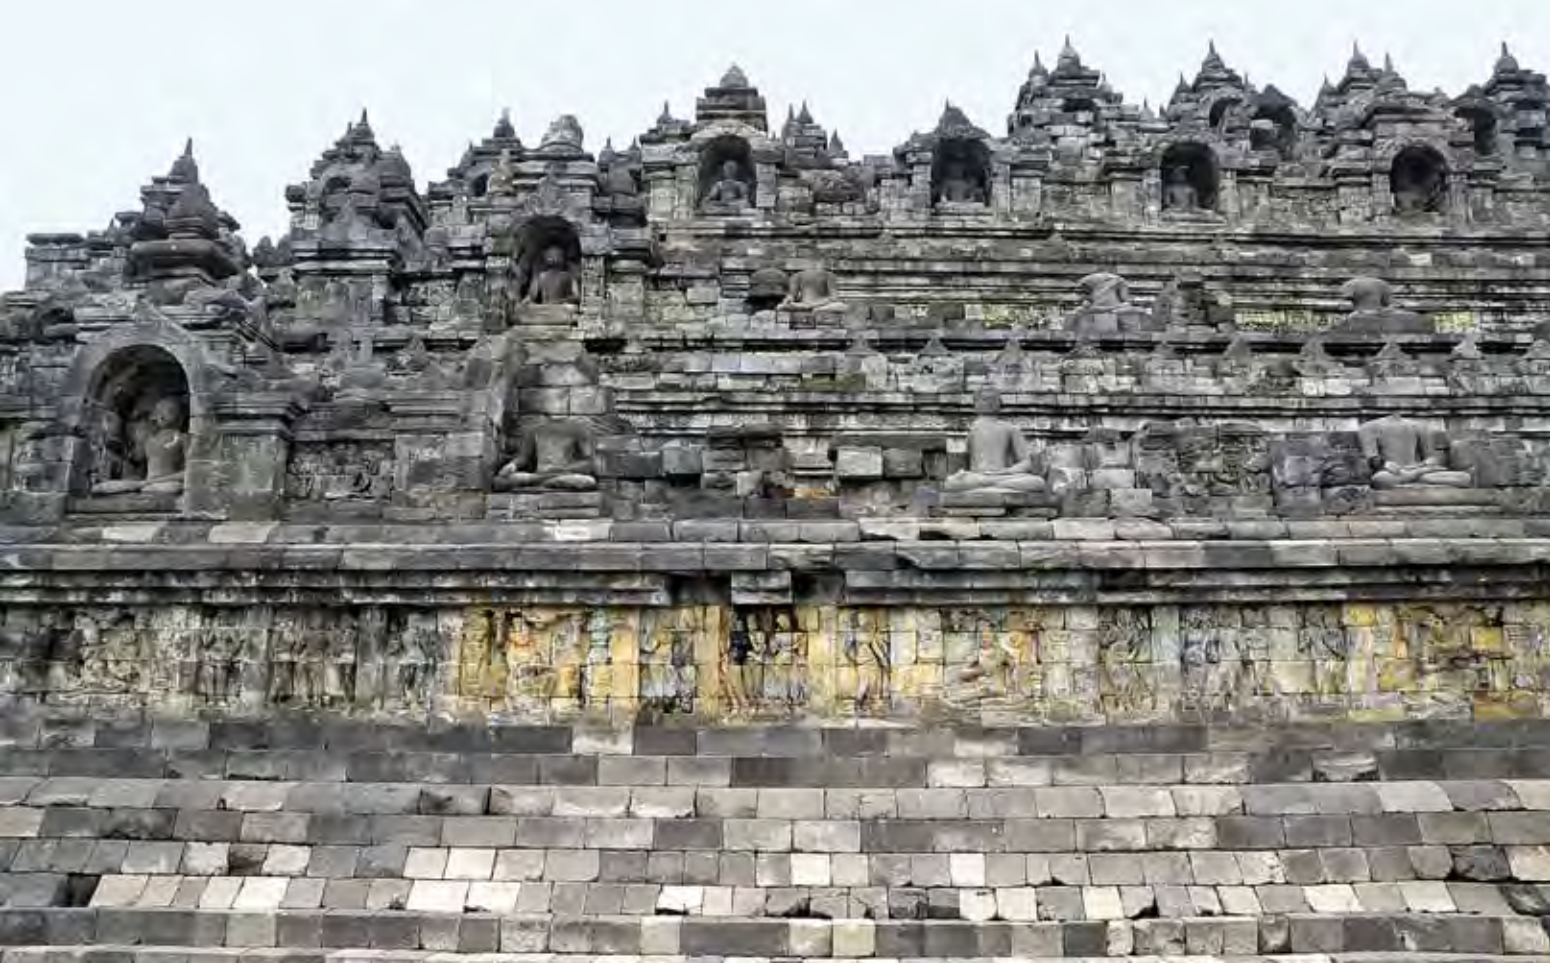
Temple front showing different types of decay

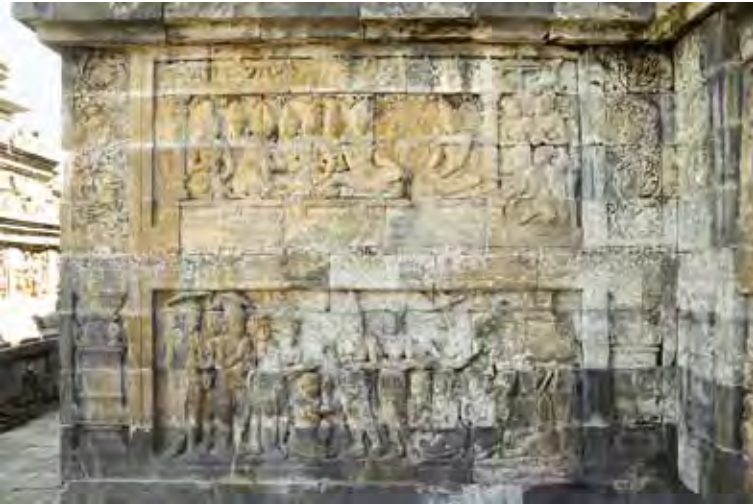
Bas-relief with pustules

The most severe stone conservation issues on the bas-reliefs of the temple walls and the balustrades are so-called pustules, crust formation with different compositions, cracks, and uncontrolled water seepage. They are independent of the ashes and solutions from the ashes. Everywhere breakages at the horizontal joints can be observed which derive from the dismantling and reassembling of parts of the temple during the intervention of the 1970s. Other negative influences are salts with damaging effects on building materials and microbiological contamination. They cause the loss of the precious carved surface in very small fragments. The

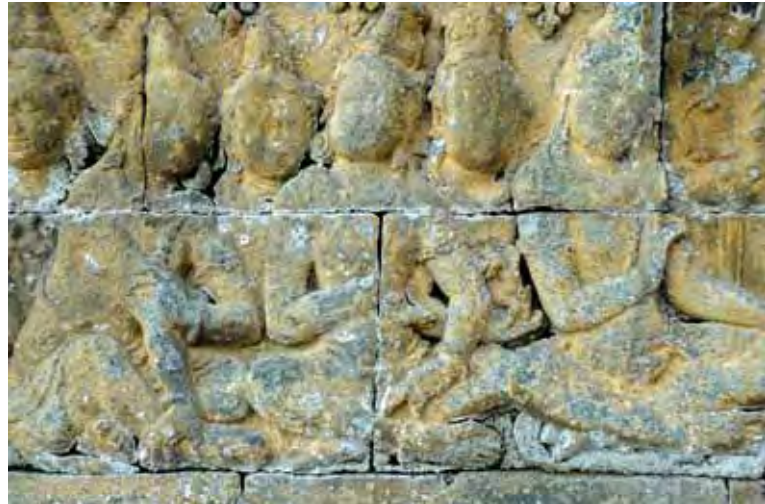
Detail of a relief showing severe rounding

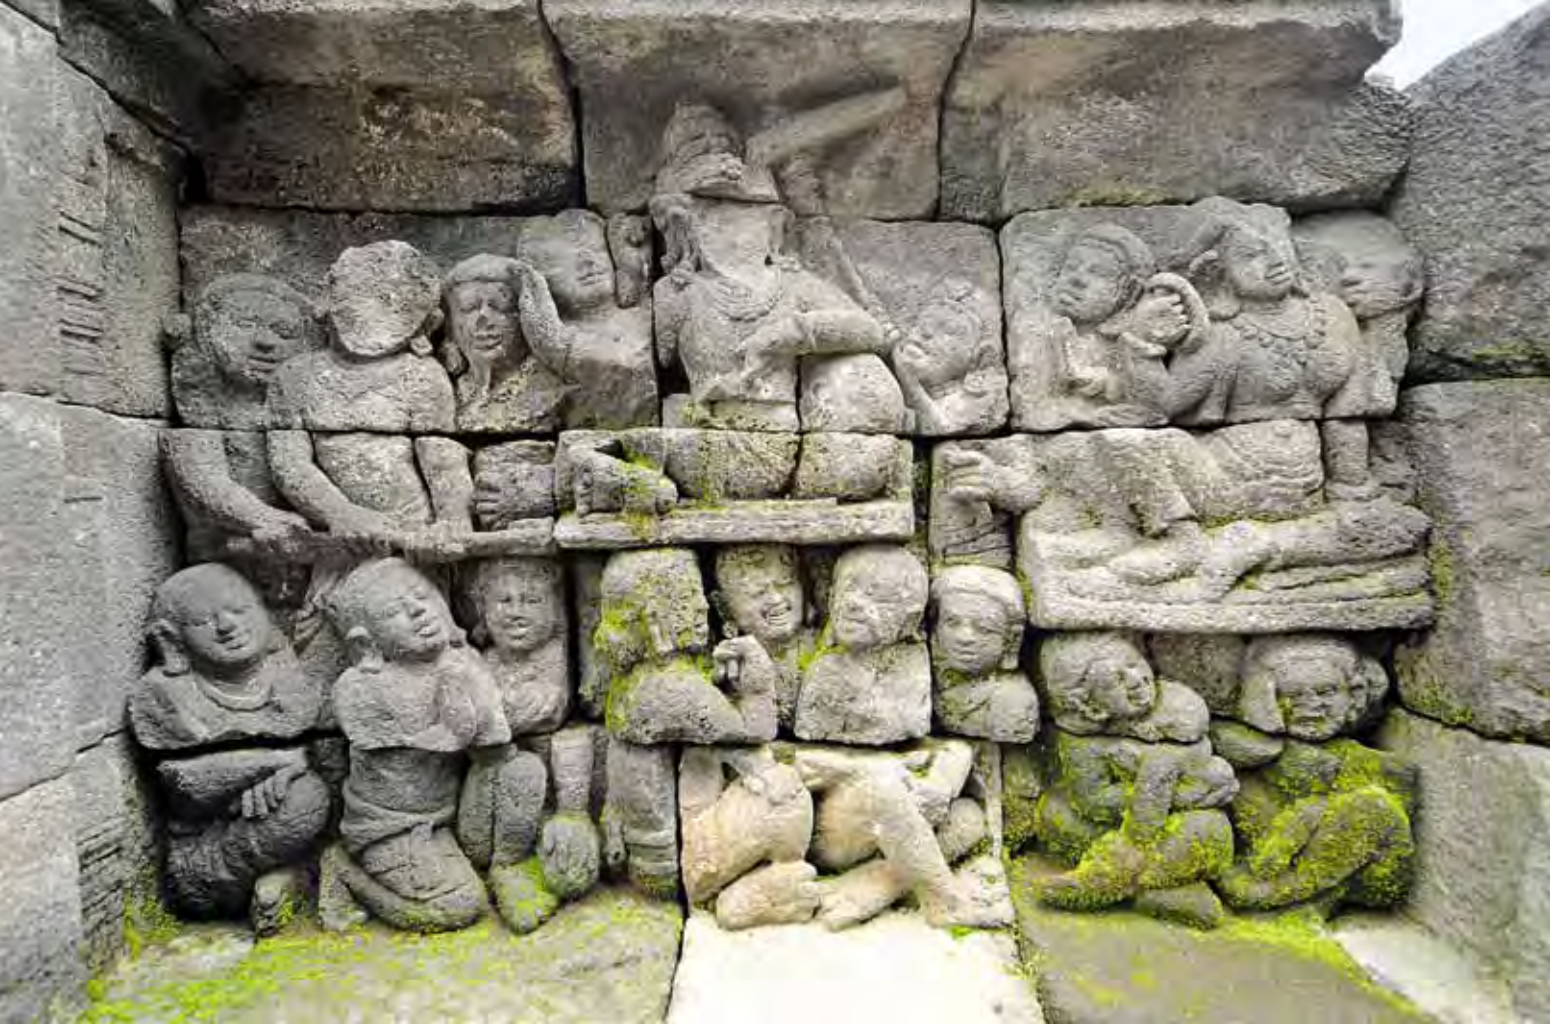
Relief showing biological growth and breakage
