IMPACT OF THE 15 OCTOBER 2013 BOHOL EARTHQUAKE ON THE BOHOL CHURCHES

Prepared by **Ma. Joycelyn Bolhayon-Mananghaya, M. Arch, uap**
Trustee, ICOMOS Philippines

Paper that came out of the Assessment Mission to Bohol 18-26 October 2013

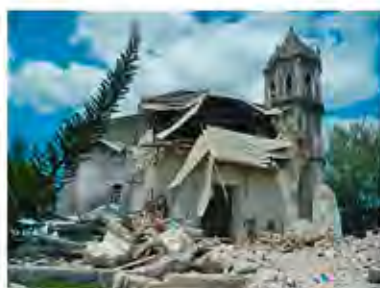
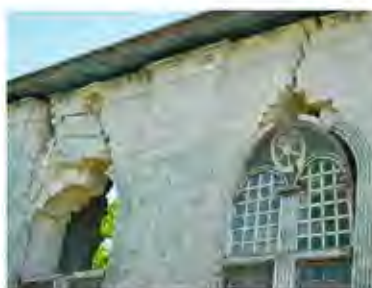
Dauis Church

nearest to the keystone, and including the keystone, are those where failure occur. Such failure is apparent in the church of Dauis where practically all its arch openings succumbed to vertical and diagonal cracks that emanated from the uppermost part of the wall, following a downward direction that reached the underside of the said arch openings. In most apertures in Dauis, stone parts have been totally dislodged, leaving the apex of the arch opened. It has also been observed that churches having vertical pillasters acting as buttresses instead of the inclined retaining wall type buttress, have sustained much graver damage. In some instances, walls of churches having inclined buttresses that absorbed the outward splaying of the roof remained standing, although in many cases, some of these buttresses have also incurred major damage such as the dislodgement of its stonework from base, the dismemberment of the interior rubble fabric as well as in grave cases, the total collapse of the said structural element. Despite occurrence of these failures in the churches, they are still restorable/repairable.

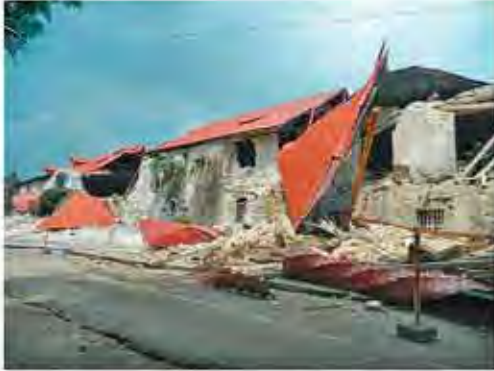
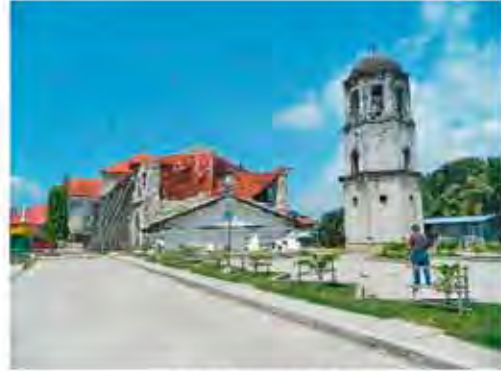
Loboc church (L); Loay church (R)

The churches where central parts of lateral walls partially or fully collapsed in an inward direction and where buttresses failed to hold together the structure (Loboc, Inabanga, Clarin) showed that said walls similarly independently acted on its own sans being tied together to the rest of the structure or its adjoining members. In the case of Clarin, the front façade and its sanctuary wall remained standing

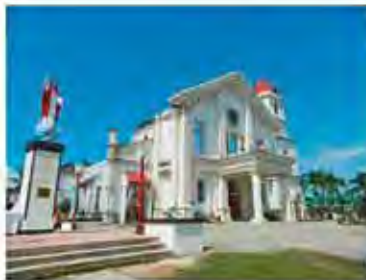
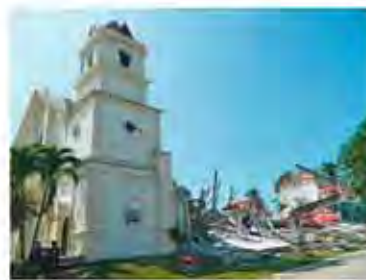
Clarin church

while both its lateral walls fell inward, an indication of the lack of a fastening material at the corners that could have prevented total collapse.

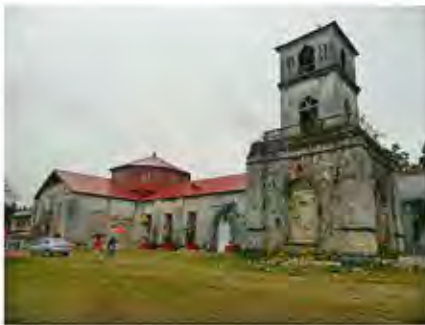
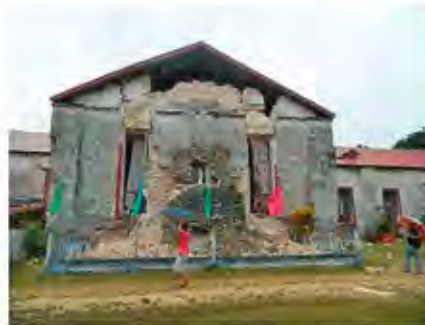
*Cortes church*

In many churches, failure occurred at arch openings with vertical/diagonal cracks emanating from the apex of the wall following downward directions and cutting into spandrels (Dauis, Loboc, Jagna, Baclayon, Cortes, Loay, others). In Dauis, this was most apparent as almost all apertures manifested the same problem. This means that the weakest points in the walls consequently gave way due to the movements. The arch action (compressive action of all its parts) eventually failed when the spandrel and arch abutments also fell short in putting together the compressive stresses that held them together. Arch openings should have in full the keystone, voussoir stones and the impost. These should be solid enough to carry its own the load. The coursework beside the arch which is the abutment helps prevent thrust thereby assisting in strengthening compressive qualities of the arch. If all these are subjected to multi-directional movements, they become weak and eventually result to the disintegration of parts. Most churches likewise manifested damage at the cantons with the bulging and eventual dislodgement of hewn stones that held the wall together. There were also cracks between the corner pillars and adjacent walls. Very much apparent in all churches was the state of the interior rubble masonry fabric which was found pulverizing and disintegrating. It was only the coursework that held these together so that when movements occurred and the coursework were eventually dislodged, the interior fabric similarly gave way.

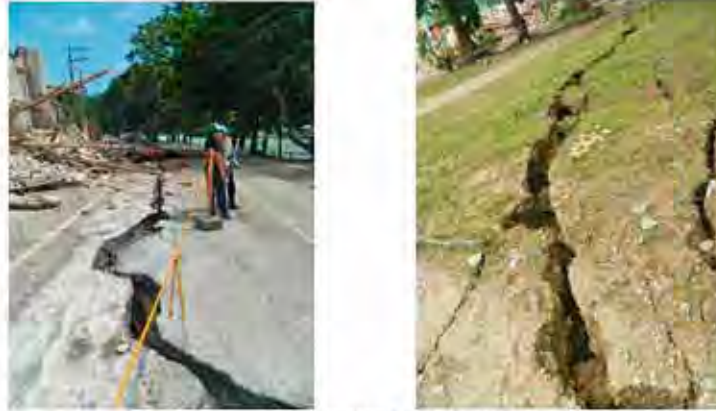
Ground cracks Loboc church (L); Maribojoc church(R)

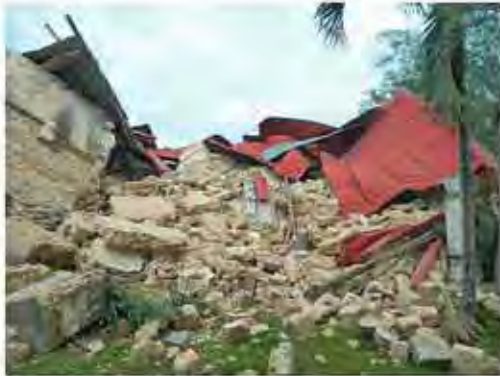
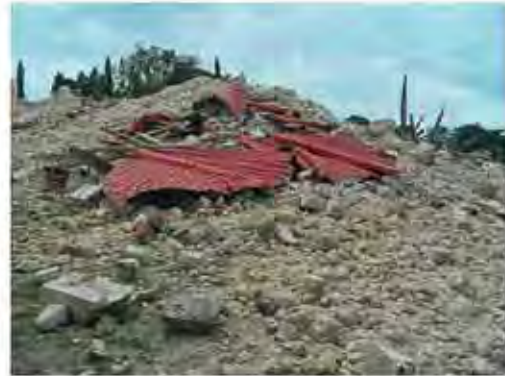
In the case of the Loon and Maribojoc churches, ground ruptures found to have laterally cut across the longitudinal part of these churches at central and strategic locations may have led to the total collapse of the edifices. Owing to the karst topography of Bohol, the existence of caverns crevices within the karst substrate and theories of the presence of crevices under these churches remain as a plausible reason for the total collapse. This theory can only be substantiated by geophysical investigation.

Loon and Maribojoc churches in state of rubble

1. Propose solutions that are beyond standard restoration and reconstruction practices; consider innovative approaches that are appropriate to the present and future needs of the place and the people as well as those considering the thrust of the owners of heritage and government in as much as the conservation of heritage is concerned;
2. Work within a consultative, participative and inclusive framework (for issue resolution, for information generation and for interpretation)
