JAPAN

The Tohoku Earthquake and Tsunami of March 11, 2011 and their Impact on Cultural Heritage

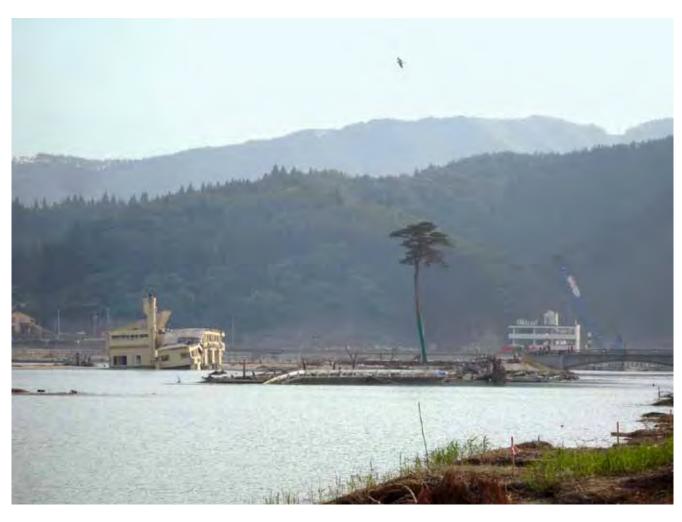
The Takata-Matsubara scenery is backed by beautifully shaped mountains. It also includes a reef formed by a sandy beach as well as by pine trees growing densely there. The eastern half was greatly eroded by the tsunami, and the few surviving trees were harmed by salt water. Moreover, it is believed that

Takata-Matsubara, only one red pine survived

the width of the reef from north to south has reduced to one third.
