# JORDAN Petra

Heritage at Risk 2004/2005 Jordan 155

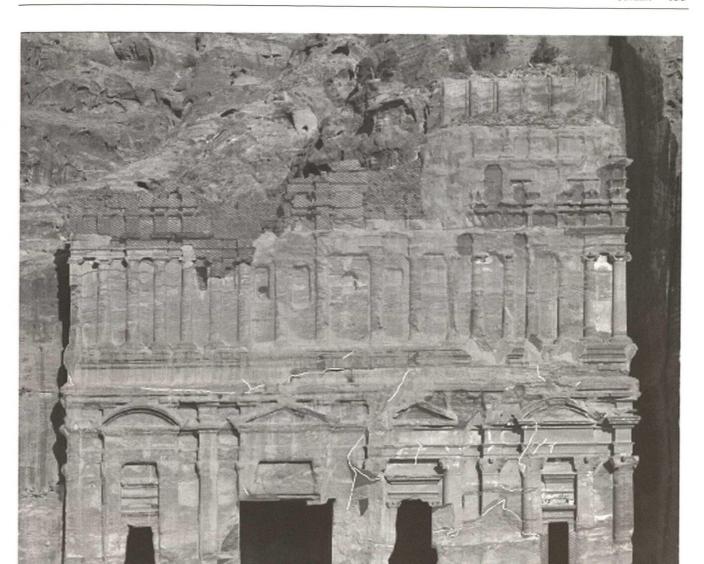
Palace Tomb: Elements, which have been masoned, not cut from the rock

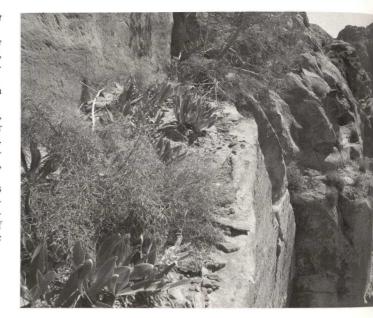
Corinthian Tomb, verdure

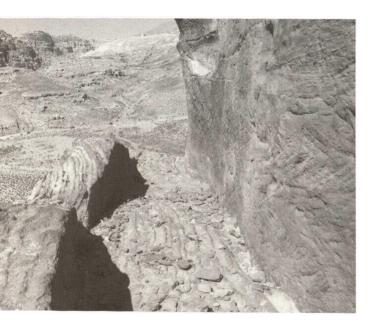
Corinthian Tomb, drainage

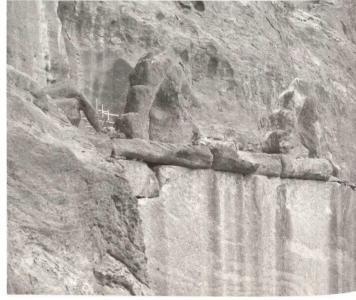
Tomb 824, endangered architectural elements

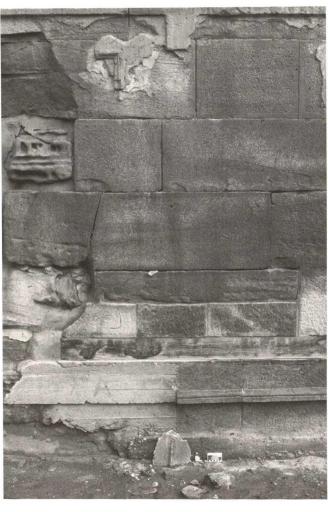
Qasr al Bint, condition of stucco decoration
