BRAZIL Flood Damage at Goyaz Velho

This report considers the damage to Goyaz Velho, as a result of the flooding of the Vermelho River on 1 January 2002. It is based on a site visit by a group that included the honourable Representative and Superintendent of the 14th Region of IPHAN, Dr. Salma Paiva. The conclusions presented are those that require a larger discussion with the inter- and multi-disciplinary team co-ordinating the rescue and restoration of the areas afflicted by the flood that took place during New Years Eve.

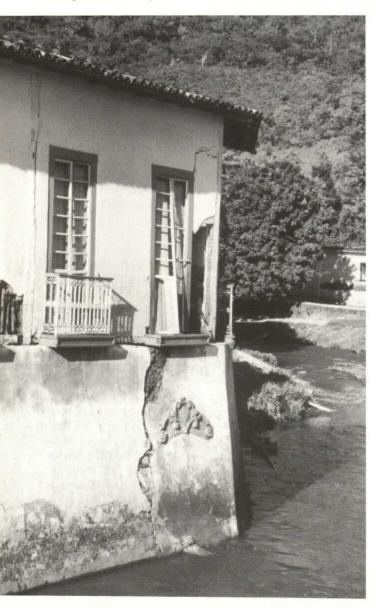
Building after flood damage

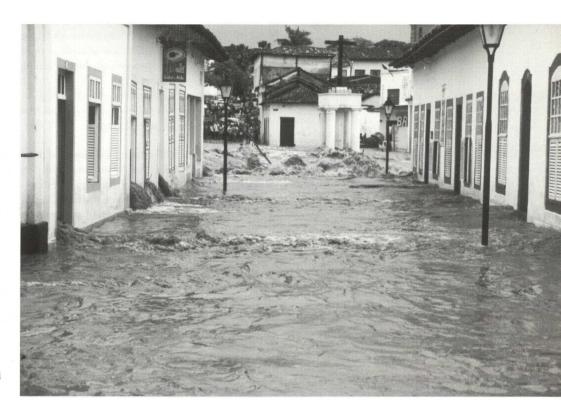
Dom Cândido Street and Anhaguera at the back

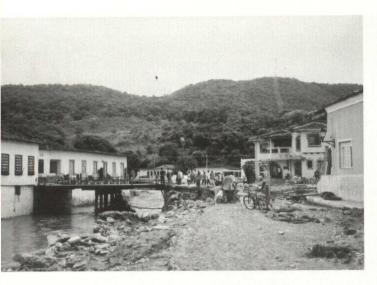
Lapa's Bridge, which resisted the flood

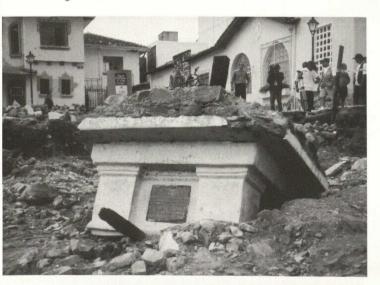
Anhaguera Cross foundation

- · monument: Cross of 'Anhangüera';
- archives preventive measures and restoration; rescue services in action by the IPHAN specialised technicians and local volunteers;
- urban cleaning (presently taking place) and cleaning of the buildings;
- · painting.
