MOROCCO – HERITAGE @ RISK!

Case Study – The Historic City of Meknes

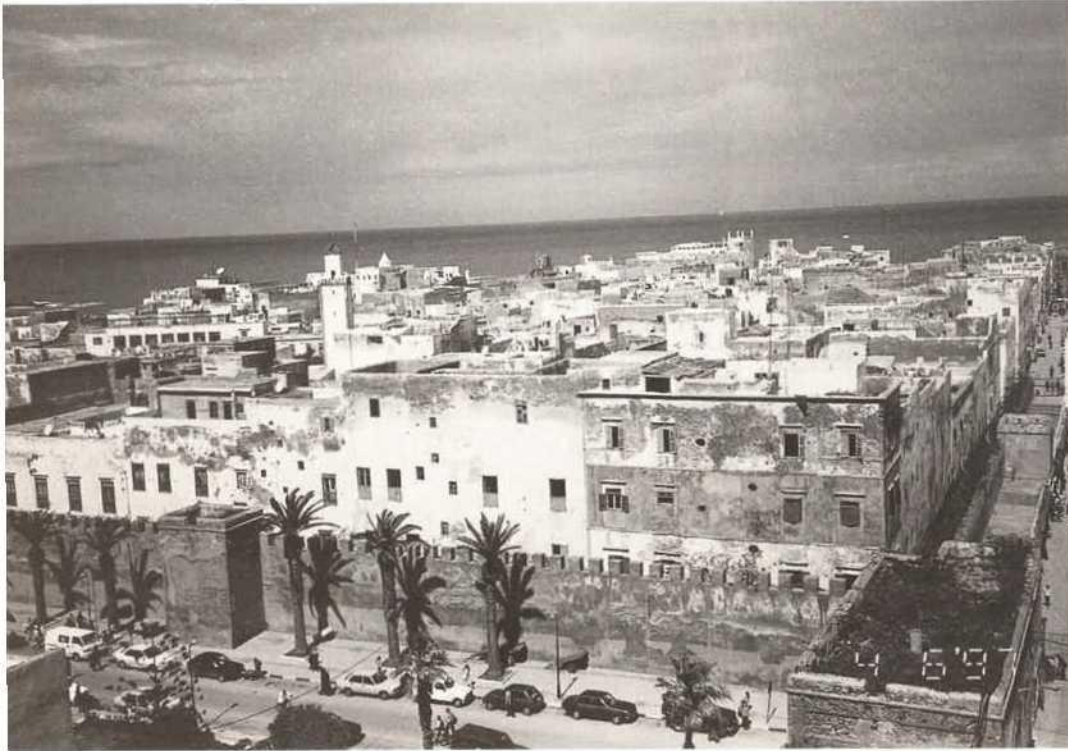
Essaouira (Mogador). Second east wall: rising damp due to surface water and rain water, causing stone surface erosion

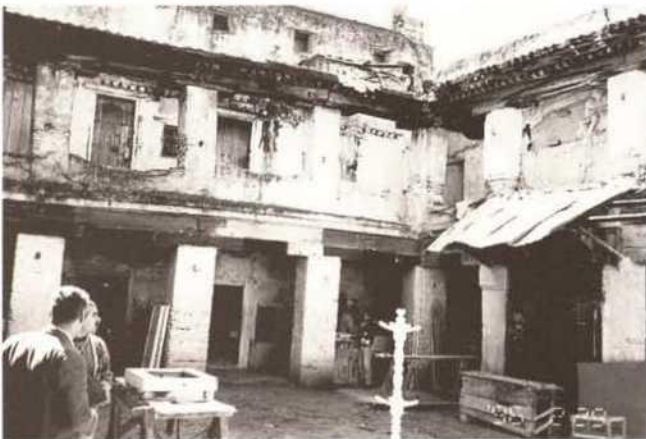
Meknes, deteriorated Caravanserai, re-used as carpentry workshop
