Microclimatic Measurements and Laboratory Research in Historical Buildings with Medieval Wall Paintings at Croatian Adriatic Coast

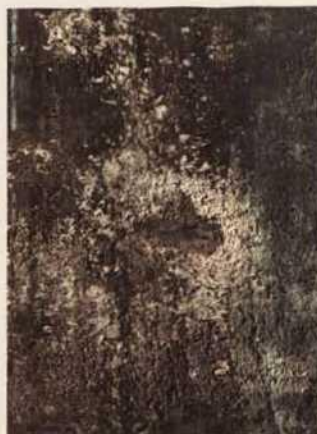
ble inadequate restoration, their condition at the time and the microclimate in the cathedral also contributed to their deterioration. After removal of several layers of lime coatings and plaster that protected the wall paintings from harm caused by crystallisation of salts on their surface and the area close to it, the destructive processes in fact continued at a faster pace, destroying the *intonaco* and the painted layers that were partly damaged earlier (Fig. 2).

Fig. 2. Zadar, Cathedral of St Anastasia (Sv. Stošija), south apse, wall painting, detail: typical deterioration of paint layer.

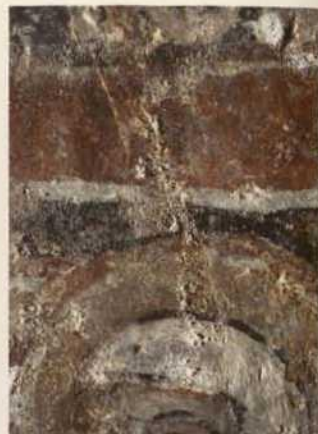
Wall paintings from the first half of the 12th c. on the first floor of the belfry of St Mary's Church in Zadar were discovered through an unhappy concurrence of events, following heavy destruction of the town's centre just before the end of the Second World War. Among other buildings, the convent complex, including the church, the Capitulum Hall and the Convent, suffered damage, whereas the belfry remained unharmed. Because of strong detonations in close vicinity to the belfry, the upper plaster layers that covered the wall paintings fell off.⁸ Conservation-restoration research proved that the paintings had been in fragments before they were covered with plaster and lime-coated, and that their destruction was mainly caused by natural processes of deterioration. Rainwater flowing down the openings of the belfry for centuries onto the vault and walls of the room on the first floor, together with specific microclimatic conditions, contributed to rapid deterioration of the painted layer, *intonaco* and lower plaster layers (Fig. 3).

Fig. 3. Zadar, St Mary's Church, belfry, south-east wall, wall painting, detail: salt efflorescences.

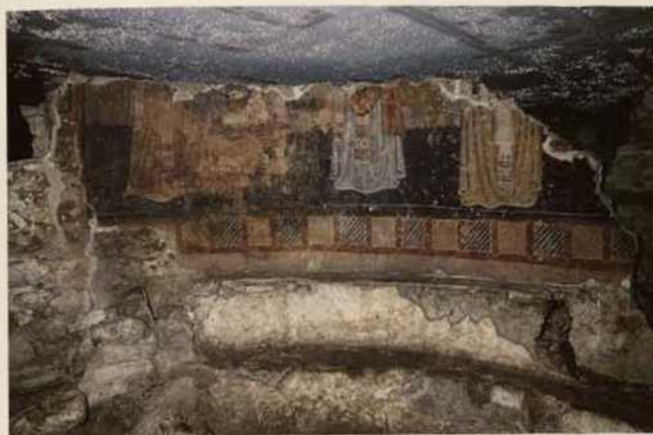
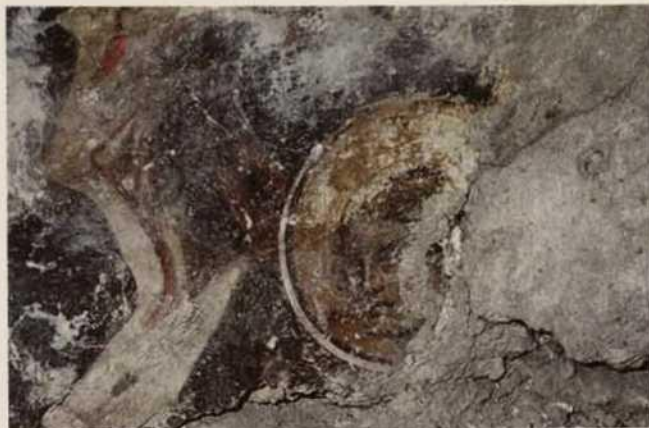
Fig. 7. Dubrovnik, Franciscan Monastery *Mala braća*, room above sacristy vault, wall paintings (first half of 14th century), detail (after excavation).

An example of fragmentation of wall paintings from the first half of the 14th c. where damage was mainly caused by human impact involves the paintings preserved on the walls above the vault of the sacristy in the Franciscan monastery *Mala braća* in Dubrovnik. The initial damage to the wall paintings occurred on the eastern wall of the sacristy after a chapel with an altar was added there at the end of the 15th c. Soon after replacing the original wooden beam in the sacristy with a vault made of stone and tufa, the wall paintings above the vault, which were damaged but still visible, were buried under rubble material. What happened to the wall paintings in the sacristy remains unknown; the results of preliminary conservation-restoration probing were negative (Fig. 7–8).

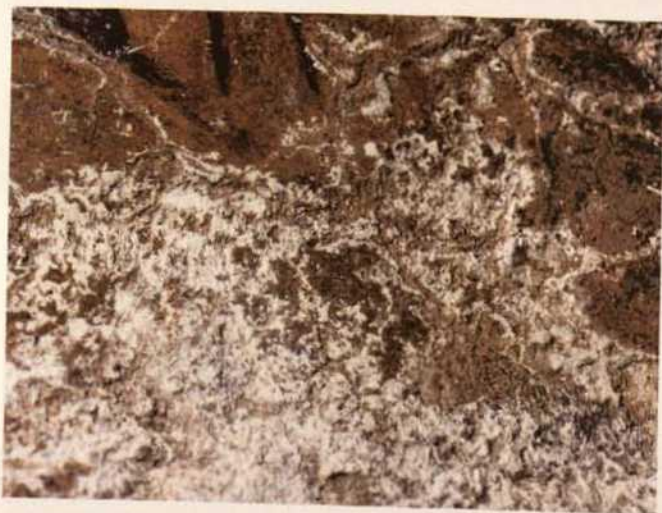
In terms of the material of the *intonaco*, which consists of slaked lime and sand together with a lot of brick-powder, wall paintings from the belfry of St Mary's Church in Zadar are similar to those in the Church of St Michael near Ston. Fragmentation of the paintings in Ston, from the second half of the 11th c., is caused by capillary moisture in the foundation which completely destroyed the paintings on the lower parts of the wall, rainwater leaking through the badly maintained roof, and perhaps also the impact of airborne salts from the salt-pans near Ston (still the subject of research) (Fig. 13 and 18).

Fig. 18. Ston, Church of St Michael, wall paintings (see fig. 17), detail: salt incrustation.

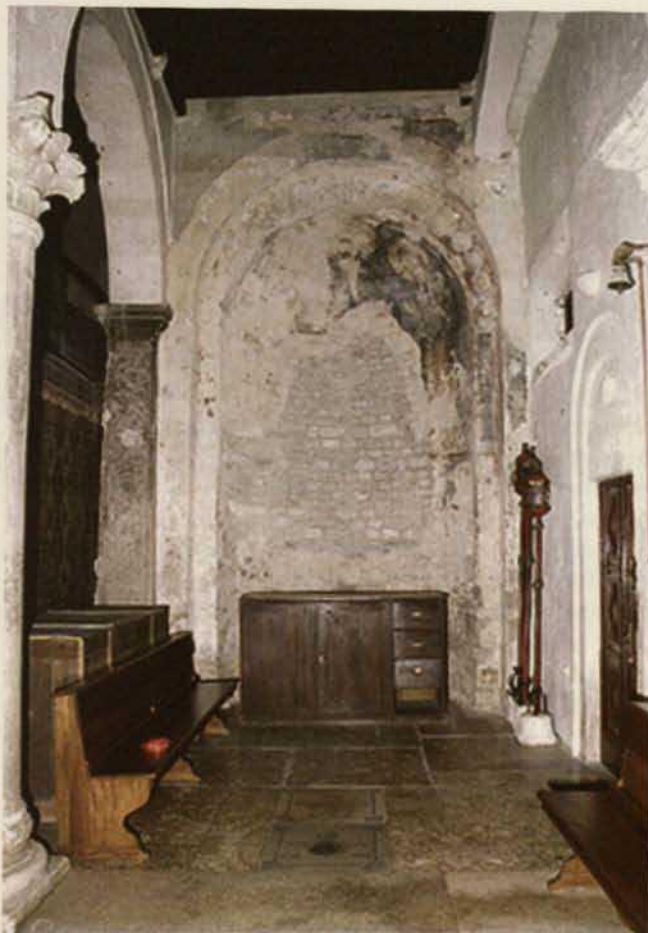
Based on these reflections, it can be concluded that the problem of increasing fragmentation of the support of the painted layer in the south apse of *Saint Anastasia's Cathedral* in Zadar could be solved in a manner similar to one suggested some thirty years ago: either by taking the wall paintings off the wall, conserving both the wall and the wall paintings, and returning the wall paintings *in situ*; or by trying to stabilise the microclimate in the apse of the south nave, after which certain conservation-restoration procedures can be applied to the wall paintings without taking them off the wall. Considering the fact that both actions require stabilisation, it seems safer to preserve the wall paintings and carry out all procedures needed to conserve them without removing them. However, on the other hand, if these actions are not undertaken as soon as possible, it could be too late for the wall paintings, and so the first solution mentioned should not be incautiously refused (Fig. 19–20). One of the ideas for improving microclimatic conditions in the south apse is to install a glass partition between the apse and the nave, so that the apse would be isolated and an adequate microclimate would be easier to establish (Fig. 21).

Fig. 20. Zadar, Cathedral of St Anastasia (Sv. Stošija), south apse, wall paintings (2004).

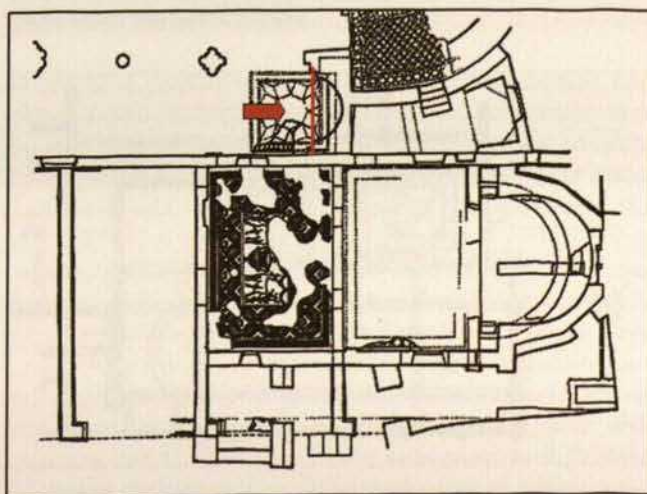
Fig. 21. Zadar, Cathedral of St Anastasia (Sv. Stošija), floor plan: anticipated glass partition between south nave and apse.

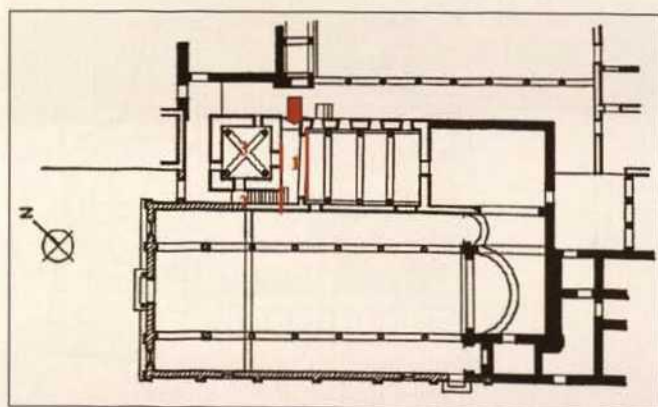
Fig. 22. Zadar, St Mary's Church, floor plan: anticipated glass partitions between belfry and capitulum hall as between capitulum hall and stairway.

Capitulum Hall and the stairway isolated from the hall by a glass door. The partitioning of the Capitulum Hall by means of a glass wall in front of the belfry in the line of two semi-columns is also being taken into consideration. The plan also anticipates stabilisation of the microclimate in the narrow passage between the belfry, the church and the attic of the Capitulum Hall, which leads to the stairway to the upper belfry floors. One of the most delicate questions in the microclimate project

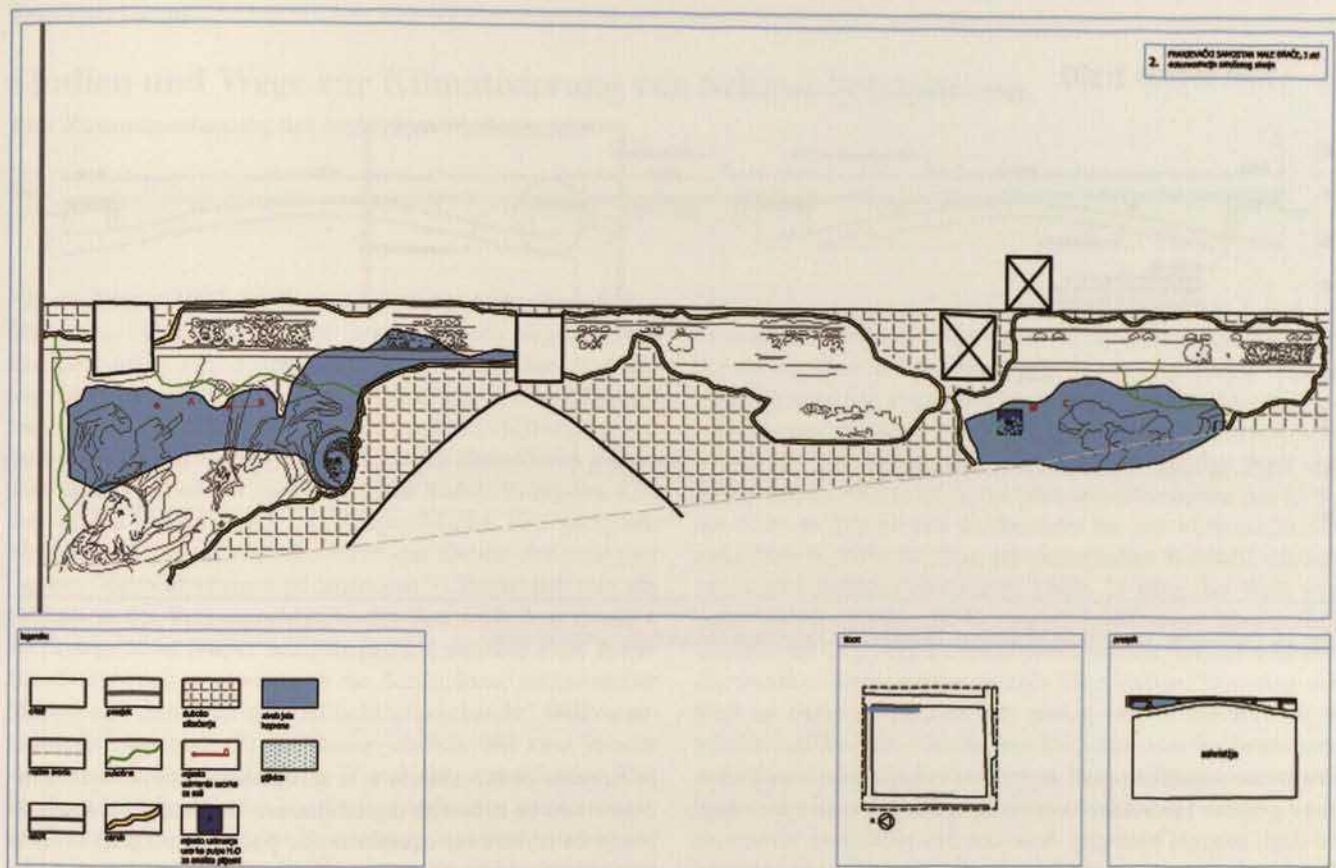
Fig. 23. Dubrovnik, Franciscan Monastery *Mala braća*, room above sacristy vault, east wall: graphic documentation of conservation-restoration works.

first floor of the eastern monastery wing even more complicated. After discovery of the fragments, the question of their conservation and protection arose. In view of the fact that six rooms, three of them with a bathroom, were being planned above the sacristy, the initial plan was to take the paintings off the wall, put them on a new support and display them on the walls of the cloister. However, this was not accepted by conservators and restorers, who insisted on protection of the wall paintings *in situ*. The project now anticipates controlling the condition of the wall paintings by means of several openings in the floors of the newly built rooms above. Research carried out so far included X-ray diffraction of samples of crystallised salts on the surface of the wall paintings; qualitative and quantitative chemical investigations of salt samples from pulps and microbiological research on samples of fungi from cellulose pulps. Their results warned of potential problems to be expected soon if a stable microclimate is not established in the new small space sandwiched between the vault and the floor (Fig. 23–24). Microclimatic measurements in the interposed space above the sacristy vault are therefore planned for after termination of the construction work, which will close the space off completely. The project anticipates using tubes built into the walls which will connect the space with the wall paintings to the attic and provide passive ventilation. In case such ventilation is not adequate, the tubes could be used for additional active ventilation (bringing in air with a certain temperature and humidity). Video-controls will be used for the long-term control of the wall paintings' condition.
