Minimal Intervention and Regular Repair

This paper deals with the conservative repair of old fabric on or near the surface of historic buildings, the first three case studies being external wall surfaces, the fourth being a floor. They illustrate a wide range of materials and techniques used on a range of substrates. However they all have in common mortar mixes bound only by non-hydraulic lime, and only traditional building techniques were used.

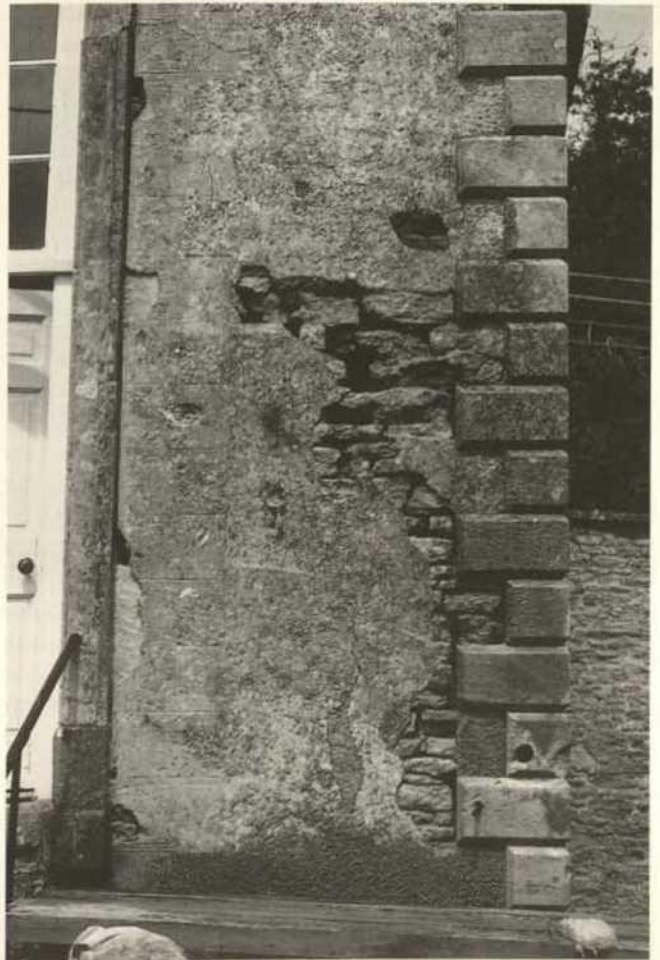
Fig. 1. First case study: Church House Gazebo. Preparation for lime mortar consolidation and lime roughcast render. Loose material was associated with settlement in the structure.

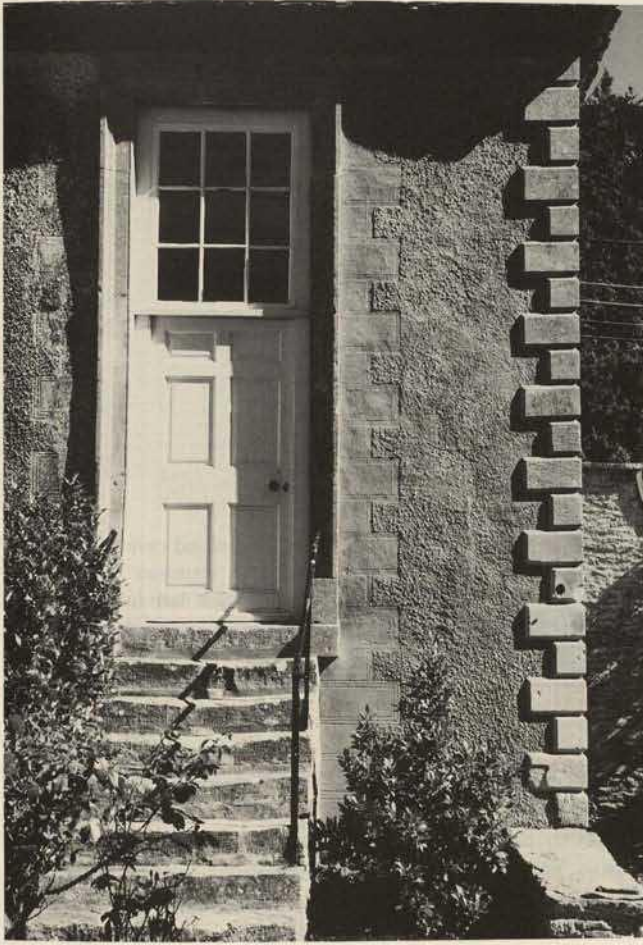
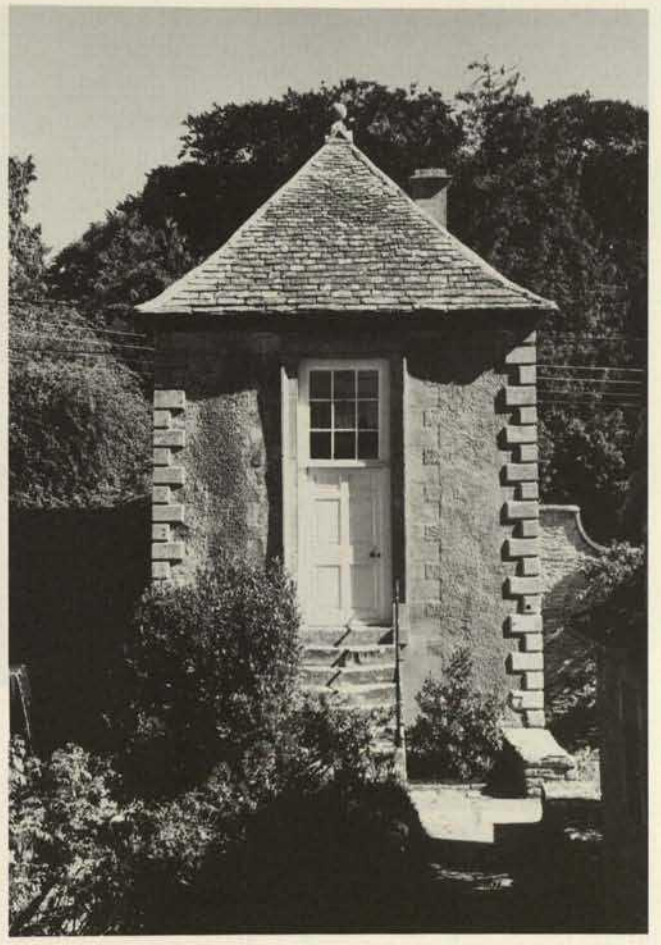
The gazebo is in a stable condition and is much appreciated by its owners. However the damp level in the basement walls has been raised by dense Portland cement repairs to the roughcast low down on each elevation, carried out in the 1960s. Then various repairs have been done to the building over the past decade, as and when required, using lime-based mixes. The owners do not want to restore the exterior surfaces as they admire their mellow grey-coloured patina.

Fig. 2, 3. First case study: Church House Gazebo. Completed lime roughcast render repairs, with coloured limewash.

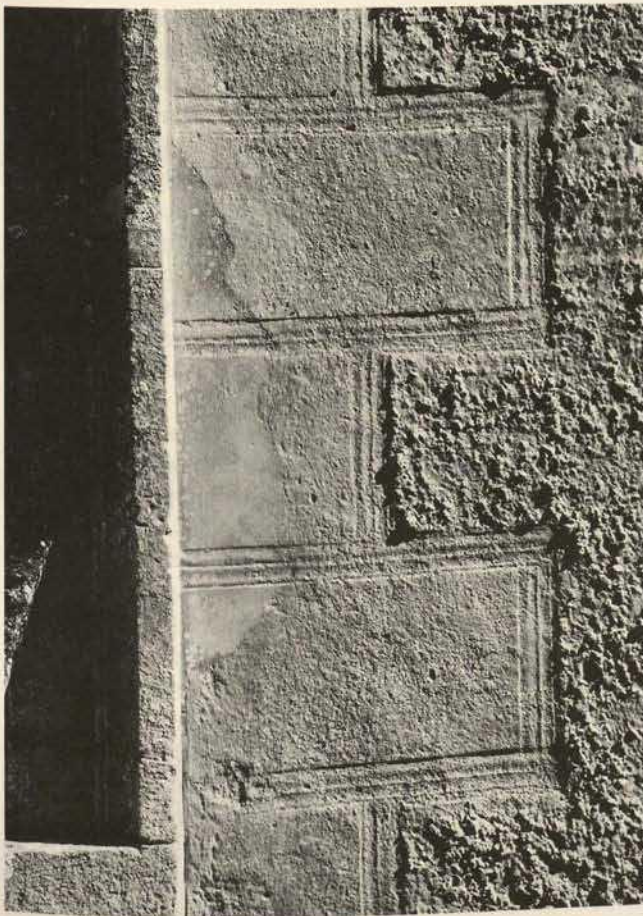
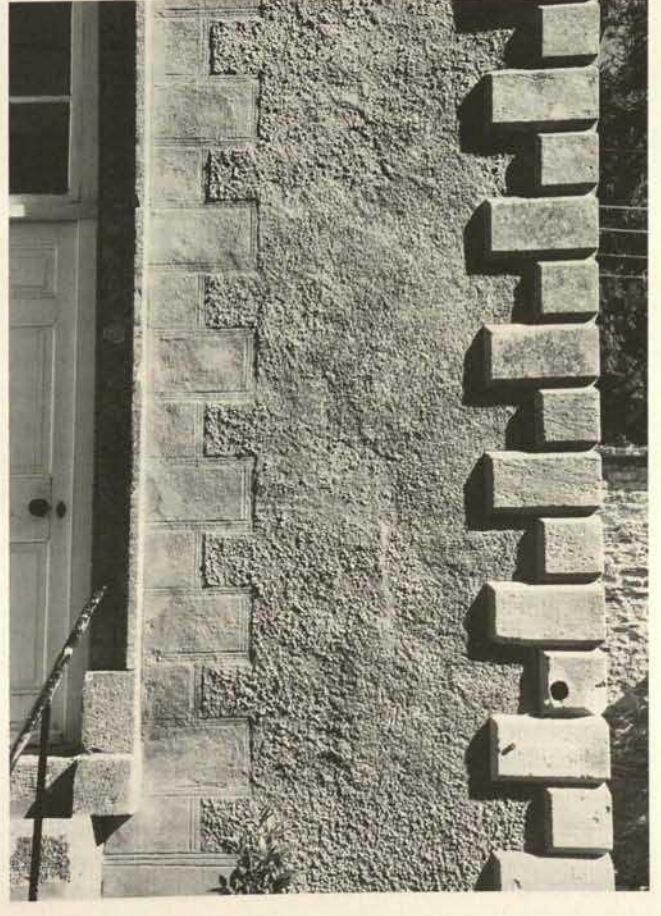
Fig. 4, 5. First case study: Church House Gazebo. Completed lime roughcast render repairs, with coloured limewash. Detail, showing repairs to fictive quoins against door architrave.

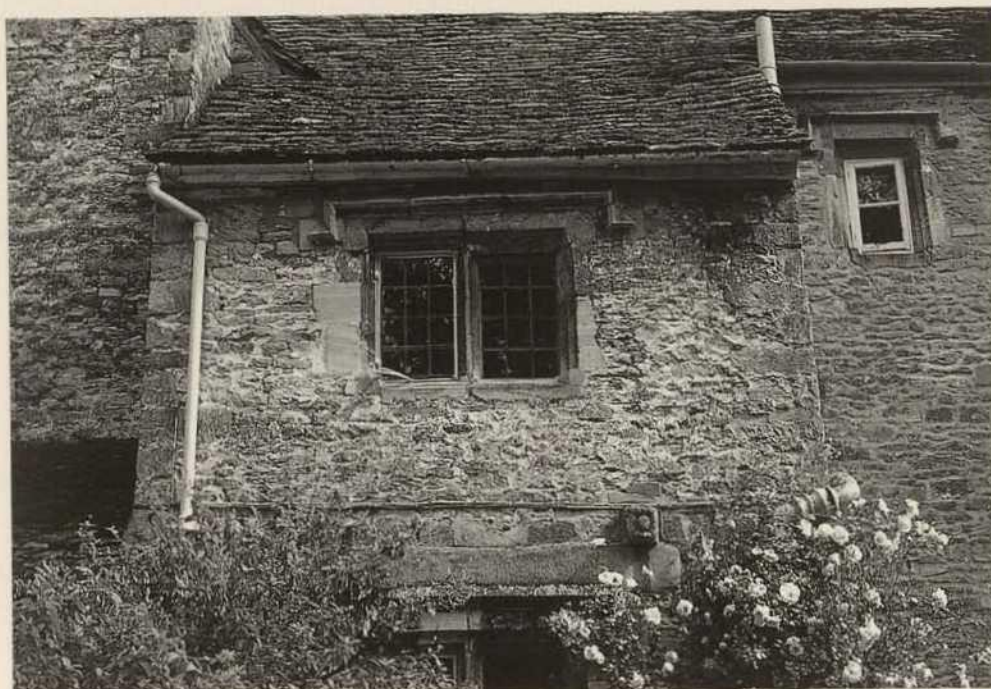
Fig. 6. Second case study: Woolgatherers staircase. The original lime surface before repair work. Note previous repairs with Portland cement on wall to right, and on timber lintel below.

Here was a true and even surface, following the medieval tradition. The wall construction was the same as that described in the first study, but it had never been rendered. Instead it was flushpointed, almost 'plaster pointed', with a very resilient lightweight lime-rich mortar, (almost pure lime putty), and reinforced with cow hair. Like the mortar used to bed the freestone

The work on this wall was similar to that described in the first case study. The minimum of fabric was removed, and only using small blade tools, except for several isolated hard cement fillings which required a hammer and sharp chisels to free them. Slight settlement within the wall had caused cracks to open up and these contained loose material. Detachment of the pointing mortar was also associated with its original shrinkage cracks. The cavities and the surface were carefully brushed down, first dry then wet, care being taken not to let excess moisture penetrate the structure. Only loose flaking layers of limewash were lost in this process.

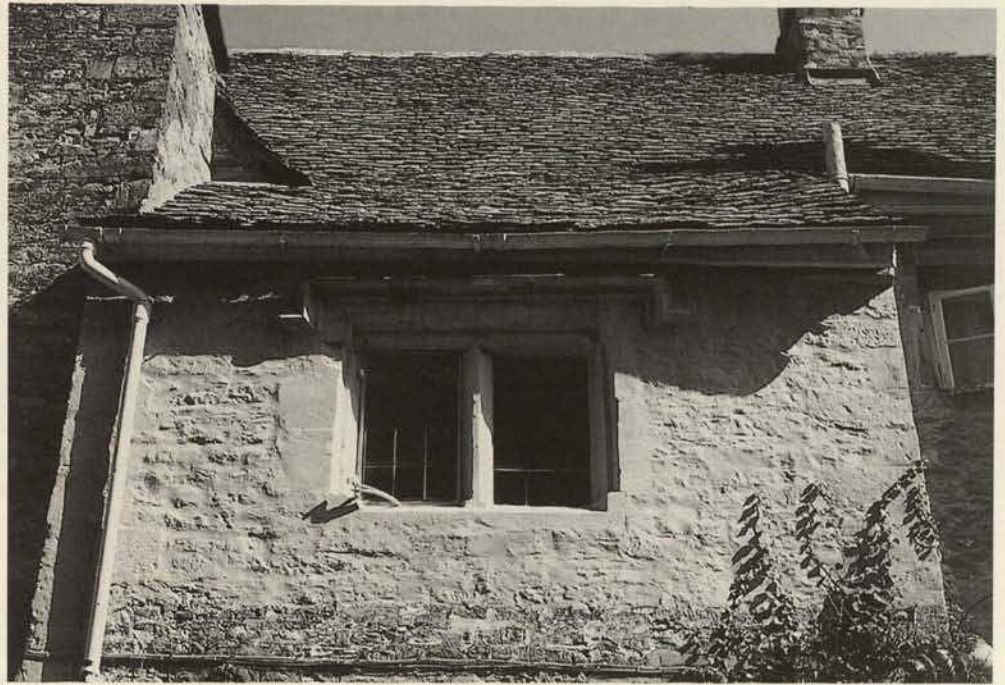
Fig. 7. Second case study: Woolgatherers staircase. Completed lime repairs to mortar joints and stones, and five coats of limewash.

Mortars similar (but not identical) to those found in situ were used to reinstate the structural integrity of the wall and then build up the surface of the mortar joints so that the new work lay precisely in line with the remaining original mortar surface, not overlapping at any point. Areas of decay in the freestone dressings were removed, and these irregular-shaped lacunae were then built up layer by layer with mortars designed to match the colour and texture of the stone.

A day after the mortaring was complete the whole area was limewashed in a colour related to those of the surviving fragments, using traditional iron oxide earth pigments. As always, after systematic and careful dampening, the limewash was flooded onto the surface and worked into all fissures and granular areas and allowed to partially absorb. It was taken up to the glazing line in the window. Then it was 'burnished' with an empty but damp brush to compact it, in the same way as the mortar has been pressed in to counteract shrinkage cracking. The work was protected from sun and wind. Four more coats of limewash were added, no more than once a day, allowing for carbon-

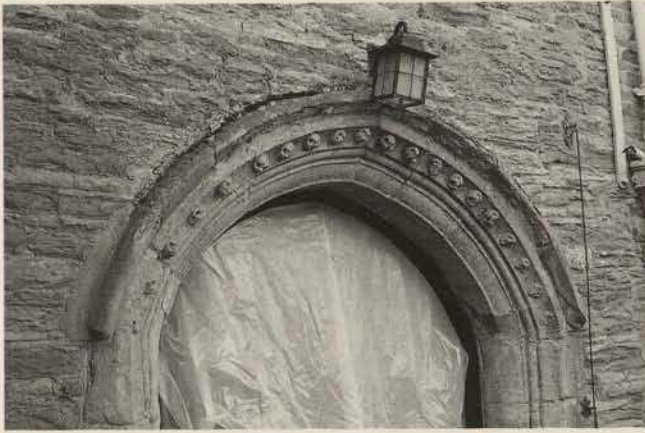
Fig. 8. Third case study: Broadfield Court. The fourteenth century doorway before repairs. Note decayed surfaces to hoodmould and surrounding rubblework, and Portland cement fillings.

The aim of this project was to find ways of arresting the decaying doorway masonry without adversely changing its appearance, or losing original fabric. Commonplace lime mortars if used with mastery and invention (as is often the case in 'old work') were considered to be a desirable alternative to unproven (and expensive) chemical 'preservatives', or to conventional masonry practice. Cutting out and replacing so-called 'failed' stone would have drastically altered the ancient character of the doorway, and would have been expensive. On closer inspection the decay, though active, was only affecting the stone to a maximum depth of 15mm and it was mainly confined to the encircling hoodmould which was of a green coloured soft siltstone. Apart from ancient wear, the gritstone masonry was basically in a stable condition. It was assessed that there were two principal causes leading to the decay of the doorway which posed a serious threat in the future. One was the hoodmould that had become so decayed that it was no longer functioning as a water-shedding feature, with the result that the carved voussoirs and jambs were suffering unnecessarily. The other was the surrounding rubblework of friable weakened stones in a perished mortar exacerbated by a large area of recent repointing in a dense cement mortar, associated with a once-leaking drainpipe.

It was agreed that the ambient conditions within the fabric must be improved. Therefore its functional equilibrium in the immediate area of the doorway was restored so that it could perform efficiently as a rain-absorbing and evaporating surface. It was hoped that this in turn would alleviate stress in the hoodmould, and the masonry below, by reducing direct run-off and avoiding an accumulation of moisture within the wall. It was decided to restore the full architectural form of the hoodmould so that it might once again perform its intended function. The chal-

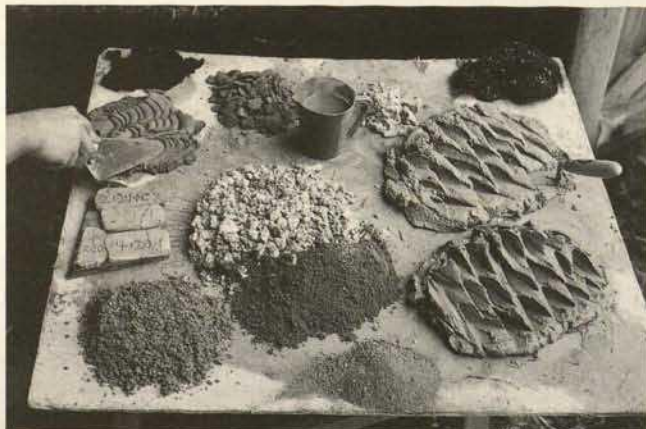
Fig. 9. Third case study: Broadfield Court. The range of lime products used on the repairs to the doorway. Note goat hair for reinforcement of mortar for hoodmould.

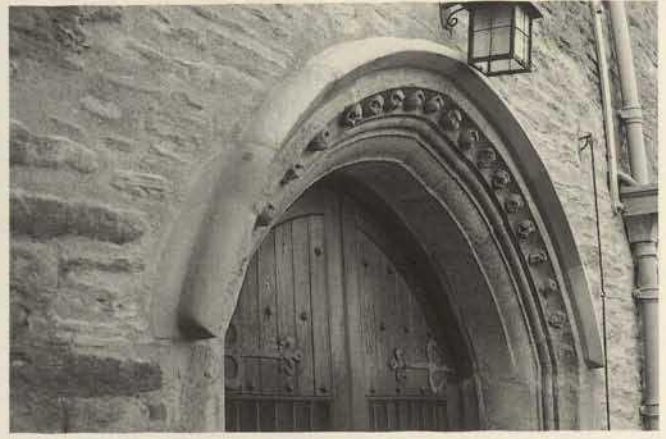
Fig. 10. Third case study: Broadfield Court. The completed lime repairs. Note the limewashed stones of the hoodmould, and repointed rubblework.

The work was carried out in September 1995 and amounted to twenty man days. Various lime mortars were prepared in advance. Decayed or cementitious material was removed from the doorway and the surrounding rubblework, after which the masonry was cleaned. Joints and voids were filled with the appropriate mortar, and subsequently 'finished' by compacting, then paring away, and brushing and sponging the surface to reveal the aggregates, that is, the full character of each mix. Because they would be exposed to view it was important to counteract the inherent light tone of lime. However the most intricate operation was the consolidation and building up of the hoodmould to its full form. This involved incorporating terra cotta chips, thereby providing a core to counteract shrinkage by halving the thickness of this necessarily plastic mix. It was then limewashed to match the colour of each stone within its length. Lime shelter coats were applied in very localised areas such as the disaggregated ballflower ornamentation. Finally a rotten stone near the base of the right jamb was replaced with a suitable piece of gritstone. A mortar repair was not chosen for this position because it might be too weak, being vulnerable to salt decay, frost and mechanical damage. The immediate environmental conditions were controlled so the work would dry out gradually. Fortunately the autumn was warm and dry. The first frost came seven weeks after completion of the work. The doorway has been inspected every six months since, and is looking well three years later.

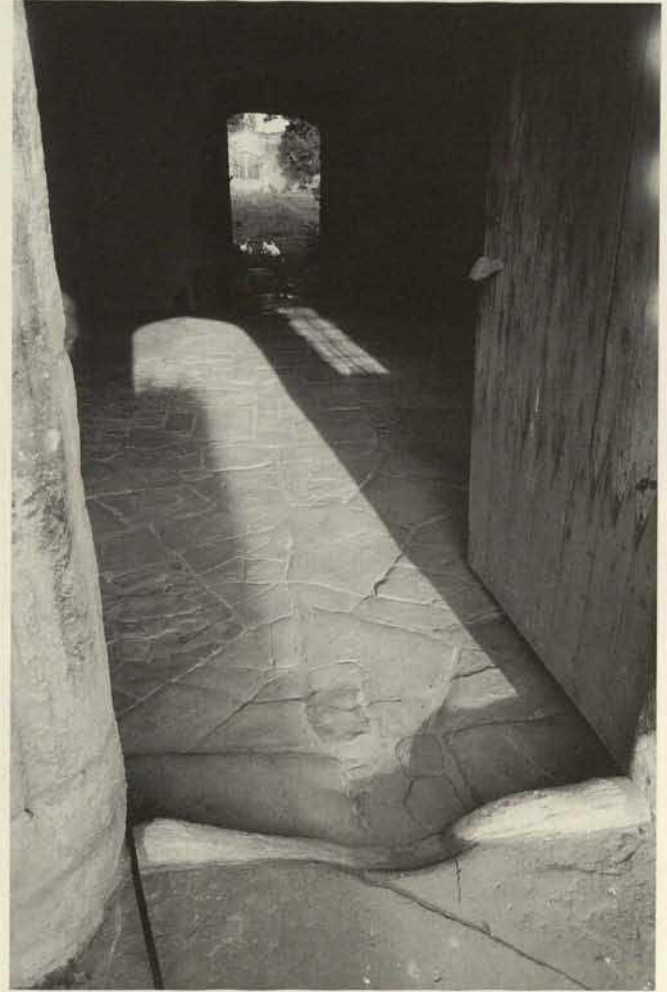
Fig. 12. Fourth case study: Acton Court. Cross passage floor from west to east after lime mortar repairs. Note the unusual configuration of pennant stone parving.

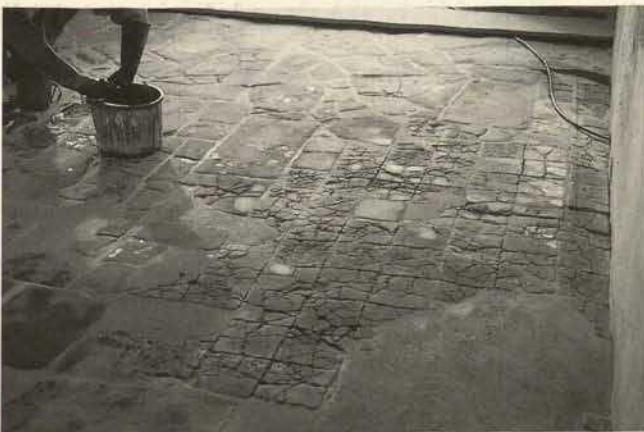
Fig. 11. Fourth case study: Acton Court. Cross passage floor after lime repairs. Note lacunae filled with mortar, and only the larger joints.

It was decided not to 'confuse history' by restoring the missing paving with similar materials. Two exceptions were made in front of two door thresholds, areas which would always receive more traffic. Instead, all the other lacunae, both those existing and those caused by the removal of concrete, were packed with a composite repair material consisting of layers of low fired tile and lime/brick dust mortar, bulked out with clean permeable stone if the depth exceeded 50mm (being the approximate thickness of the larger flooring components.) The deepest of these areas remained damp and workable for ten days. During this time and subsequently, they were absorbing soluble salts from the ground and the adjacent floor, which were later to effloresce. This phenomenon was expected and accepted as beneficial to the long term health of the floor. Two months later a crop of salt crystals was removed from the mortar surface which was now hardening steadily. It is hoped that all subsequent efflorescence will be likewise removed from these buffer zones so they can continue to alleviate salt levels in the floor. The glazed tiles are particularly vulnerable and precious.

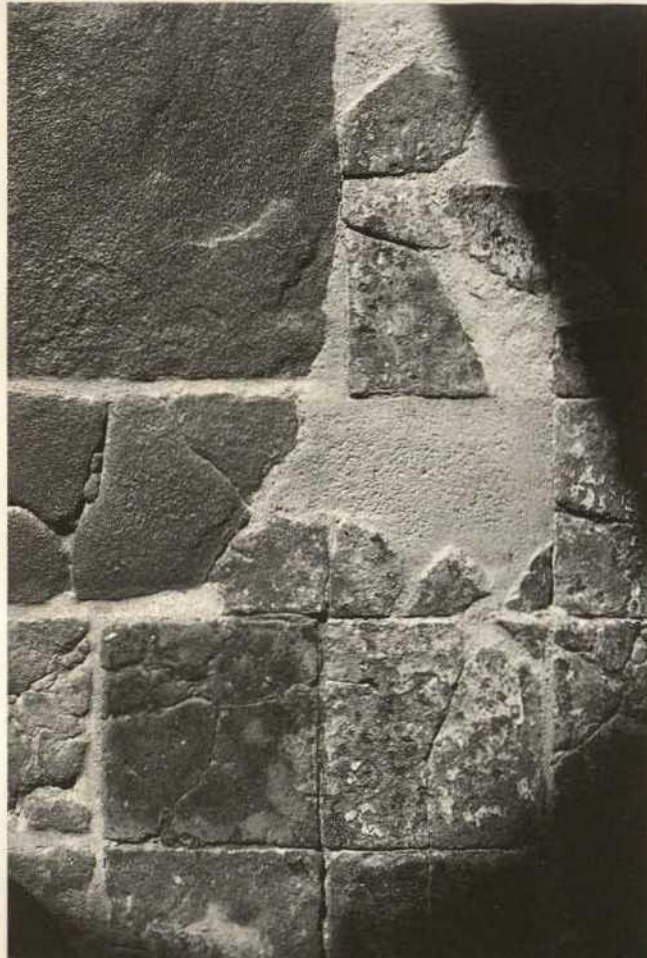
Fig. 13. Fourth case study: Acton Court. Cross passage floor on completion of lime repairs. Note area of contrasting mortar to indicate resiting of buried tiles.

As shrinkage cracks appeared the mortar was compacted and given a wood float finish, their surface plane being adjusted so it was always between 1mm and 3mm below the adjacent floor surface. One deep lacuna contained loose tile fragments and other debris. It was decided that the tiles should be used on the surface above where they were found. So they were set in a small area of contrasting (pink) coloured mortar to indicate a conjectural reconstruction. When the lacunae and all the joints and larger cracks had been filled one could read the floor as one continuous surface. Though fragile under-foot it looked solid; its delicate integrity had been regained.
