Kazumi Murose

An Example of Conservation Work: A Portable *Namban* Style Altarpiece with *Makie* Design from the Nagoya Municipal Museum

This report is concerned with the process of conservation of a portable *namban* style altarpiece done at the Mejiro Institute of Urushi between June 1997 and March 1998.

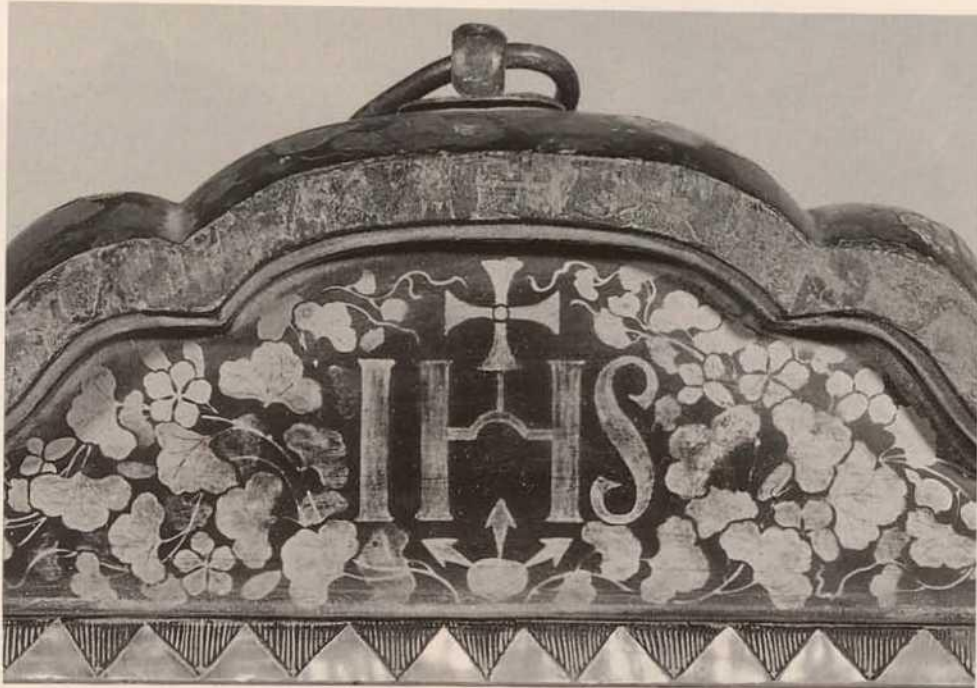
Fig. 1. Portable *namban* altar, front view of altar top with initials of the Society of Jesus I.H.S. before treatment

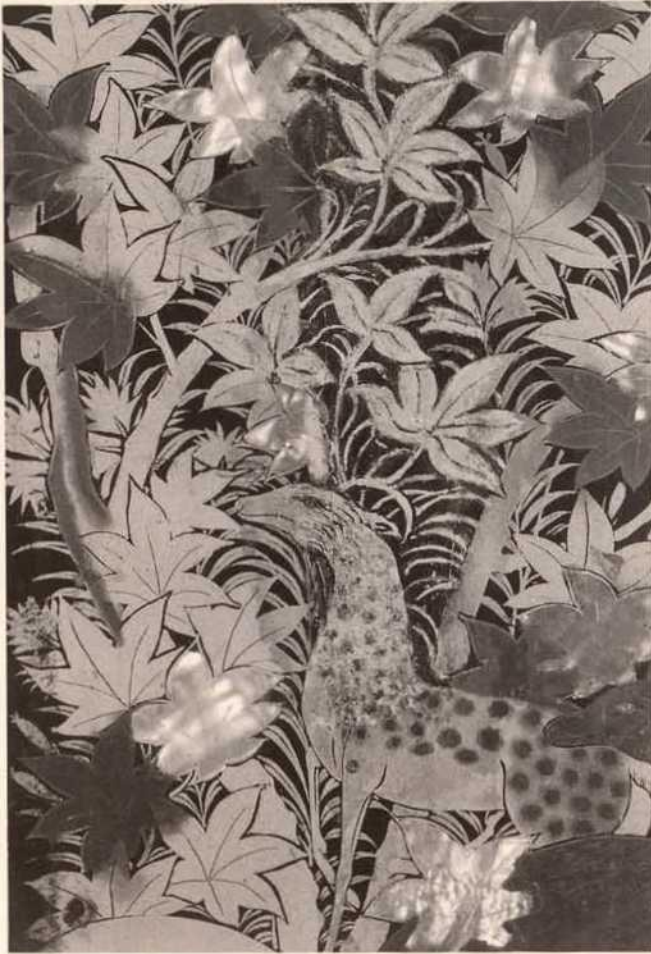
△ 2

Fig. 2. Right door inside in *makie* with supplements before treatment

body, some of which have been restored in Europe with white material like putty. The center of the right door is seriously damaged and coating and *makie* are inlaid in later restorations with unknown materials.

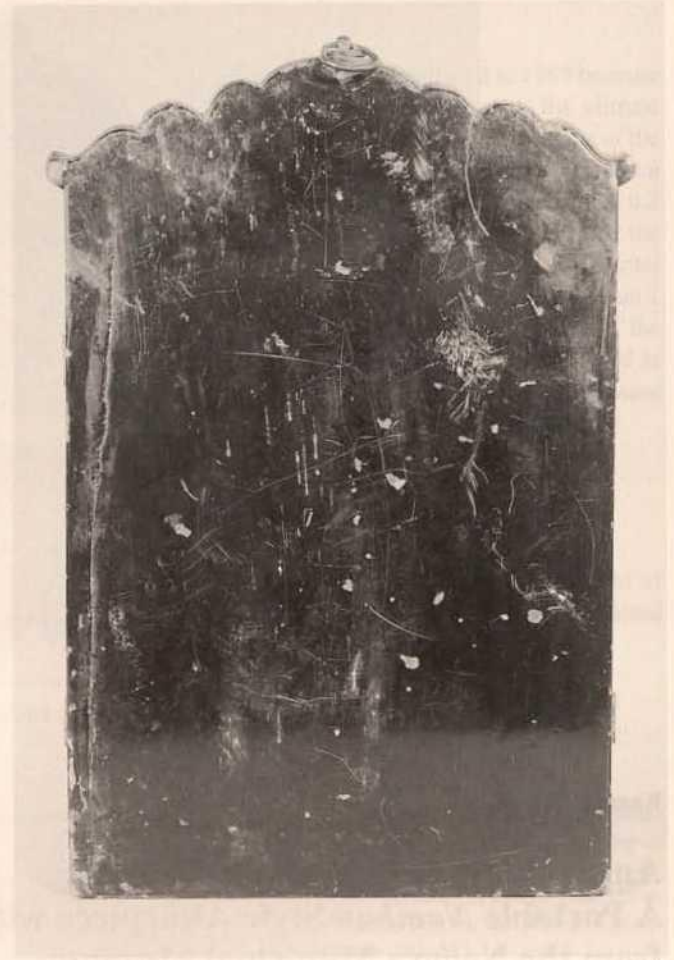
3 △

A vertical crack from the shrinkage of wood is seen on the backside of the main body and caused a difference in level (fig. 3). The structure of the altar is unsteady because of cracks also seen at the joint of the body and the top part which is shaped like a Chinese-style gable, and a lacquer coating near the cracks is lifting. There are many dents from the side to the bottom of the

Fig. 3. Overall view of altar back before treatment

Cracked areas were set with *mugi urushi* in the same way as the process above. The backside of the altar, where a deep crack was making the surface uneven, was restored by pressuring the surface with a clamp.

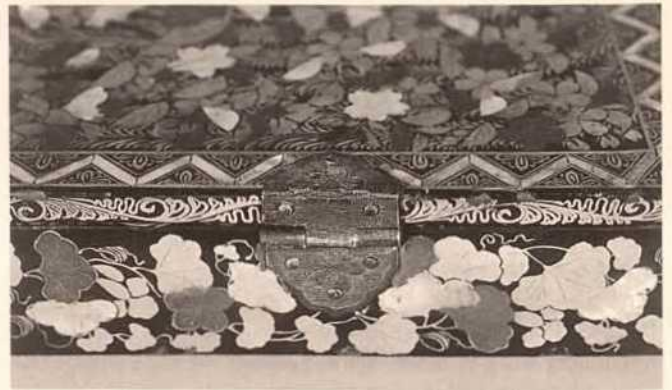
△ 4

Fig. 4. Hinge, outer edge, right side, after treatment

Bent hinges were straightened, and the right upper hinge, which had been broken in two, was reinforced with a thin metal plate from the back. New nails were applied to the missing places and in place of the nails of the previous restoration.

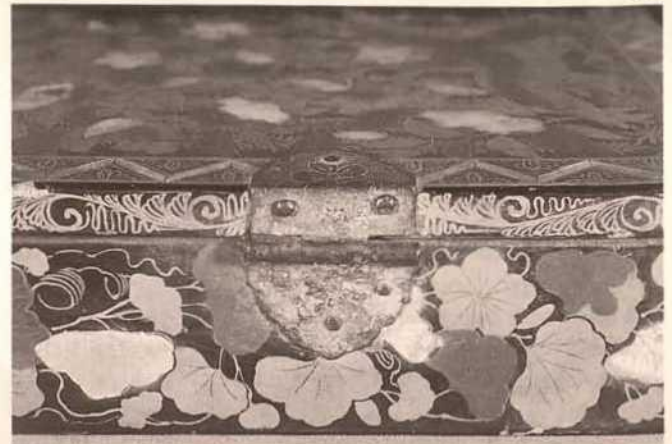
5 ▽

Fig. 5. Hinge, left bottom, before treatment

The panel of the painting is strongly warped. Dryness also added a long crack in the center which runs to the frame. Too much adhesive and animal glue has been stuffed into the crack in later restorations and now spoils the outward appearance of the piece of lacquerwork. Nails used to attach the metal hinges have become loose and prevent doors from opening smoothly. The right upper hinge is broken in two, only held with two nails (fig. 4). The left bottom hinge is also cracked in the corner. Two of the nails have been applied later, as many are missing and new ones need to be supplied (fig. 5).

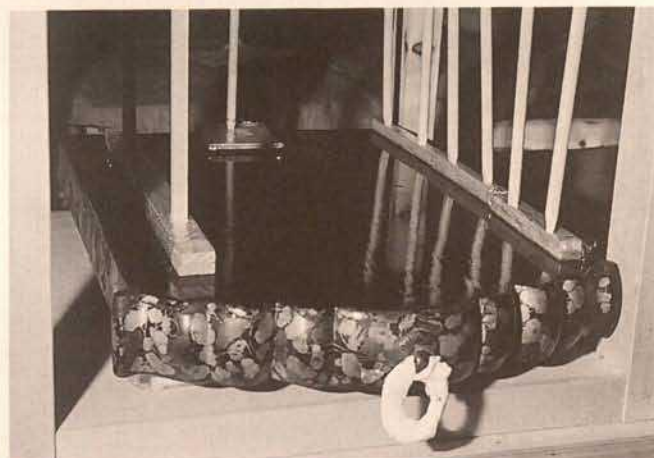
Fig. 6. Altar back: glueing with *mugi urushi*

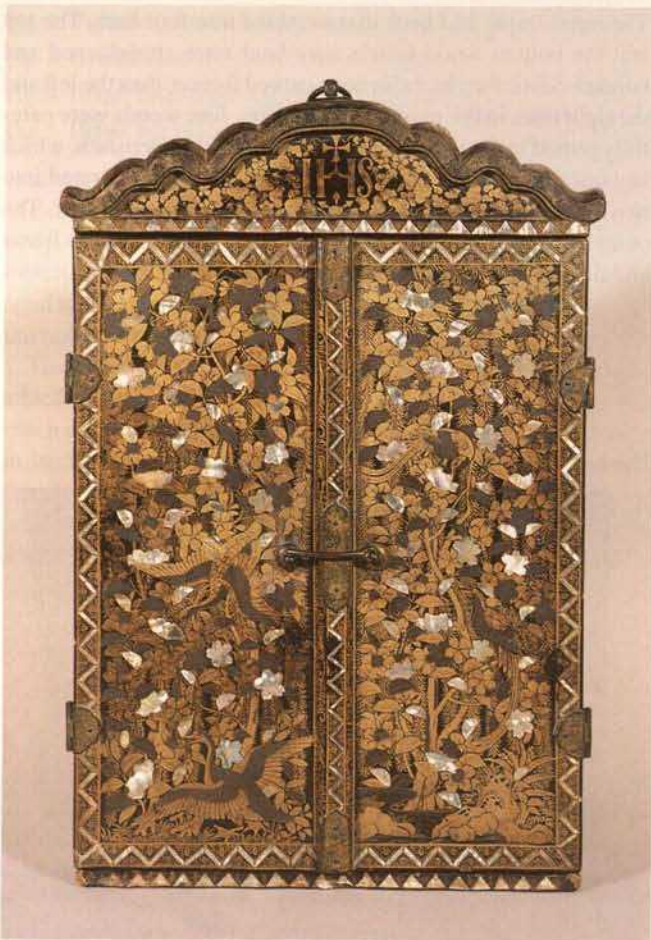
2 Overall view of the portable *namban* altar before treatment

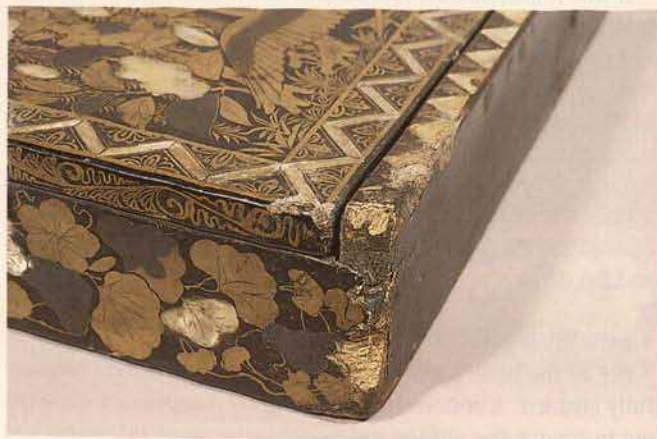
3 Outer edge, left side below, fault, before treatment

Chipped and dented areas were filled with several coats of *kokuso* of different consistencies and set just under the original surface (colour plate XVIII.3, 4). This is to show that the area was conserved rather than restored. White putty-like material used in the previous restoration was removed and replaced with *kokuso* (figs. 7, 8).

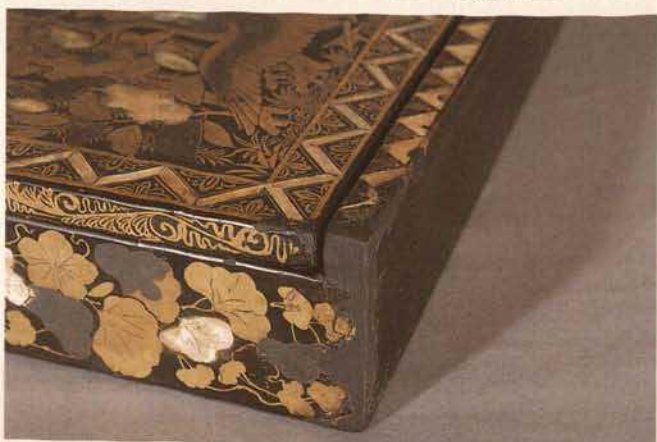
4 Outer edge, left side below, after treatment with *kiwasabi*

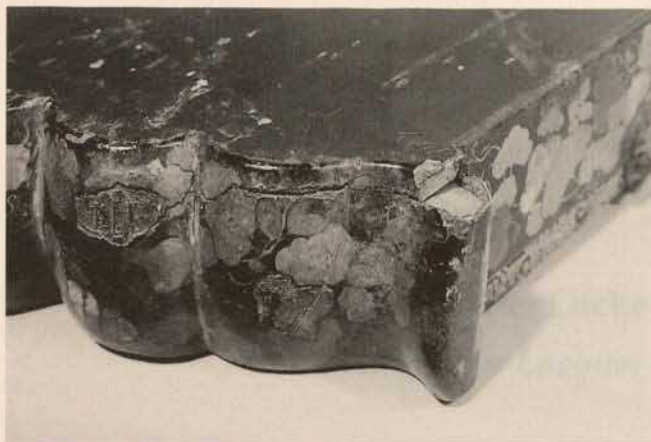
Fig. 7. Back side, upper left, fault within the wood before treatment

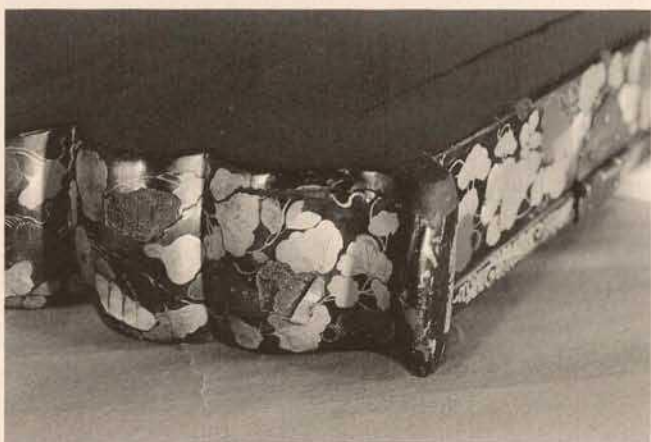
Fig. 8. Back side, upper left: application of *kokuso*, condition after treatment
