## Office Buildings of the Chicago School: The Restoration of the Reliance Building

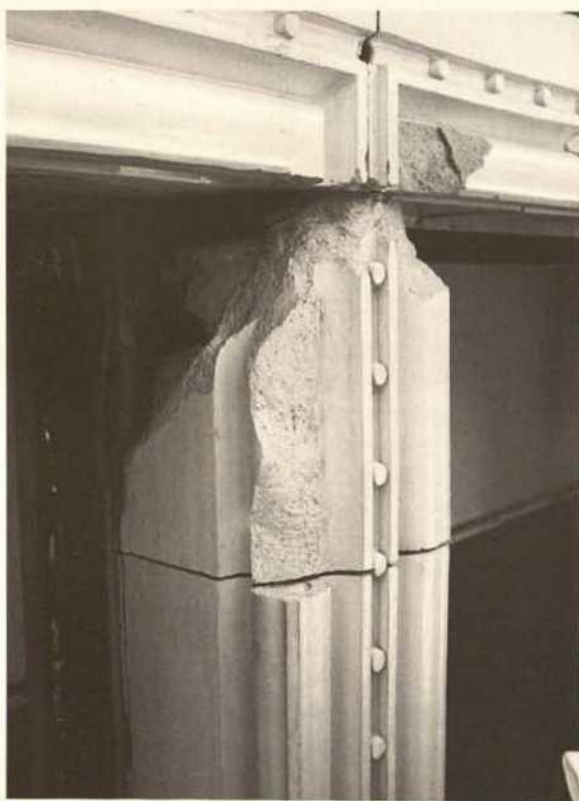
### III. 2

Chicago, Reliance Building: The build-up of compressive stresses within the façade had caused mullions to fracture and hundreds of terra cotta units to crack and split. This was the single most prevalent cause of deterioration. (left)

It was determined that the terra cotta portions of the curtain wall were under a tremendous build-up of compressive stresses due to foreshortening of the steel frame under the weight of the building, expansion of the terra cotta masonry caused by environmental forces, and a lack of means within the curtain wall to accommodate these contrary forces. This compression build up had caused fracture of a significant number of terra cotta units. Cracking promoted water infiltration which attacked the wrought iron clamps attaching the terra cotta to the cast iron mullion and rail system. The consequent corrosion of the clamps caused further cracking of the terra cotta and exacerbated the water leakage problem. Furthermore it was determined that, until the stresses within the wall were addressed, terra cotta units could not be removed from the wall for replacement or repair without damage to adjacent panels. Openings were also made at the top of the building to view and record those portions of the cornice structure which were still in existence. The original architectural documents that were available gave no record of the appearance of this element of the building. The new cornice was designed from the study of historic photographs.

To address the stresses within the curtain wall, temporary horizontal expansion joints were saw-cut through the wall at each level. The joints were introduced continuously below floor line relief angles and at mortar joints starting

at the top level and working downward. The result was a graduated relaxation of stresses as the expansion joints were installed floor by floor. Once the expansion joints were completed and the stresses were relaxed, the joints were again filled with mortar to reinstate the original integrity of the curtain wall.<sup>15</sup> It was accepted that stresses will eventually reappear in the curtain wall, but it is believed that they will never reach the magnitude of the time before restoration.

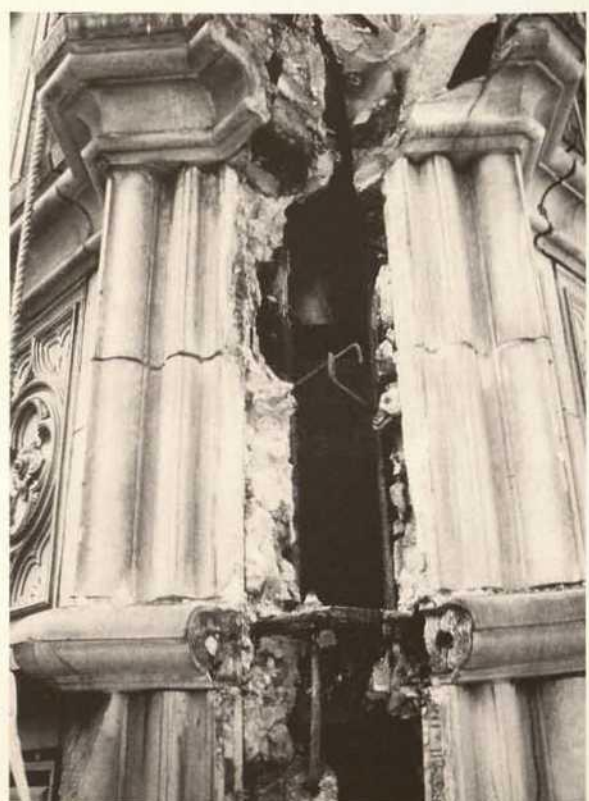
### III. 3

Chicago, Reliance Building: Corrosion of wrought iron clamps within the terra cotta and the consequent expansion of the corrosion product also caused large cracks and fissures to open up within the façade. These openings promoted further water infiltration and accelerated the corrosion process. (right)

Once the stresses were relaxed, restoration of the terra cotta curtain wall could proceed. Approximately 3,000 units were removed, 1,000 of these were conserved and reinstalled and 2,000 were replaced with newly fabricated terra cotta. With all replacements and re-installations, the wrought iron clamps were replaced with similar anchors of stainless steel. In addition, about 500 pieces were repaired in situ. Each unit of terra cotta was treated with extreme care and, when possible, terra cotta units were reused rather than replaced. Small chips and spalls in terra cotta that were unrelated to system pathologies were patched with mortar in the color of the terra cotta bisque and were molded to conform to the original shape of the unit. The patches were then coated with a breathable paint of the same color as the terra cotta glaze.

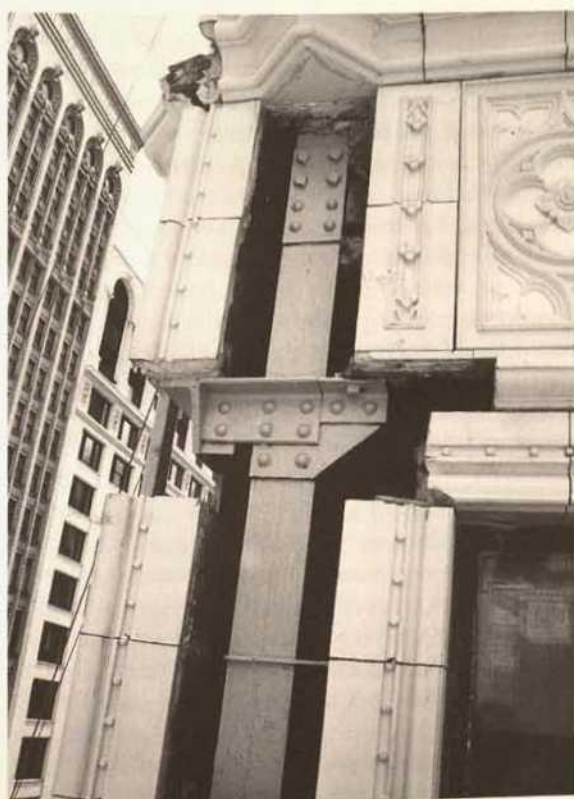
III, 5  
Chicago, Reliance Building: During terra cotta replacement exposed metal elements such as columns, spandrel beams, and the cast iron mullion and rail system, were cleaned and painted. It was found that the mullion and rail system was in relatively good condition. If this system was found to be significantly deteriorated the restoration project would not have been feasible. (left)

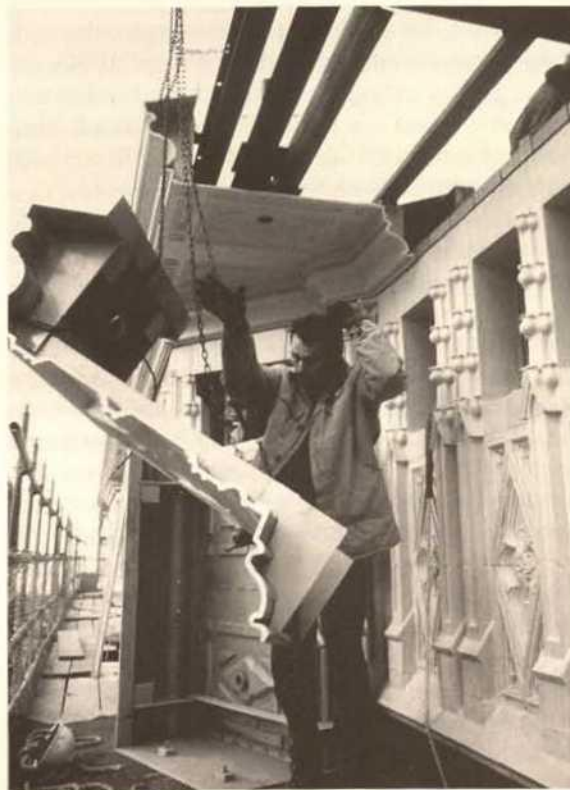
III, 6  
Chicago, Reliance Building: Cast aluminum that was painted was used as a substitute material for replacement of the cornice because of its durability. The cornice was realized as a system of panels that were independently suspended from a steel frame above with joints to allow movement between adjacent panels and between panels and the terra cotta façade. (right)

No portions of the original cornice remained and it was decided to consider substitute materials other than terra cotta for the cornice replacement. Cast aluminum that was painted was chosen as the best substitute material because of its durability. The new cornice was detailed so that it was separate from the façade so differing movement of dissimilar materials would not cause future distress on the building. The cornice was realized as a system of panels that were independently suspended from the frame support with joints to allow movement between adjacent panels and between panels and the terra cotta façade.

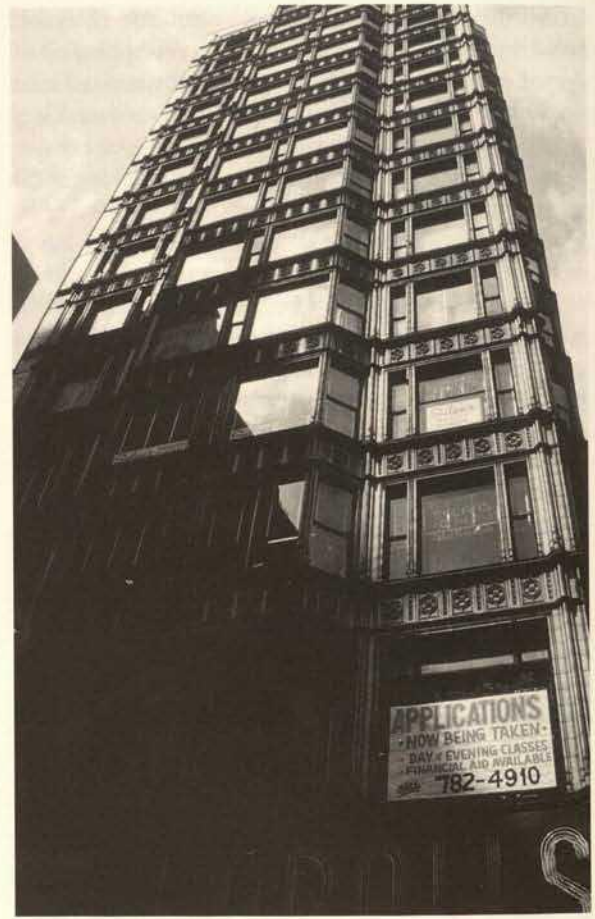
Chicago, the view of the east elevation of the Reliance Building before restoration reveals the Chicago style windows made up of fixed glass flanked by double-hung windows. The largest panes of glass on the façade would not fit into the elevators. Consequently, when larger windows cracked, they were replaced with smaller panes of glass with vertical mullions which bisected the once magnificent windows (right side).

economical manner. By 1941, the base of the building including two of the three projecting bays were altered to accommodate signage. Many of the large windows had cracked and were replaced with smaller panes of glass with vertical mullions which bisected the once magnificent windows because full size window glass would not fit into the elevators. The building had become noticeably darkened by atmospheric pollutants. By the mid 1980s, the building posed a danger to pedestrians due to falling terra cotta and its future was in question. The Reliance Building was purchased by the City of Chicago in 1994 and funds were allocated for restoration.

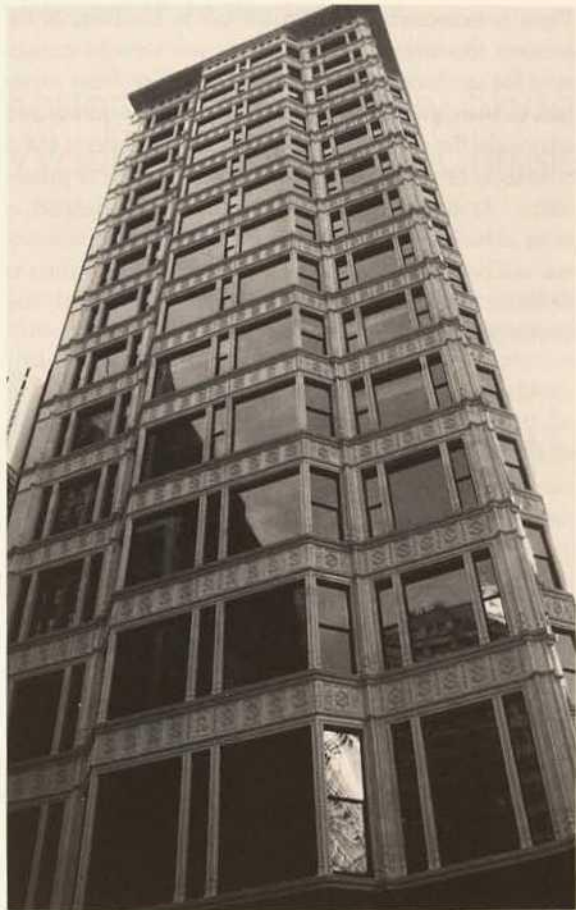
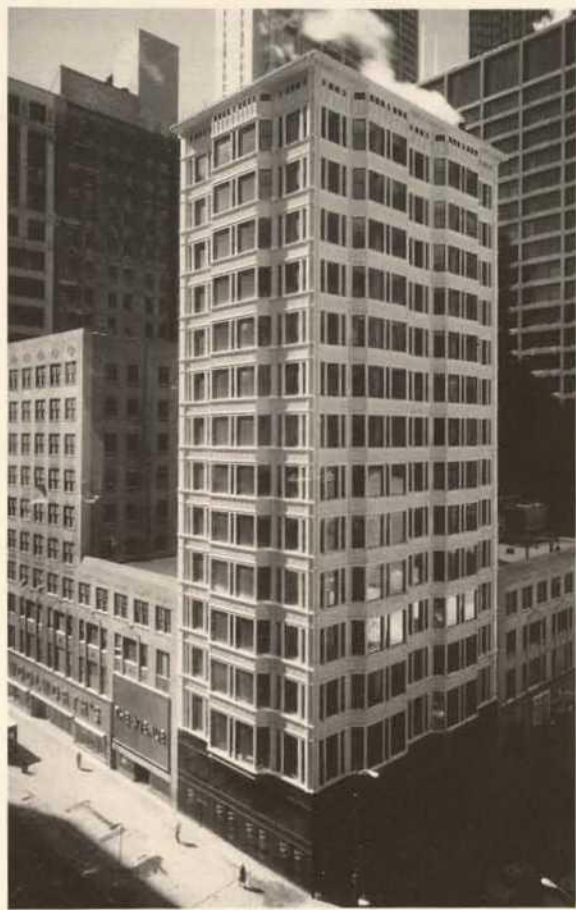
Ill. 9

Chicago, Reliance Building: The restoration of the exterior façade was completed in November of 1995. Remaining to be restored on the exterior are the storefronts which are now covered with a temporary aluminum curtain wall system. The storefronts will be restored along with the interior of the building in the phase-II-restoration set to begin in 1997.
