Dagmar Knotková, Jiri Had, Katerina Kreislová

Restoration of Copper and Bronze Monuments in Prague

Corrosion Manifestations. Anticorrosion Measures

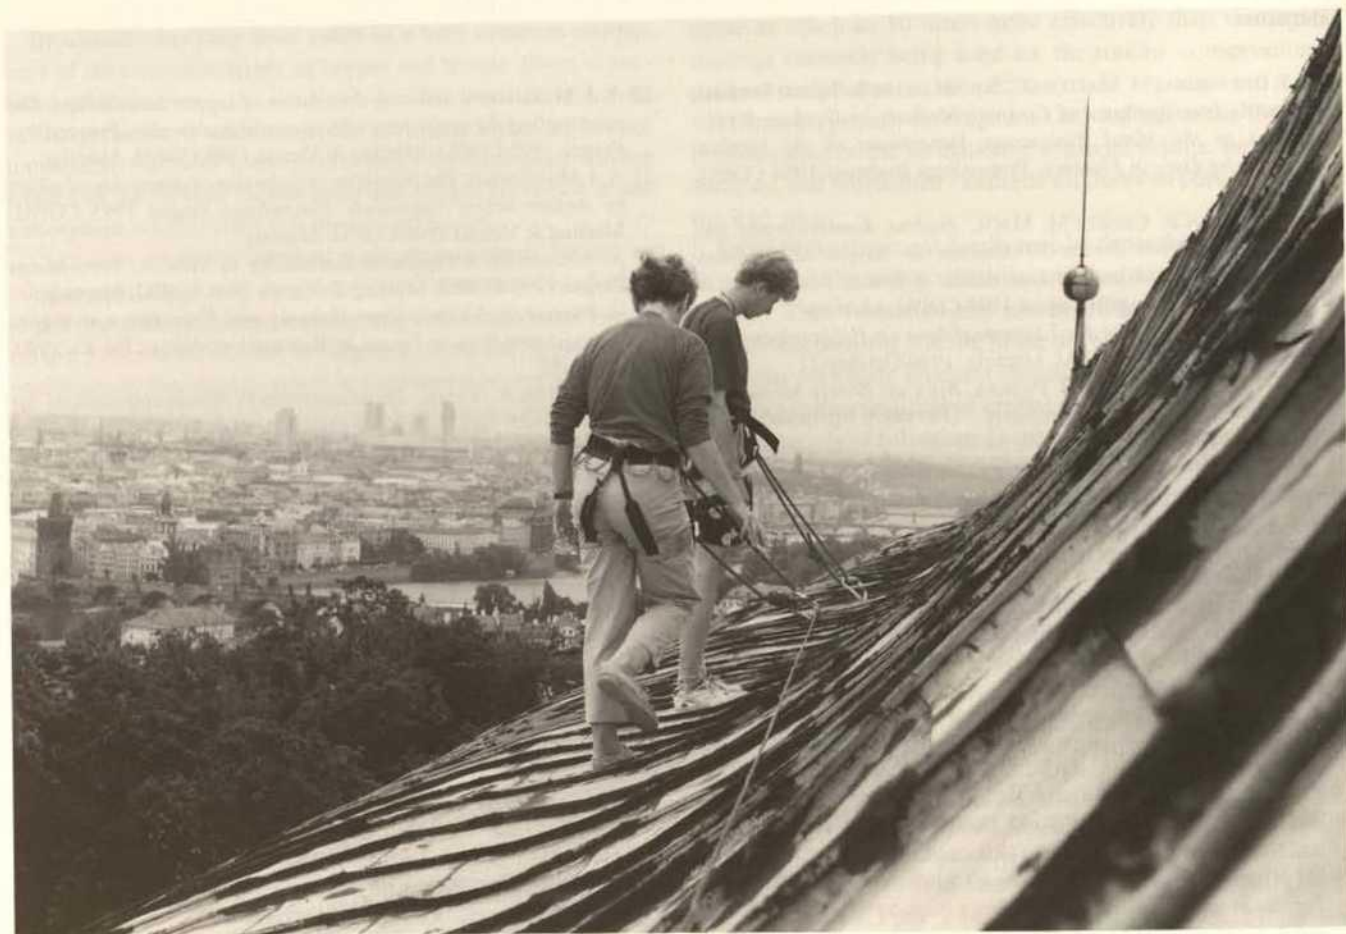
Fig. 1. Copper roof of Queen Ann's Summer Palace (Belvedere), built in 1558-1564; eastern ridge damaged part

Built in 1558-1564, some parts replaced during the centuries. For many years, it was exposed to an environment of corrosivity category C3-C4-C3. Extensive measurements of the residue thickness of the sheets proved that the original thickness of about 0,8 mm of the most affected eastern ridge part has decreased to 0.35-0.50 mm with minimums of 0.30 mm. The residue thickness of other, less affected parts is about 0,6 mm. The formation of corrosive-mechanic cracks is caused also by an insufficient fixation of the sheets (Fig. 1 and 2). Numerous occurrences of black spots not only on the joints, but also on the surface of some sheets, cannot be derived from the orientation of a surface, or from the processing technology. Bound repaired joints are loosened.

The eastern ridge part was recommended to be replaced with new roofing material patinated by a modern, rather industrial technology. The final proposal of reconstruction is being prepared.

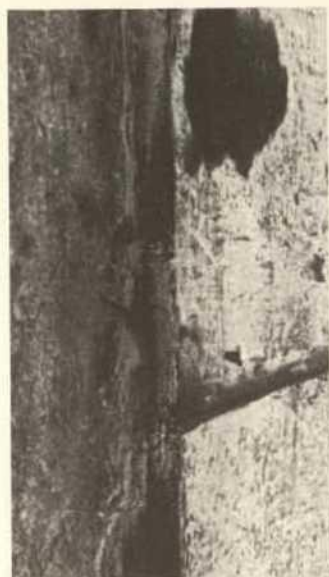
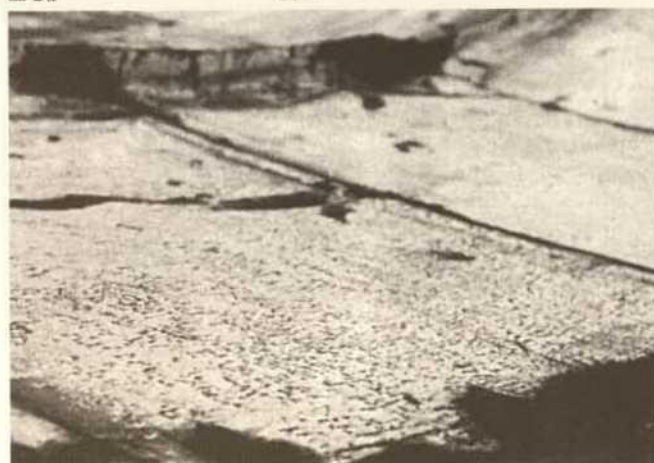
Fig. 2a, b. Copper roof of Queen Ann's Summer Palace (Belveder), built in 1558-1564; sheet with corrosion-mechanical defects

- Corrosion-mechanical manifestations were evaluated on the roof of Queen Ann's Summer Palace (Letohradek kralovny Anny) on part of the surfaces with an increased combined stress connected with the shape-design of the roof and an insufficient fixation of the components. This defect limits the serviceability of the roof.

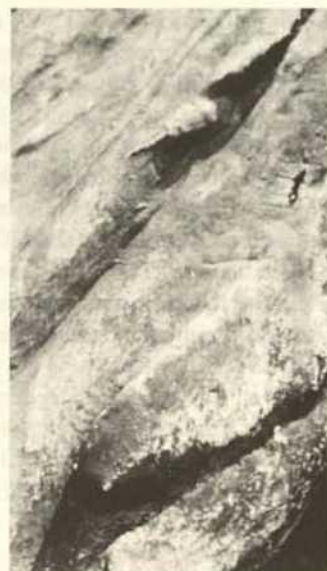
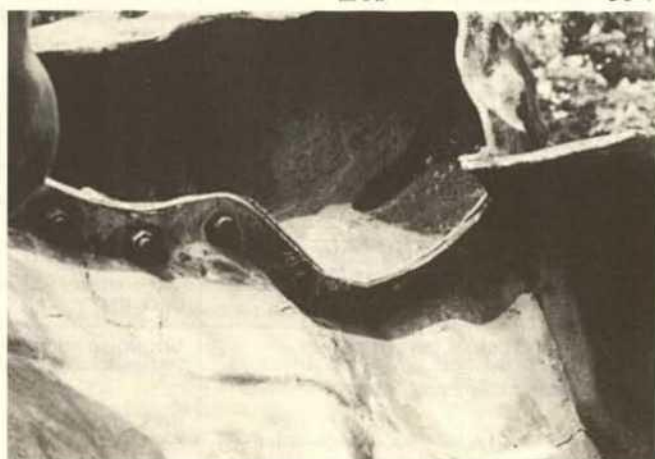
The second cast needs to be restored (Fig. 3). Corrosion manifestations: lengthwise hole on both upper and bottom sides of the right wing, where corrosion products of copper with rust leak from. Water is formed as a condensate and it also leaks in through joints and assembling hole at the back part. Impurities are being held up in a lap and voluminous patina containing gypsum forms. Marked corrosion or even destruction of the steel screw joints on the back untreated part of the sculpture. Loosened joint on a bronze plinth, bond washed off from the masonry plinth, broken compactness of masonry. Corrosion of the unprotected steel fixation rope.

Fig. 3a, b. Sculpture Embrace of Love and Death (Objeti lasky a smrti, B. Kafka, 1933); corrosion manifestation

SVÚOM elaborated a proposal for the restoration involving procedures for cleaning, closing the holes, local patina completion and complete anticorrosion treatment of the back part including the replacement of the screw joints.

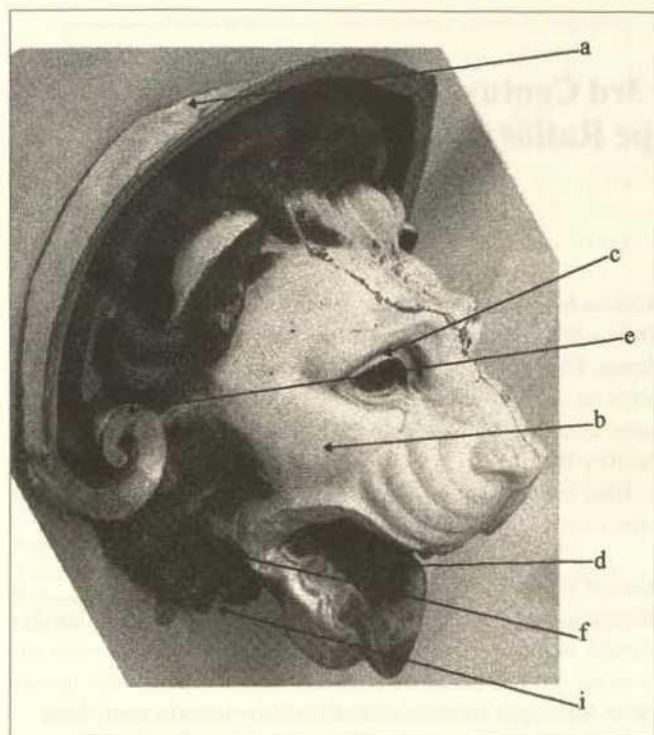
Position on sculpture	Appearance of sample	Crystalline compounds (in order of strongest XRD reflection)
External surfaces (Fig. 4)		
a – upper border (fully exposed)	light green	brochantite
b – head of lion (convex parts)	light green	brochantite
c – surface of the eyes (partly sheltered)	light turquoise	brochantite, antlerite
d – oral hollow	gray-green	antlerite, quartz, gypsum
e – upper perpetual part of border	dark gray	cuprite, antlerite
f – lower perpetual part of border	turquoise and dark gray	antlerite, gypsum, quartz
g – attachments of sculpture	dark gray-green	antlerite, cuprite, quartz, mooloite
h – attachment of sculpture (lower part)	dark brown	antlerite, cuprite
i – lower dark border	brown-red	cuprite, antlerite
Internal surfaces (Fig. 5)		
a – lower part with dirt and crusts (semi-sheltered exposure)	dark gray - green	antlerite, chalcantite, gypsum, $(\text{NH}_4)_2\text{Cu}(\text{SO}_4)_2 \cdot 6 \text{H}_2\text{O}$

Fig. 4. Copper sculpture (external surface) from roof of The Decorative Arts Museum in Prague with marked position of sampling (cf. Tab. 2)

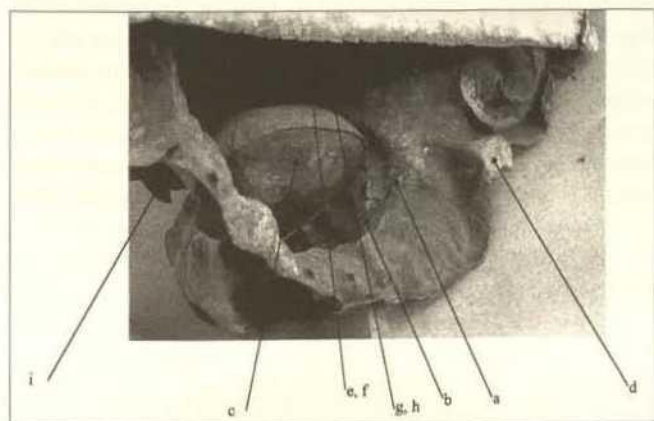
b – lower part with crusts (semi-sheltered exposure)	light turquoise with gray parts	chalcantite, antlerite, $(\text{NH}_4)_2\text{Cu}(\text{SO}_4)_2 \cdot 6 \text{H}_2\text{O}$
c – lower part (semi-sheltered exposure)	turquoise, gray parts	chalcantite, antlerite, brochantite, gypsum
d – lower part (semi-sheltered exposure)	turquoise	chalcantite, gypsum, $(\text{NH}_4)_2\text{Cu}(\text{SO}_4)_2 \cdot 6 \text{H}_2\text{O}$
e – upper part (fully sheltered by mantle of the sculpture)	dark gray, light parts	antlerite, quartz
f – upper part (fully sheltered by mantle of the sculpture)	green-gray	antlerite
g – head of lion (inner surface)	dark green	antlerite
h – head of lion (inner surface)	light brown, gray-green	cuprite, quartz, antlerite
i – lower part at border of sculpture	turquoise, light brown parts	quartz, brochantite, gypsum

Fig. 5. Copper sculpture (internal surface) from roof of The Decorative Arts Museums in Prague with marked position of sampling (cf. Tab. 2)
