# Fire-resistance Improvement of Vernacular Timber Architecture in a Historical Dong Village in China: A Case Study in Dali

Fei Du<sup>1</sup> and Kenji Okazaki<sup>2</sup>

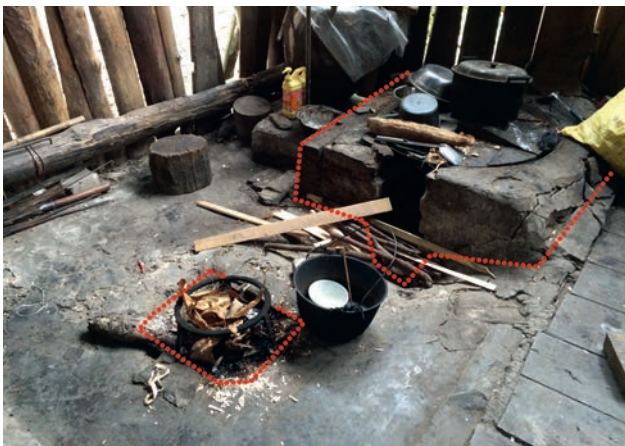
Fig. 4 (a) The open-fire oven surrounded by wooden walls in the traditional cooking space

walls in the traditional cooking space (Fig. 4(a)) in each household was replaced by a brick oven surrounded by brick walls (Fig. 4(b)). In addition, the electrical wiring installed in the 1980s was already aged and meandering after modifications by the local people (Fig. 4(c)). Therefore, the local government implemented projects to replace the electrical wiring (Fig. 4(d)) in each household in 2008 and 2015. According to the interview in 24 households, all of them believe that the projects reduced the fire risk (Fig. 4(e)).

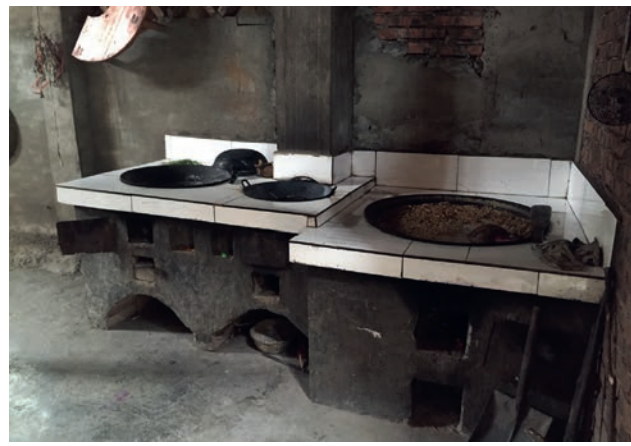
Fig. 4 (b) The transformed brick oven surrounded by brick walls

However, our investigation showed that the oven replacement was not considered to be fully effective.

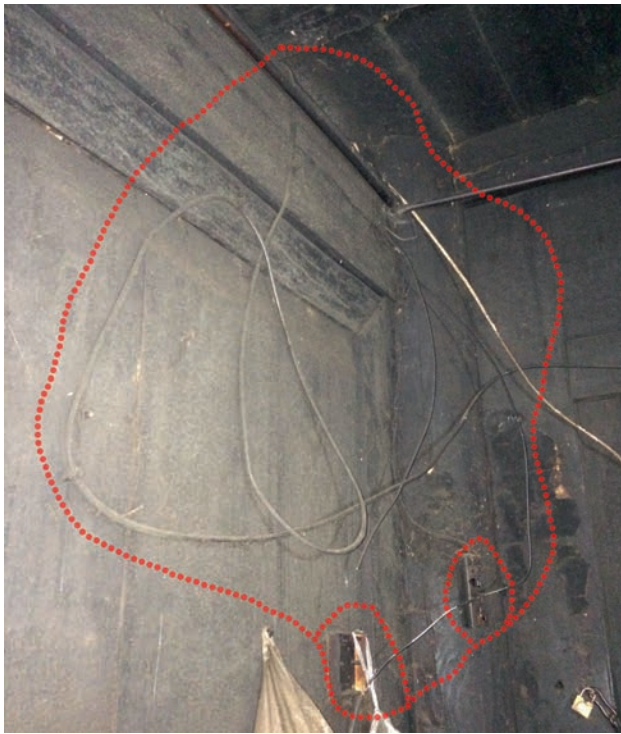
Fig. 4 (c) The meandering aged electrical wiring assembled during the 1980s

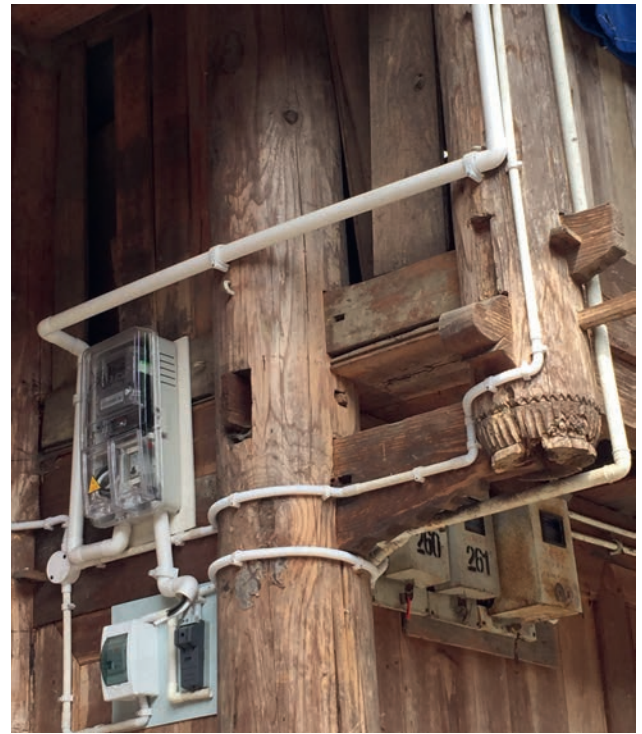
Fig. 4 (d) The improved electrical wiring

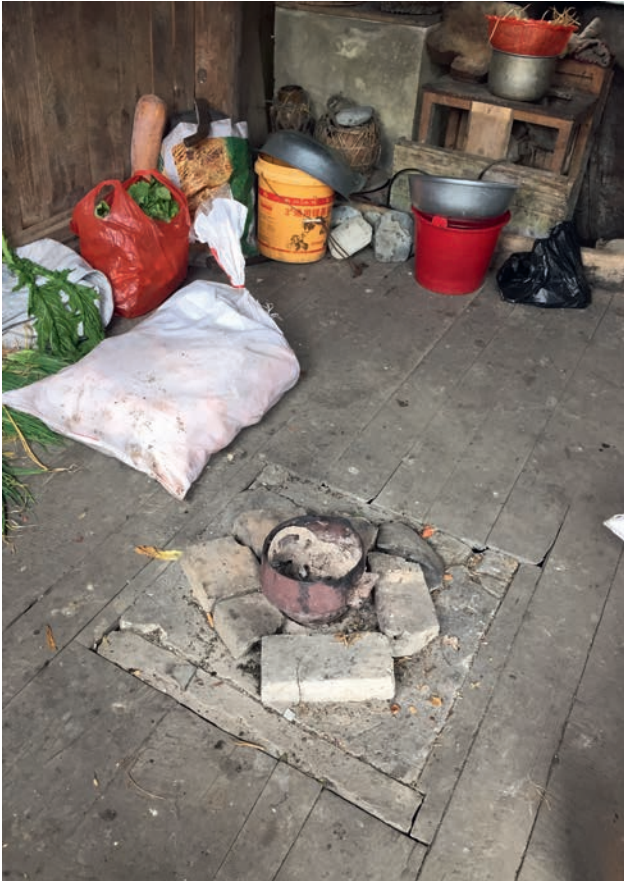
84% of the households surveyed still use a ground oven (Fig. 5(a)), 44% use a gas oven instead of a brick oven (Fig. 5(b)), 32% use an induction cooker instead of a brick oven (Fig. 5(c)), because the brick oven is too big for the needs of most families, since the young members usually leave the village for work. In addition, while the walls surrounding the brick oven were rebuilt with brick in 64% of the households, 36% still have timber walls (Fig. 5(d)).

Fig. 5 (a) Ground oven  
Fig. 5 (c) Induction cooker

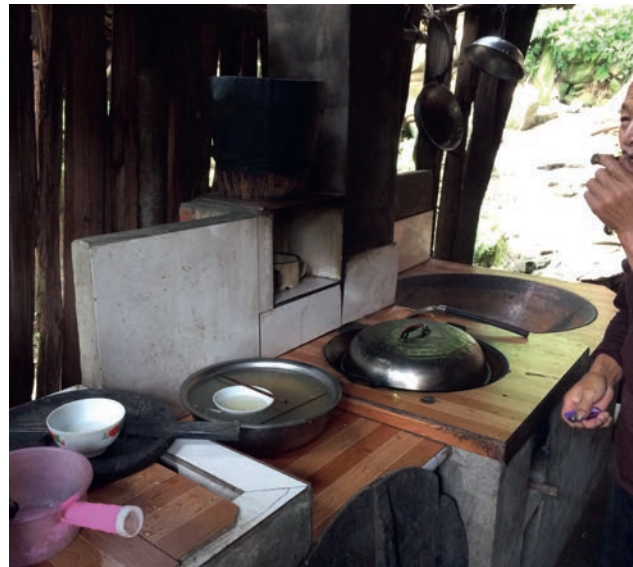
Fig. 5 (b) Gas oven  
Fig. 5 (d) Timber walls

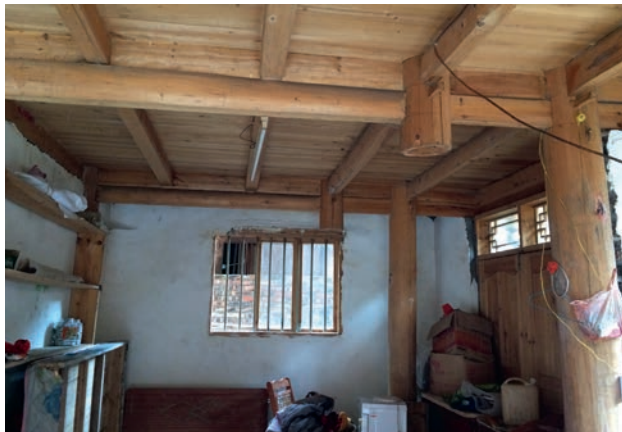
while the wooden walls were replaced by bricks (Fig. 6(a)). In the buildings of type 2, the pillars and walls were all rebuilt with bricks, while the wooden beams were not altered (Fig. 6(b)). This could be regarded as if the original wooden building was directly uplifted and put on a new brick structure. The buildings of type 3 have confined brick pillars, reinforced concrete ring beams, and brick walls (Fig. 6(c)). The structures of the buildings of type 4 are composed of reinforced concrete pillars,

Fig. 6 (a) Type 1  
Fig. 6 (c) Type 3

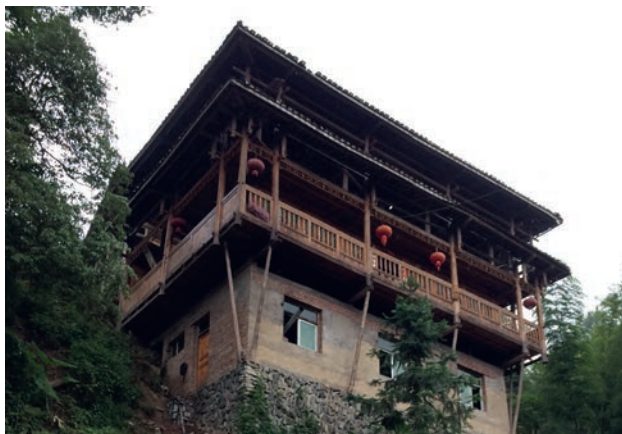
Fig. 6 (b) Type 2  
Fig. 6 (d) Type 4

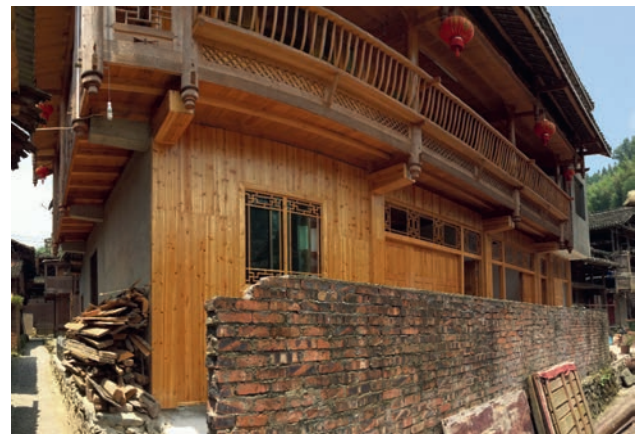
ring beams, and brick walls (Fig. 6(d)). The transformation may have enhanced the fire resistance of these buildings to some extent; nevertheless, it seriously affected the original architectural characteristics and appearance of this historic village.

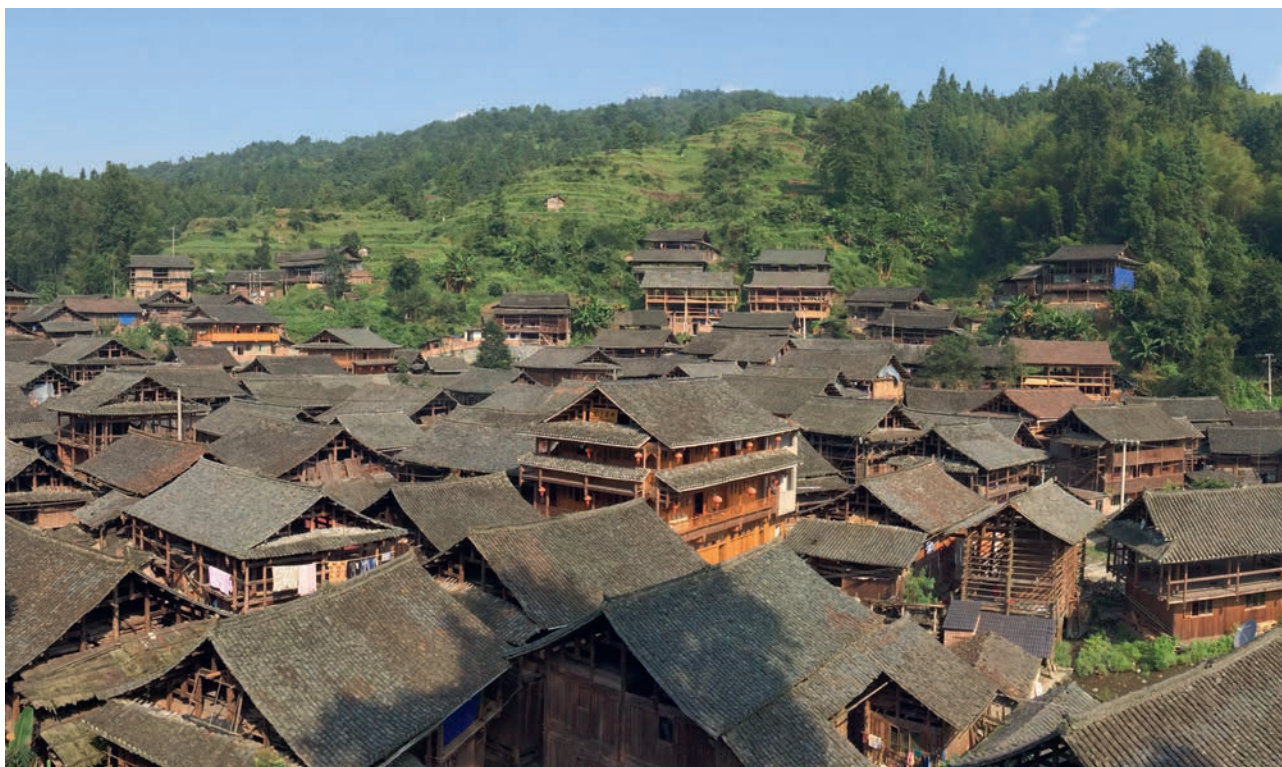
will protect the building from being affected by fire from other buildings. All the residential buildings investigated in Dali Village were built with traditional wooden roof trusses covered with grey clay tiles (Table 3, Fig. 7 (a)), but the eaves are without fire-resistant coating (Table 3; Fig. 7 (b)). The facades of the traditional wooden buildings without transformation have no fire-resistant coating (Fig. 2(a)), while 27% of the transformed buildings have no coating on brick walls (Fig. 7(c)),

Fig. 7 (a) Building roofs paved with gray clay tiles in entire Dali Village

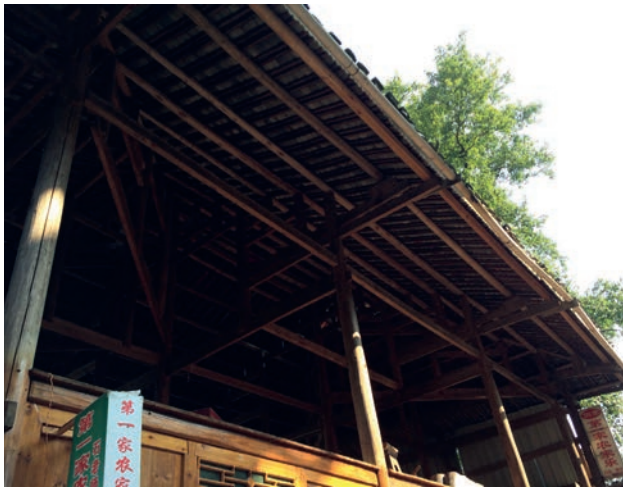
Fig. 7 (b) Wooden roof trusses and eaves without fire-resistant coating in entire Dali Village

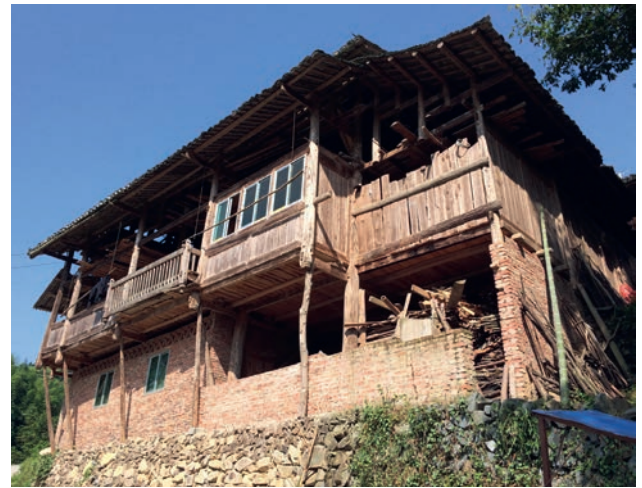
Fig. 7 (c) Transformed building with brick façade

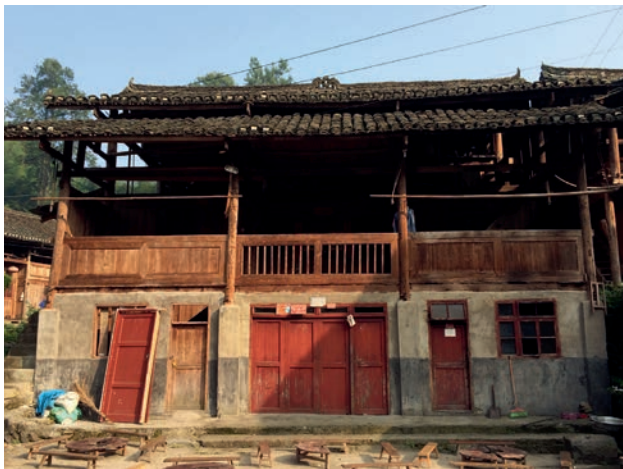
and 73% have cement mortar or ceramic tile coating (Fig. 7(d), (e)). However, the upper storeys of all the transformed buildings still retain their wooden facade without fire-resistant coating.

Fig. 7 (d) Transformed building with brick façade and cement mortar coating

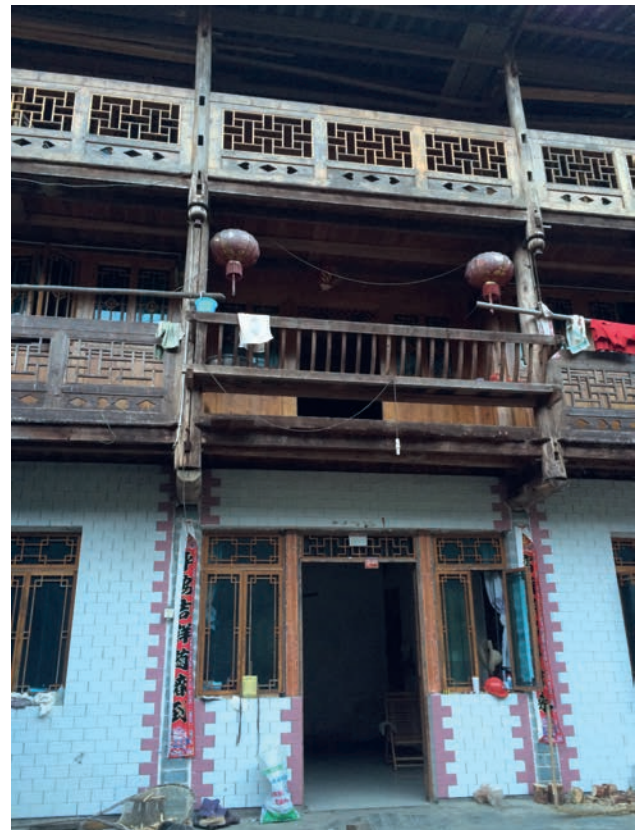
Fig. 7 (e) Transformed building with brick façade and ceramic tile coating
