First Considerations on the Stability of the Buddha Niches and their Stone Material, 2002*

* Abridged version of the report *Situation of the Buddha Statues in the Valley of Bamiyan, Afghanistan* by Dr.-Ing. Y. Zou and Dipl.-Ing. F. Unold, 5 November 2002. – See also Yazhou Zou and Florian Unold, *Die großen Buddha-Statuen von Bamiyan/Zustand, Stabilität und Möglichkeiten der Rekonstruktion*, in: *Bautechnik* 80 (2003), Heft 7, pp. 417–422.

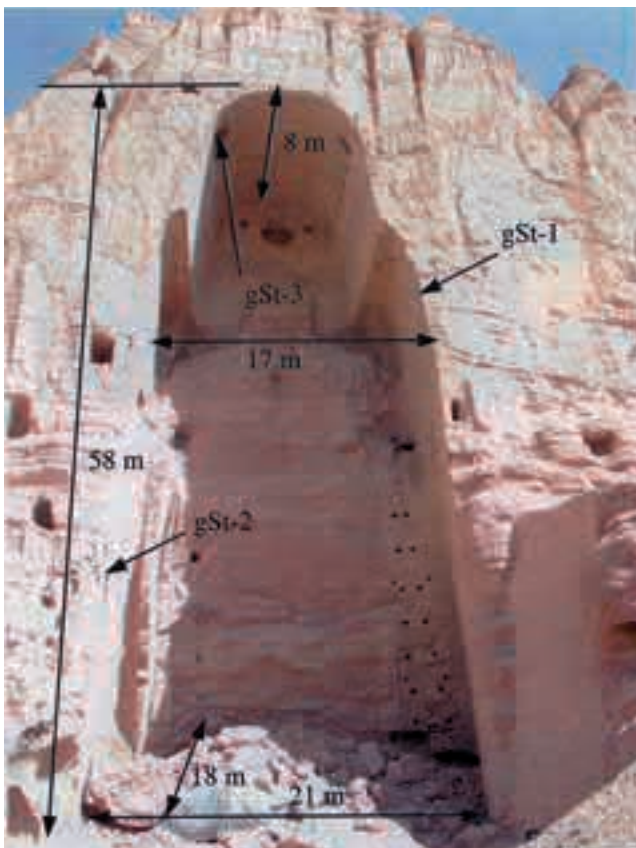
Fig. 1. The Western Buddha, 2002

At the Western Buddha, the stability of the niche is endangered on three spots (gSt-1 to 3, see Fig. 1). On the spots gSt-1 and gSt-2, the local stability is at risk. If the local stability is lost on several spots, the overall stability will be endangered by further weathering. On the spot gSt-3, the rock is cut through by cracks widened by the blasts. Inside

the staircase, the widened cracks are clearly visible at that place behind the wall. The stability on this spot influences the entire stability of the cave.

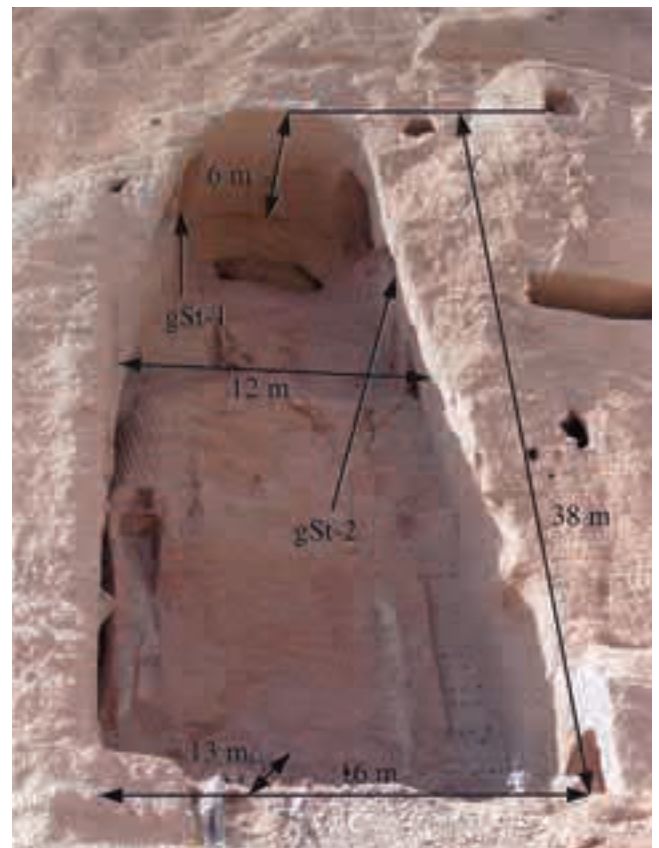
Fig. 2. The Eastern Buddha, 2002

At the Eastern Buddha, the overall stability of the niche is highly endangered on the two spots gSt-1 and gSt-2 (see Fig. 2). The cracks newly caused as well as the cracks widened as a consequence of the blasts are clearly visible here. The stability on both spots has a direct influence on the overall stability of the niche.

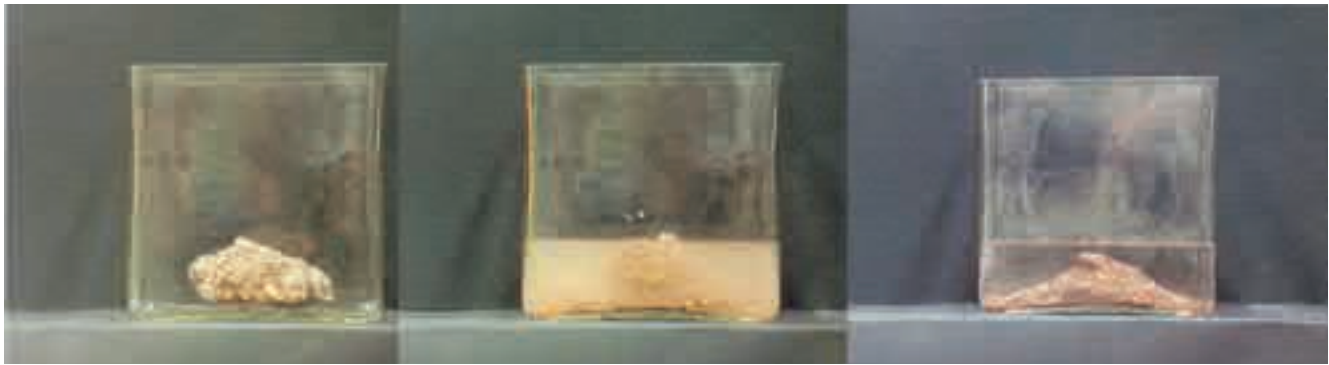
The conglomerate is highly susceptible to water. Under water, a specimen of the material disintegrated into a pile of sandy pebble stone after only a few seconds (see fig. 3).

Fig. 3. Testing the conglomerate: dry specimen (left), after a few seconds under water (centre), after sedimentation (right)

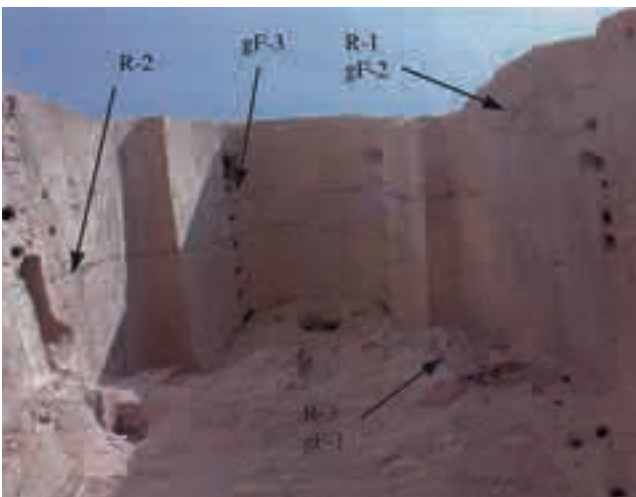
Fig. 4. Upper part of the Western Buddha

blasting. The cracks that already existed prior to the blasting are mainly located in the vault area above the head and on the side walls of the niches and run downward in straight lines. The blasts caused new cracks especially in the area of the back wall of the niche (viewing area). Figures 4 and 5 (view from the bottom) show the location and extension of the various forms of cracks.

The endangered areas in the viewing walls of both niches (back walls of the niches) are so much at risk with regard to their stability that, prior to the performance of any possible reconstruction measures, it will be necessary to take measures for their stabilization (including the removal of areas that were damaged to a particularly large extent).
