Report on Preservation Measures in the Eastern Buddha Niche, 2008

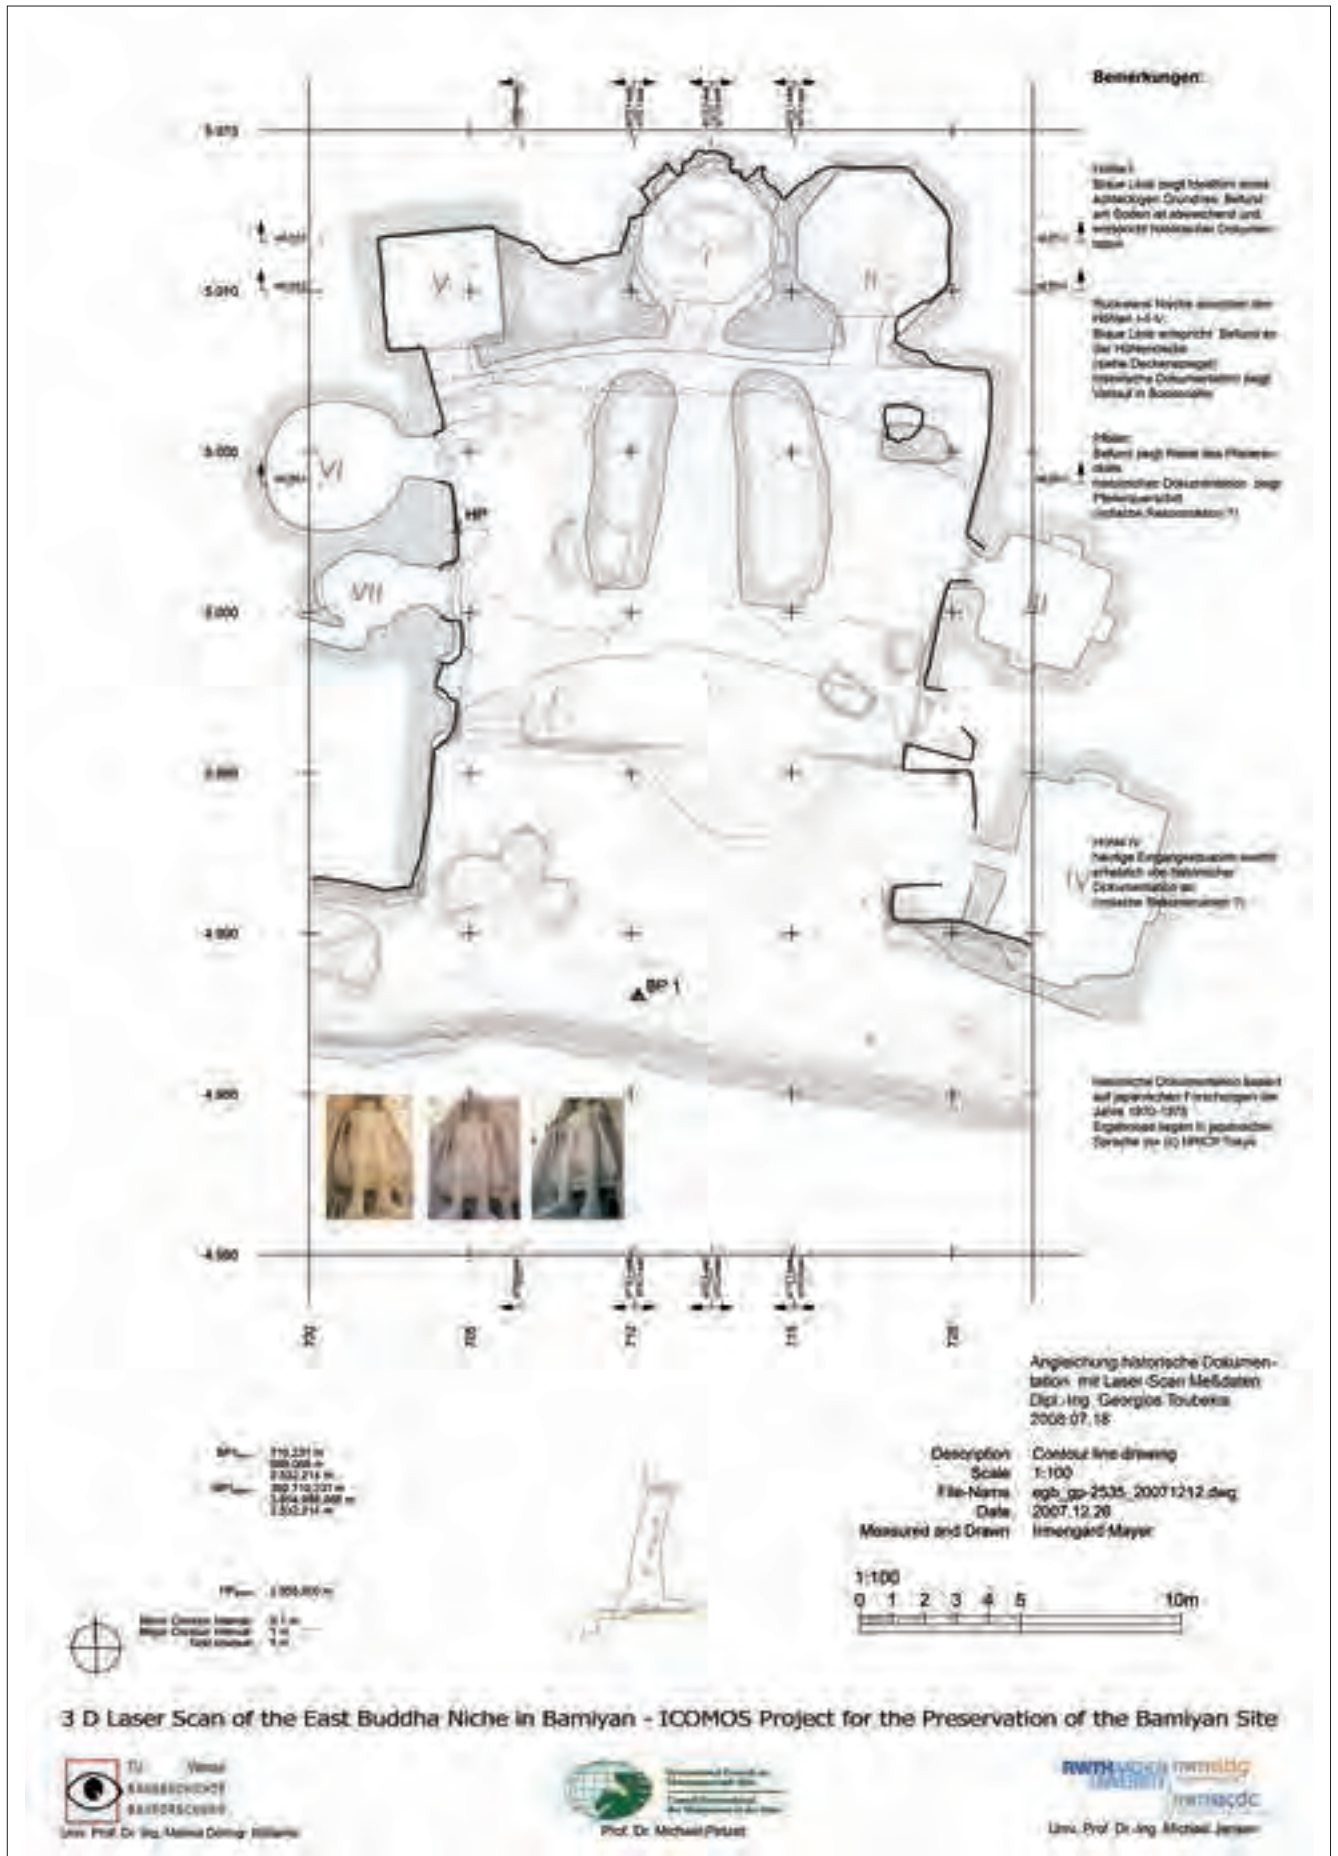
Fig. 2. Plan view of the Eastern Buddha niche with the location of the Buddha fragments KBF

Figure 1 shows the list of the fragments KBF001 to KBF016 with their measures and specifics. Figure 2 shows a site plan of the niche where the position of all fragments and the belonging number is drawn in. Figures 3 to 5 show photos of the particular fragments from different perspectives.

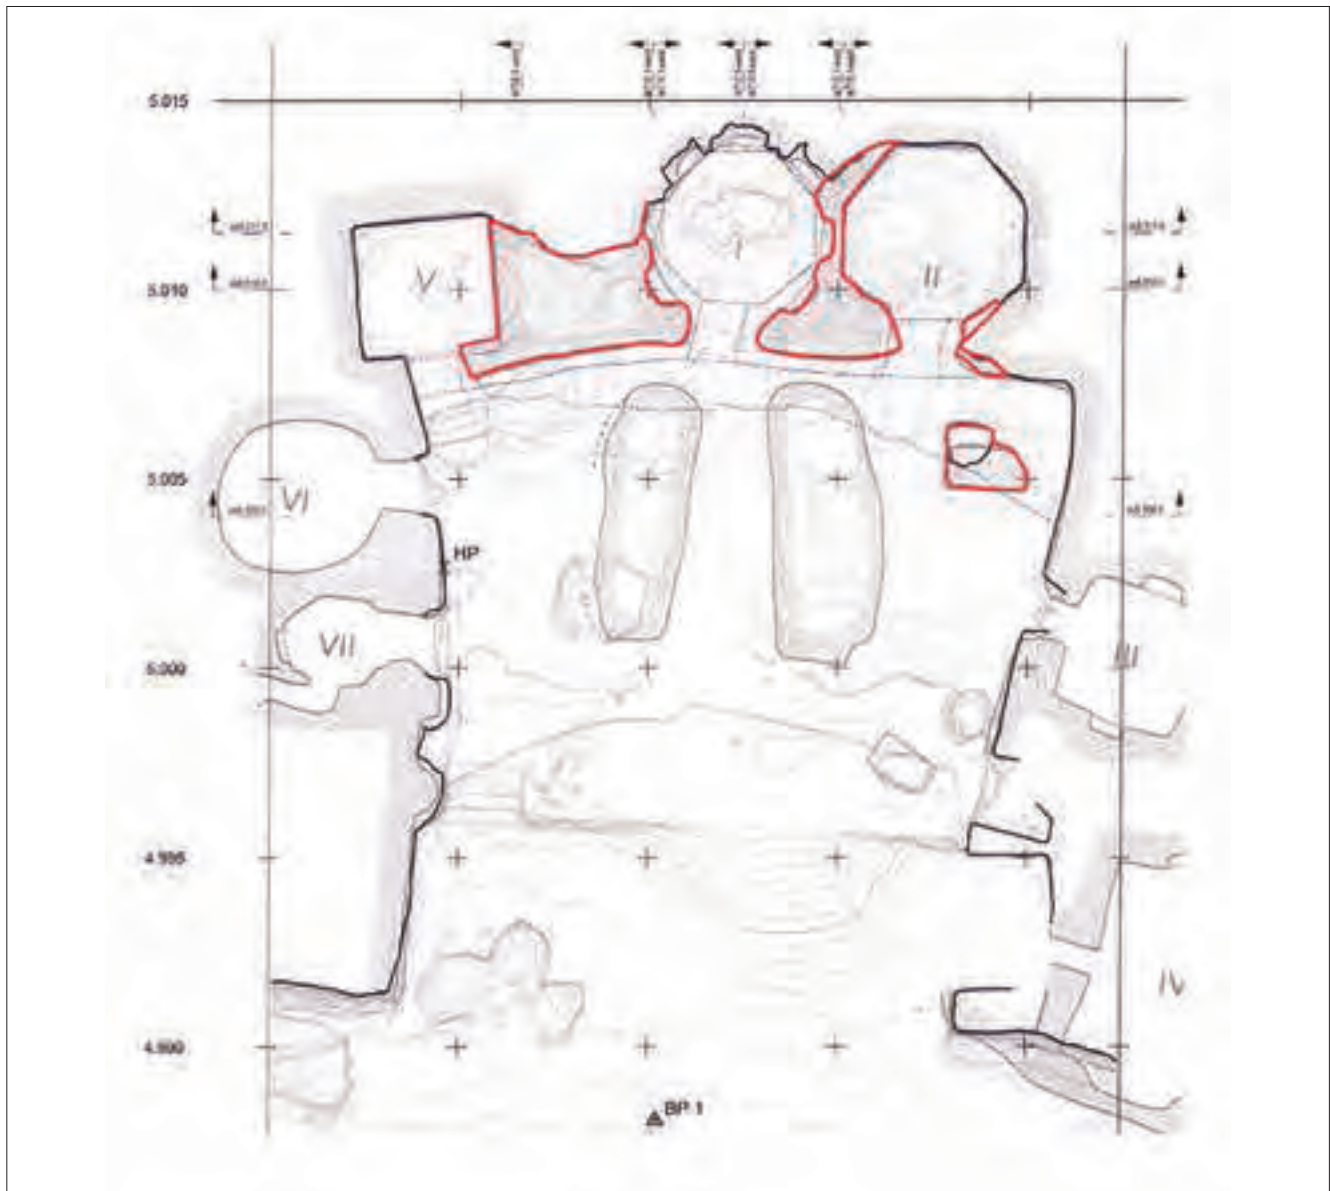
Fig. 6. Plan view of the Eastern Buddha niche with the contours of the destroyed caves and of the reconstructed partition walls

It was in the middle cave behind the feet of the Small Buddha (cave no. I) where the explosive charge was initiated (see fig. 6). Hereby the partition walls to caves no. V and II as well as the front wall of all three caves were completely blasted out. Thus caves no. V, I and II have a common ceiling now which is crossed by a new formed gaping vertical joint (see fig. 7). This joint parallel to the slope extends only partially into cave no. V and is feathering in the west wall of cave no. V. In the east wall of cave no. II it is still some centimetres open.

For the section of the partition walls between the three caves behind the ancient Buddha statue the site plan of the niche worked out by G. Toubekis was used, which is based on the 3D laser scan of the year 2006 (see pp. 117–121) and the historic documentation of Japanese research in the years 1970–1978 (see fig. 6).

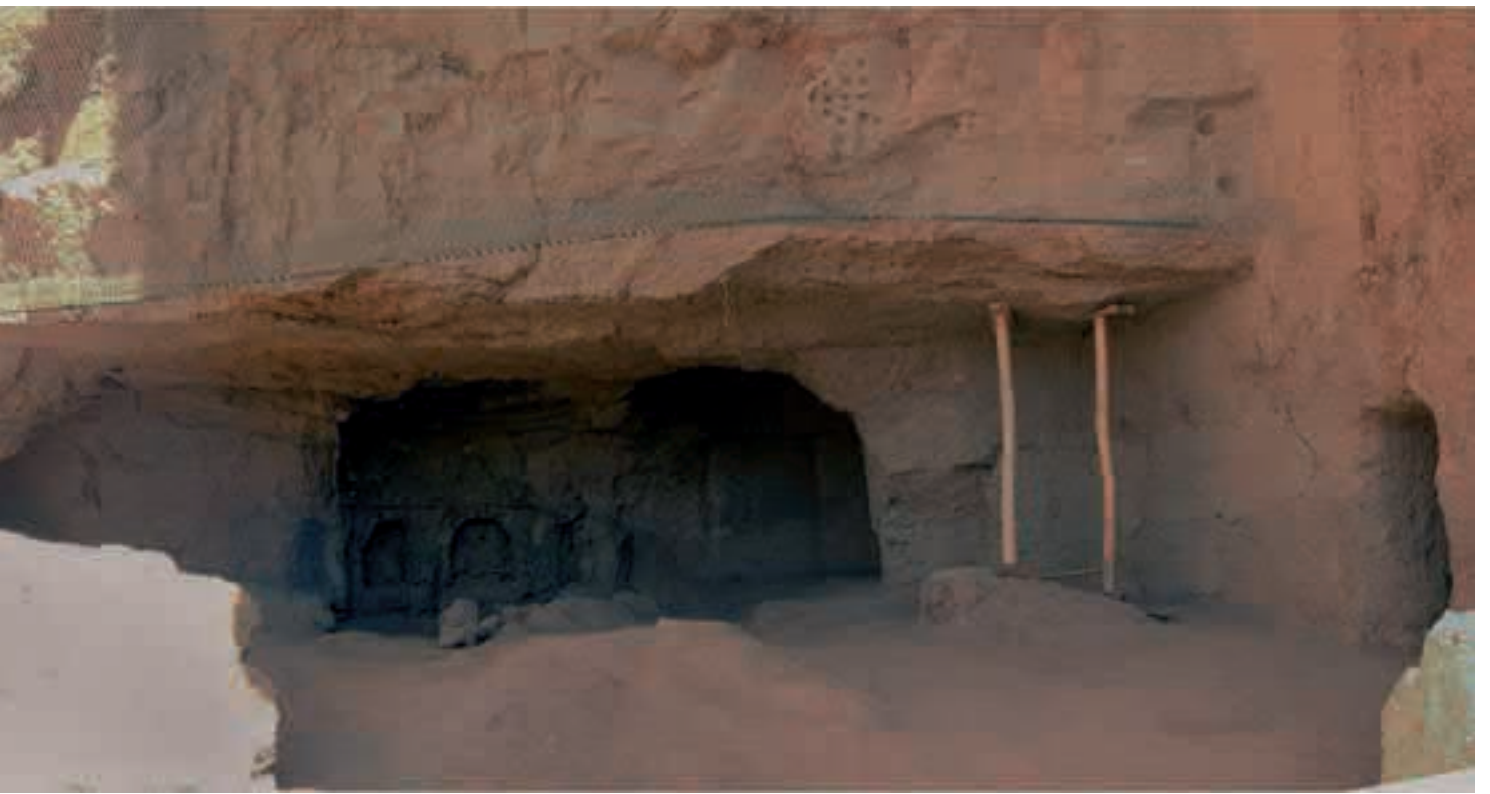
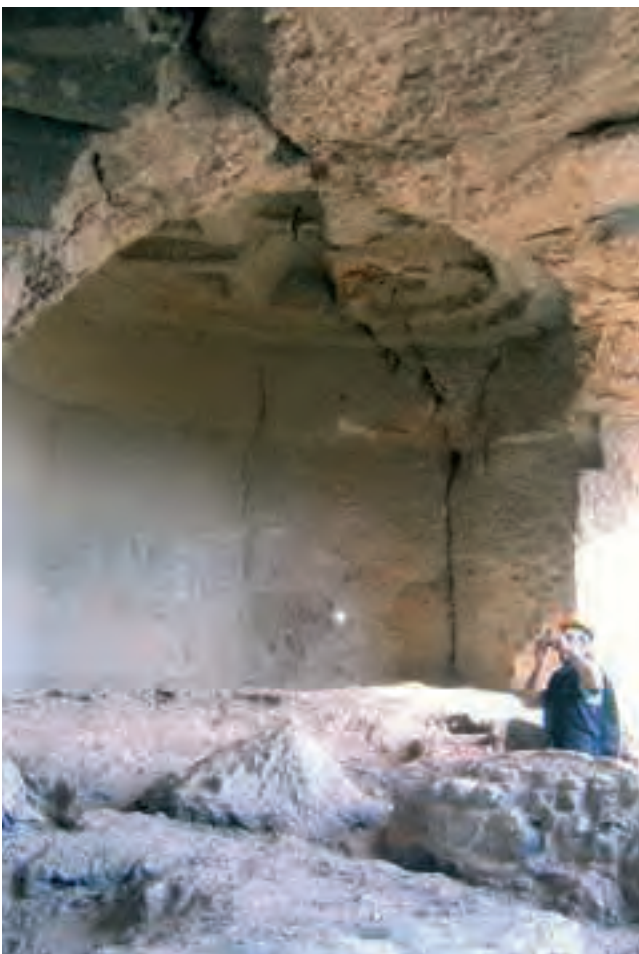
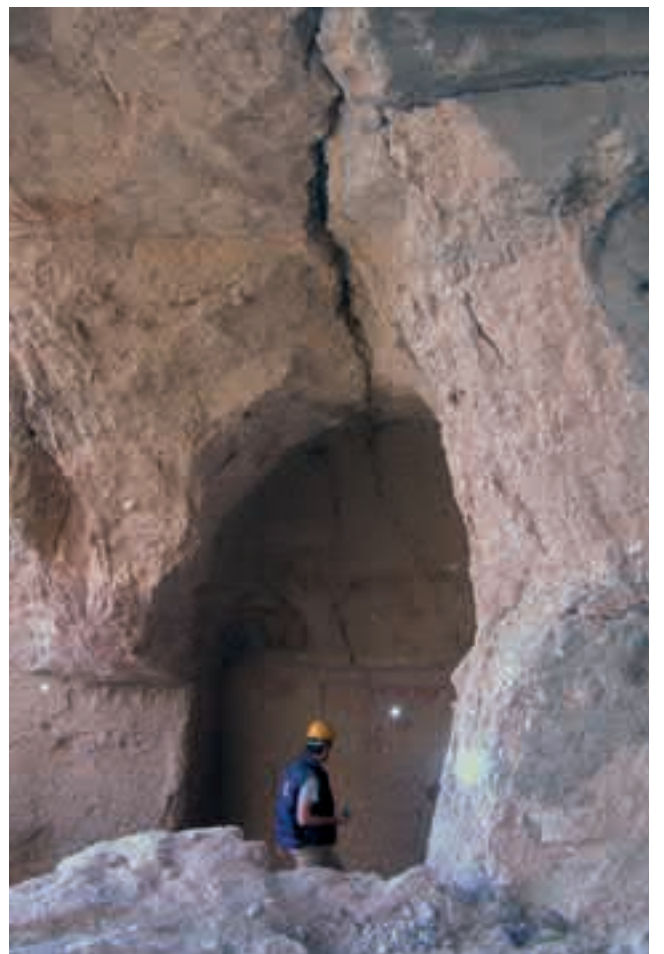
Figs. 7a, b, c. Destroyed caves at the base of the Eastern Buddha niche

There are several smaller rock plates which could fall down from the ceiling of the three caves. These rock parts, which are on the verge of falling from the ceiling of caves no. V, I and II, have been temporarily supported with wooden props. A major function of the reconstruction of the parti-

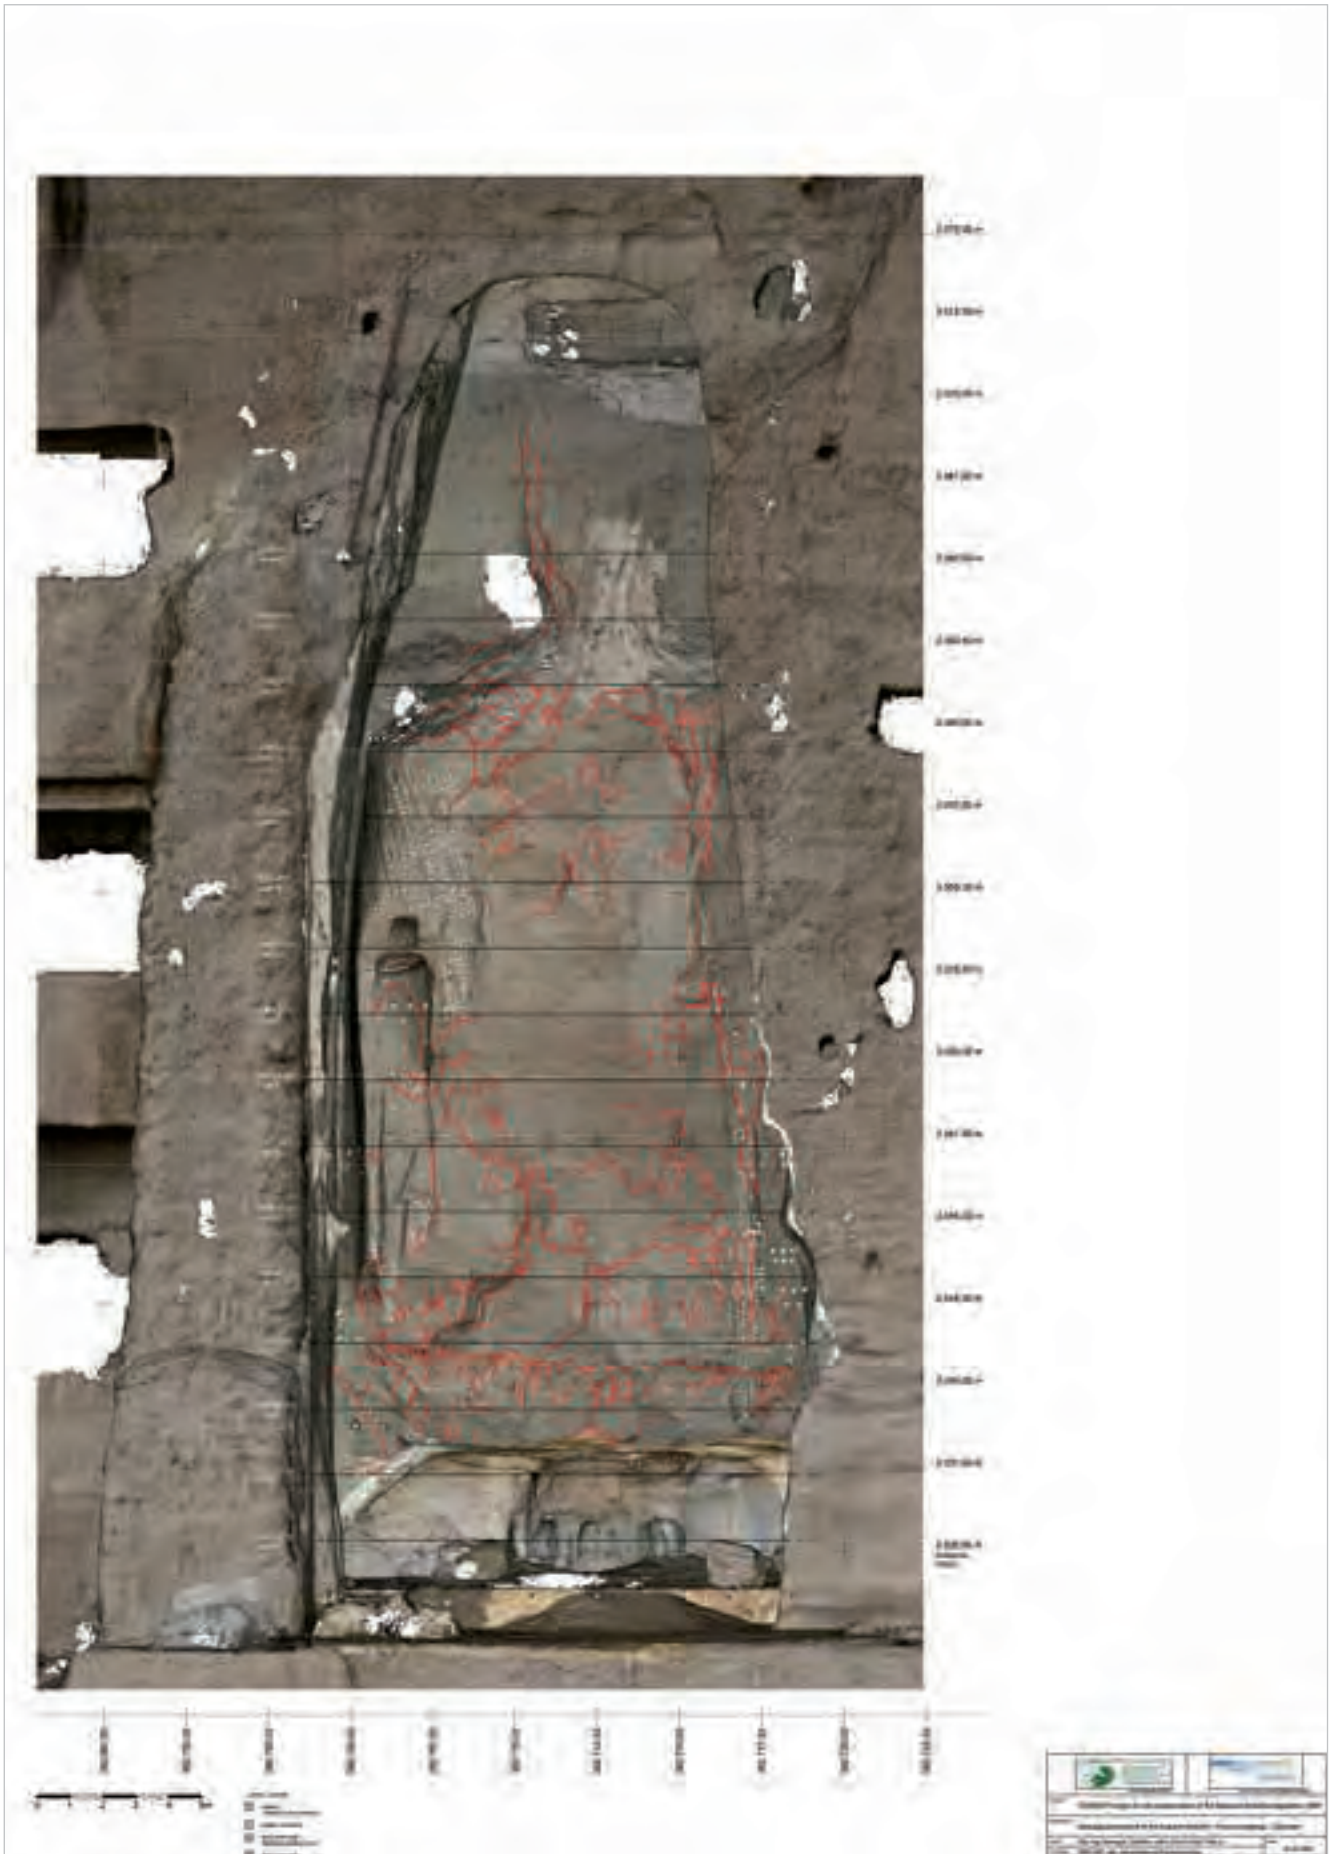
Fig. 9. Eastern Buddha niche, damage assessment of the back wall

Stripe 3/4 between floor 3 and 4 is characterized by a large number of small joints with a length of 0.5 to 1.5 m. These joints are only some millimetres open, which indicates that no rock fragments will fall down.

Underneath the right hand of the Eastern Buddha a dress pleat partially in good condition continues downwards, which is slightly loosened from the back wall at the lower east edge by some joints parallel to the wall between floor 4 and 6 (stripe 4/5, field b, c and d as well stripe 5/6, field c). The joints are scarcely open and end under the pleat. I consider the danger of falling of this section to be rather low. Safeguarding measures are not to be taken here, at best a fissurometer can be installed to make sure that the joints do not increase. The plaster made of clay, still residually present at the east side over these stripes has been secured by Bert Praxenthaler.

Upside stripe 6/7 up to stripe 10/11 the number of joints diminishes considerably. In this section the back wall of the Eastern Buddha is in such a condition that it is not necessary to be secured. Only at the west and east side where there are still rests of plaster made of clay Mr Praxenthaler has secured them.

The right shoulder is affected in many parts due to several new formed joints parallel to the wall and loosened from the back wall (stripe 12/13, field b, c and d). Some joints are open. In my opinion the danger that some parts may fall down and the total section may follow is high. As soon as the scaffold in this section is finished safeguarding measures should be taken with fibre glass anchors.

The left shoulder is also affected in many parts due to several new formed joints parallel to the slope and loosened from the back wall (stripe 11/12, field f and g as well as stripe 12/13, field e, f and g). Some joints are open up to about 10 cm. In these open joints decimetre large rock pieces can be seen which have been fallen into the open joint from the upper side of the shoulder. Only a rock gusset of about 1.5 m² avoids the falling of the section. The rock gusset is also showing disintegration. In my opinion the danger that the whole part will fall is very high.

The back wall of the Eastern Buddha is still showing in its highest part remains of the head of the Buddha. This is a large rock plate which is affected in joints parallel to the slope. The joints are slightly open. The whole part must be secured. I am considering the danger of larger rock falls in the near future to be low. The scaffold is not yet finished up to the level of the head.

As a permanent support of the loose rock formations at the left and right shoulder a fastening by anchors is necessary. As soon as the scaffold is finished and the shoulders will be accessible the works should start.

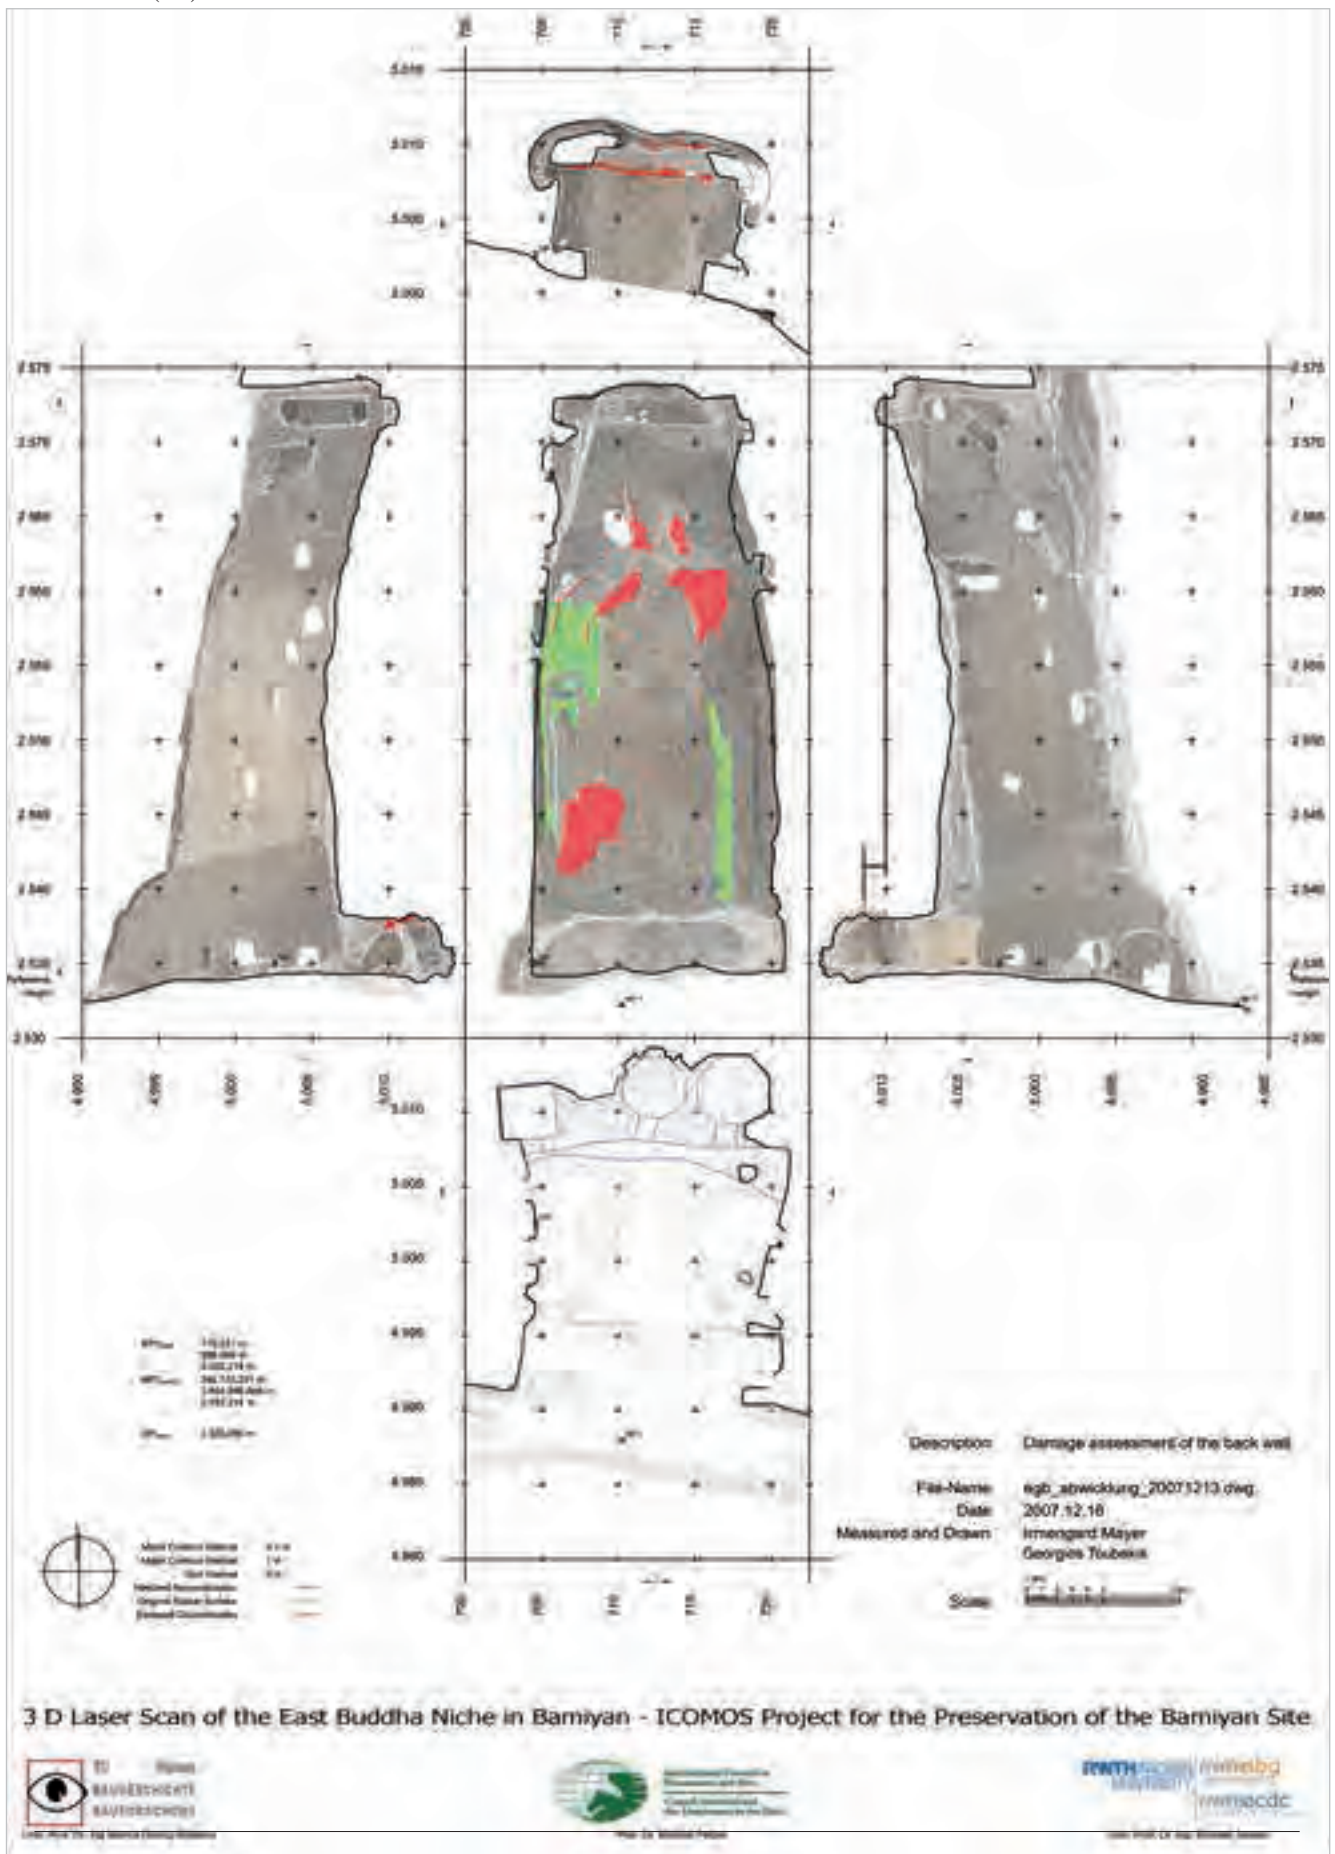
Fig. 10. Eastern Buddha niche, 3D laser scan, showing idealized reconstruction (blue line), original statue surface (green), back wall discontinuities (red)

Due to the explosion in March 2001 rock sections which were partially loosened and are now on the verge of falling can be observed at the back wall of the niche of the Eastern Buddha.

age of the back wall on a scale of 1:50 in order to record the discontinuities and partially loosened blocks. Based on these records the RWTH Aachen Center of Documentation and Conservation made a comprehensive description of the back wall of the niche and its specific features (see figs. 9–14).

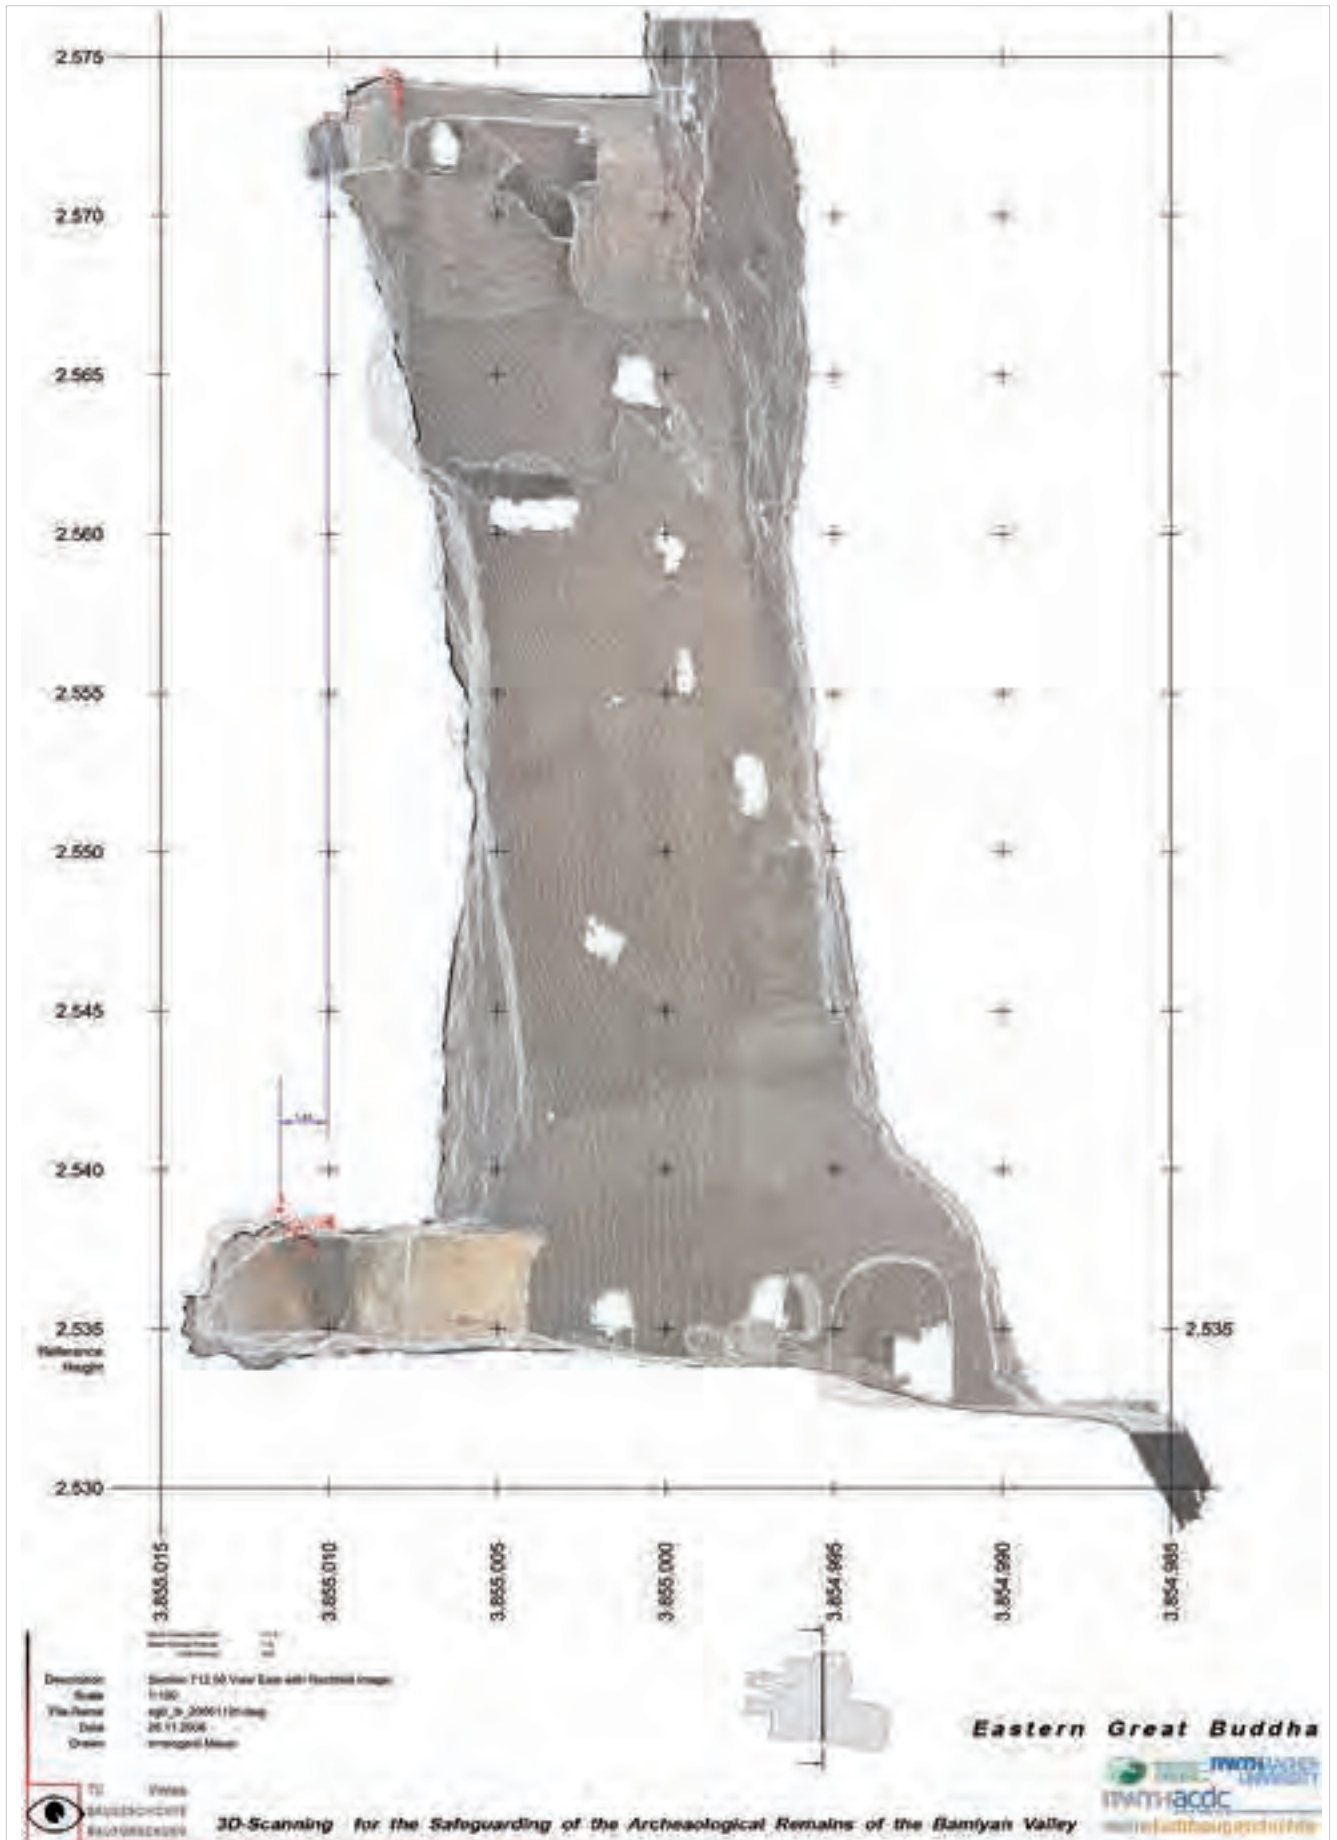
Fig. 11. 3D scanning, view east, with rectified image

The procedure at this description becomes apparent in the summary (fig. 11), where you can see that the back wall is divided into stripes resulting from the floors of the scaffold. Each stripe is two meters high, as the distance of the floors. The documentation begins with the stripe between floor 3 and 4 in the lowest part of the back wall and ends with the stripe between floors 12 und 13 where the scaffold ends.
