Edwin Fecker

Report on Stabilisation Measures in the Eastern Buddha Niche, 2009

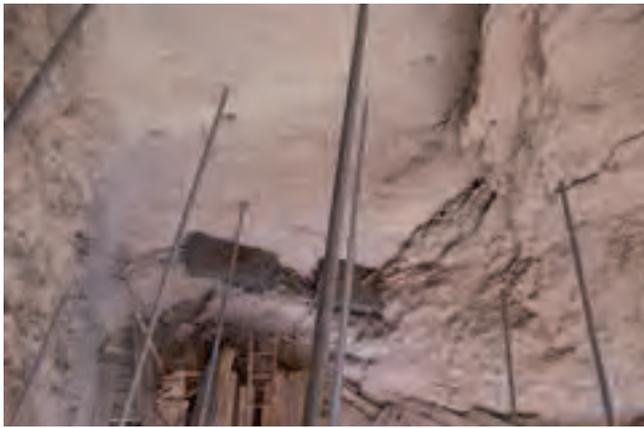
△ Fig. 1a. Right shoulder after removal of the loose rock fragments

When the scaffold reached the shoulders the detritus was removed from them and temporary foundations for the further construction of the scaffold were made hereon (see fig. 1). The wire net fixed above the head was removed, then the loose rock fragments in the area of the cervix (see fig. 2). Afterwards the scaffold could be completed.

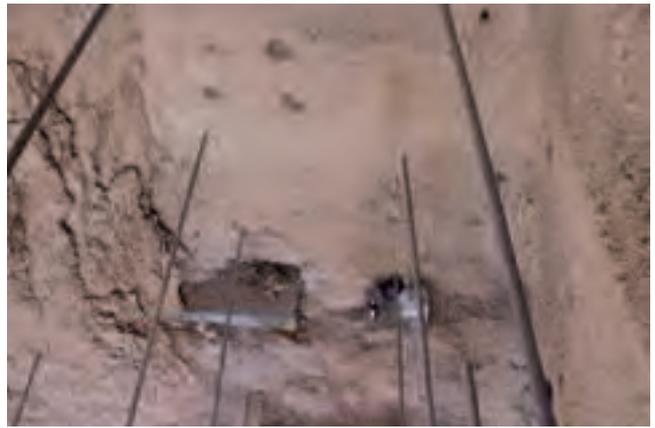
△ Fig. 1b. Left shoulder after removal of the loose rock fragments

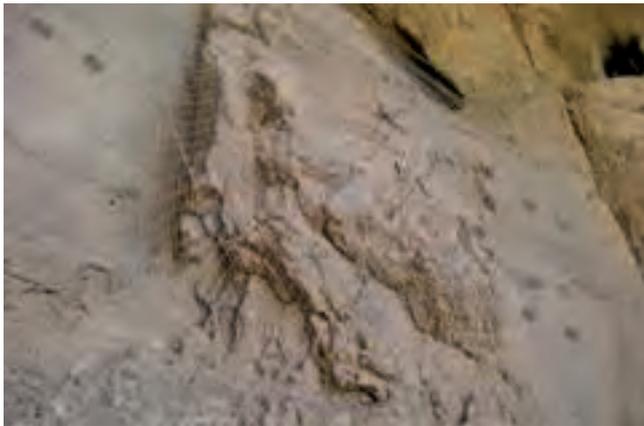
△ Fig. 2a. Head of the Eastern Buddha before removing the loose rock fragments

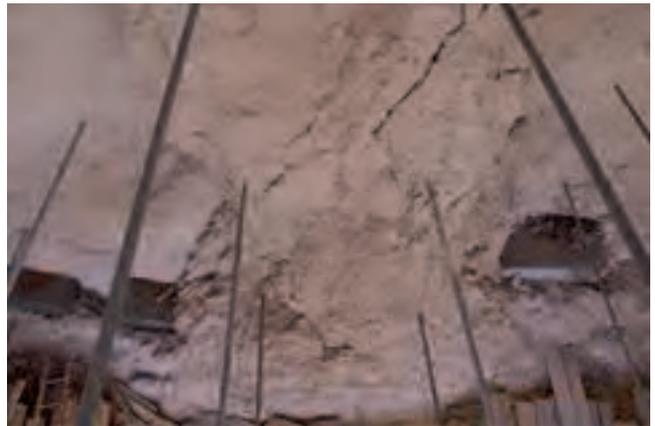
△ Fig. 2b. Head of the Eastern Buddha after removing the loose rock fragments

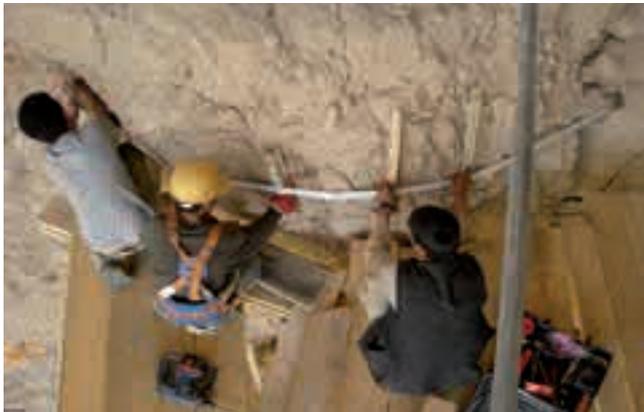
△ Fig. 3a. Provisional stabilisation of left shoulder (upper part) with tension belts

Before the stabilisation works at the back wall could start all rock fragments on the verge of falling were provisionally fixed with tension belts. The left and the right shoulders have been provisionally protected (see figs. 3 and 4), as well as the head and the wedge under the eastern gallery above the head (see fig. 5).

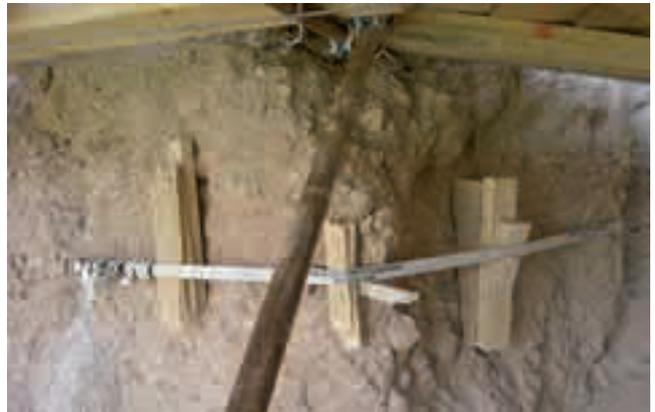
△ Fig. 3b. Provisional stabilisation of left shoulder (lower part) with tension belts

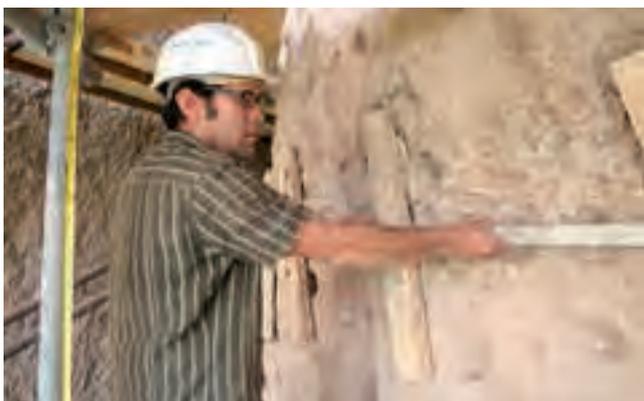
▽ Fig. 4a. Provisional stabilisation of right shoulder

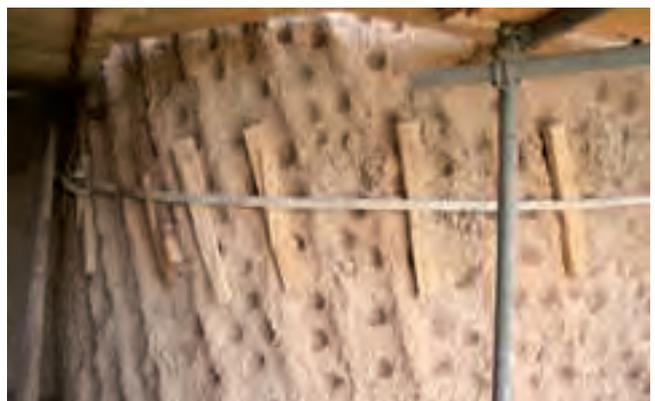
▽ Fig. 4b. Provisional stabilisation of right shoulder

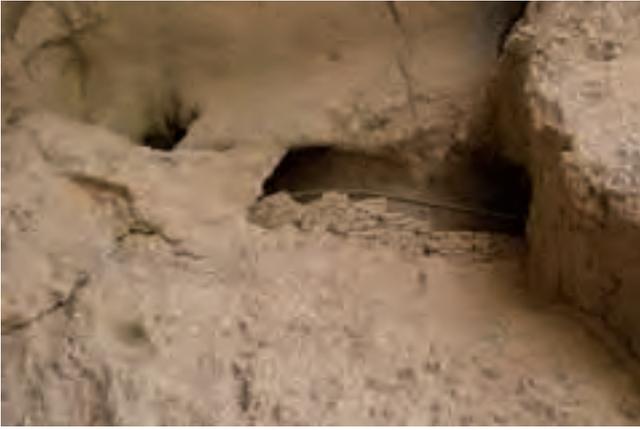
△ Fig. 5a. Loose wedge under the Eastern gallery

ers, at the head and under the eastern gallery, concerning blocks of several tons of weight, which cannot be secured with the above described measures. According to the agreements on April 16, 2009 in Munich these blocks have to be secured with rock anchors of several meters of length whose number and spatial arrangement will be decided by the experts together in situ in October 2009.

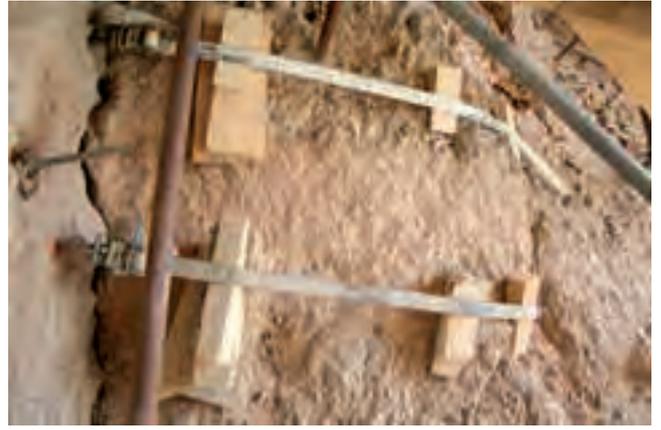
△ Fig. 5b. Provisional stabilisation of the loose wedge

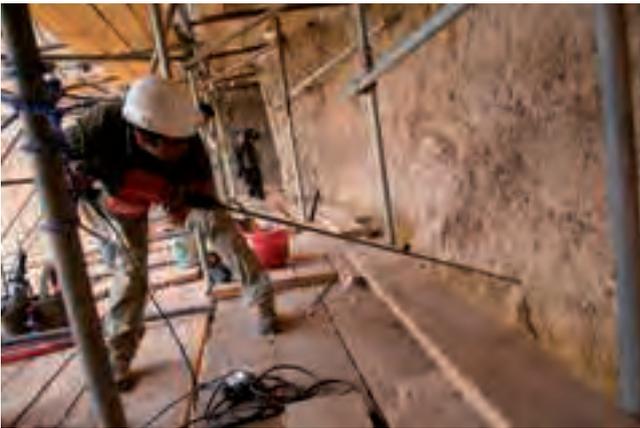
△ Fig. 6a. Drilling of anchor borehole

To secure the blocks of the above-named dimensions it is necessary to fill the joint that separates the block from the back wall with injection mortar and to harden it. Then the rock can be drilled through, in the borehole filled with mortar a rock nail of the necessary length can be inserted (see figs. 6 and 7). If the joint were not filled in with mortar before, the rock could continue to loosen from the back wall by the vibrations of the drilling and eventually fall down.

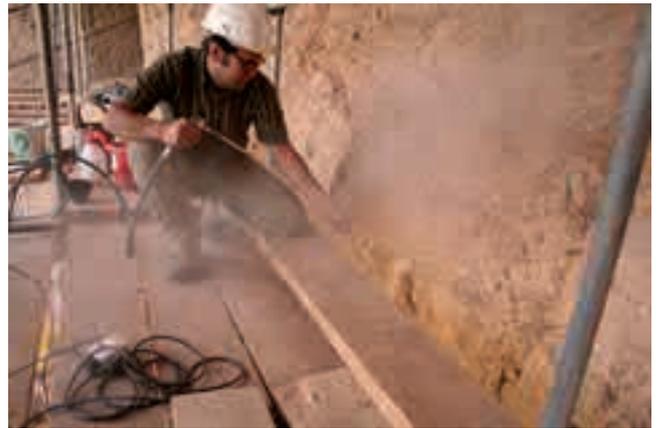
△ Fig. 6b. Removal of dust from the borehole

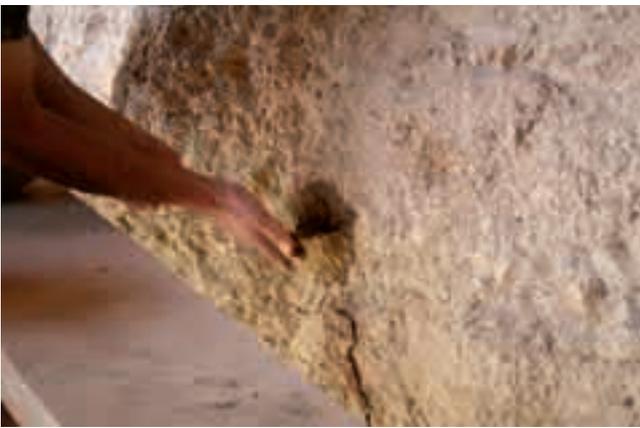
△ Fig. 7a. Preparations for refilling the borehole

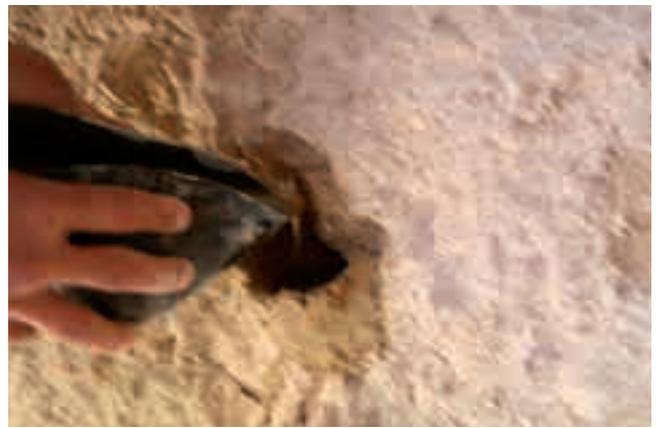
△ Fig. 7b. Filling Ledan into the borehole

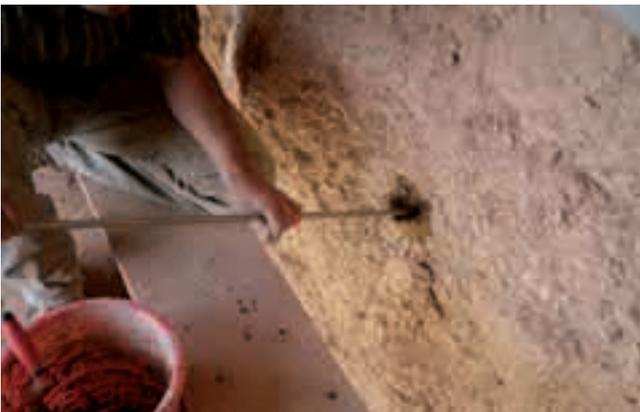
▽ Fig. 8a. Pushing anchor as far as possible into the borehole

The stabilisation of the smaller loose rock blocks in the back wall of the Eastern Buddha is largely finished. For this purpose the open joints have been filled with injection mortar and the particular blocks have been fixed with rock nails of 0.5 resp. 1.0 m length at the back wall.

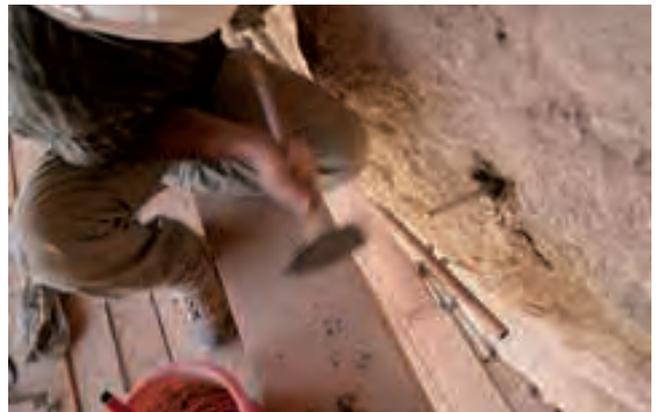
▽ Fig. 8b. Driving anchor into the borehole with a hammer

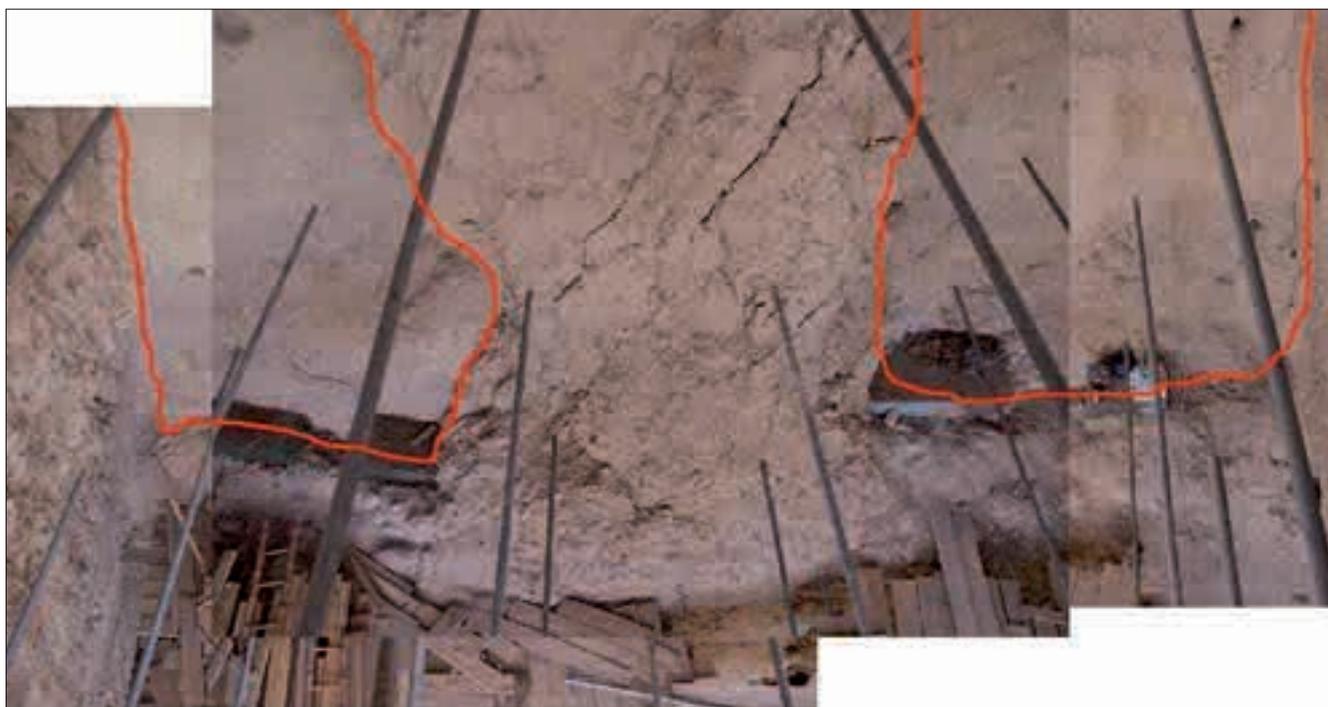
Fig. 9. Trace of an open joint parallel to the back wall (red line)

This joint separates, at least in the area of shoulders and head, the remains of the Buddha body from the original back wall continuing above the shoulders and next to the head. In

the shoulder area a 2 to 2.5 m thick rock part is separated from the in-situ rock by a dorsal open vertical joint.
