IV The Consolidation and Stabilization of the Buddha niches and the cliff in Bamiyan (2003/04; 2006)

Claudio Margottini

Abstract

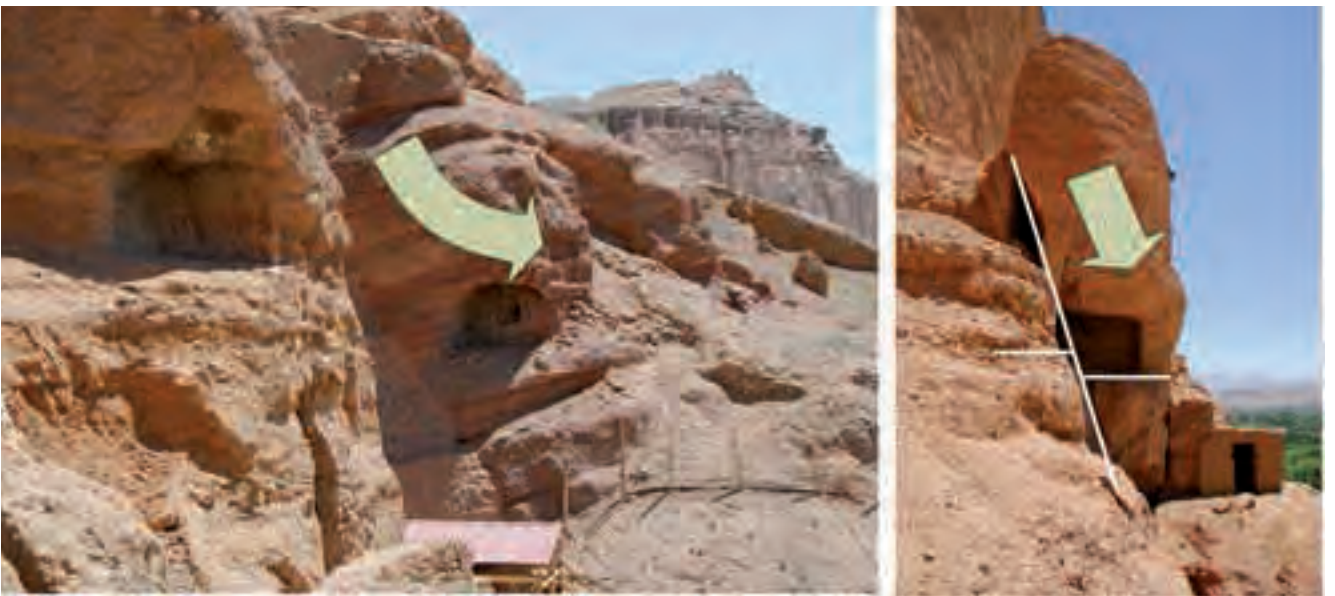
Fig. 6. Rock slides affecting the caves inhabited since the 6th century AD

Large rock slides were detected in the lower part of the cliff, now stabilized, covered by a large amount of debris; the occurrence of such a rock slide is kinematically conditioned by the presence of direct faults, not reaching the upper part of the cliff. With only two large rock slides it seems to affect the rupestrial caves and historical settlements.

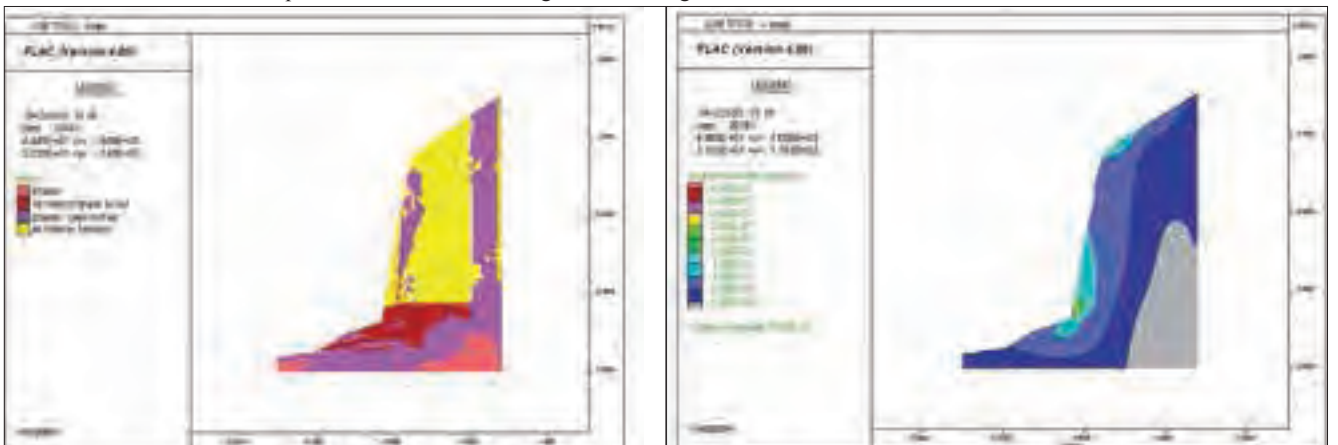
Fig. 7. State and displacement for the cliff of the Eastern Buddha with fracturing reaching the lower part of the cliff and the lower siltstone exhibit no cohesion as consequence of internal fracturing or weathering

Major effects in the Western Giant Buddha niche were the collapse of the statue and the consequent instability of the rear of the niche. Investigations of the possible long-term stability conditions of the cliff were computed using the explicit-difference-finite code, FLAC (Itasca Consulting Group, 2000). Considering the Hoek and Brown (1980) shear strength criteria for conglomerate and siltstone, and with a major discontinuity ranging from the middle of the cliff to the middle of the niche (only friction value for shear strength) the deformation of the cliff is relatively low and nowadays it seems to be in a stable condition. Since we consider the fracture in the conglomerate reaching the lower sandstone formation and decrease gradually the cohesion of siltstone due to fracturing/weathering, the cliff becomes unstable when the cohesion is near to nil. In such a situation maximum displacement and vector are at the base of the niche (fig. 7).

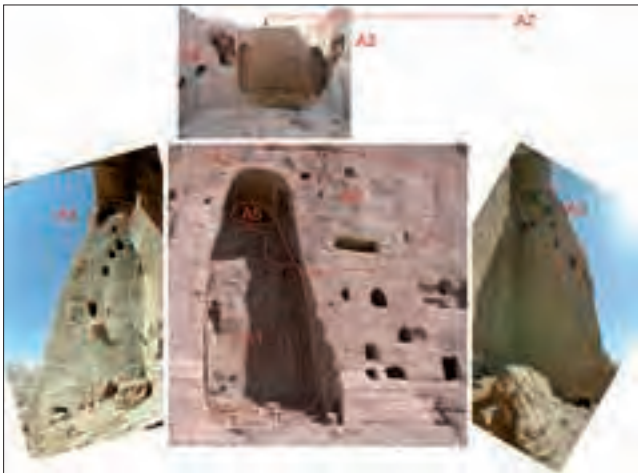
Finally, the field data (Colombini & Margottini, 2003/a and 2003/b; Margottini, 2004/a), kinematic analysis, mathematical modeling, caves and crack distribution and detail inspection of the effect of the explosion allow the realization of figures 8 and 9 which show the most endangered sites for both niches. The explosions of March 2001, besides the demolition of the statues, reduced the stability of the shallower parts of the niches. In the Eastern Giant Buddha niche, in addition to the collapse of the statue, three minor rock falls occurred from the top of the niche. Blasting also degraded the strength of the rear of the highest right part of the niche, where a stairway is located inside the cliff and the wall between the stairs and the niche is quite thin (about 30–50 cm). This part presently has the most critical instability (A3 in fig. 8).

Fig. 8. Identification of the most critical instability areas in the Eastern Giant Buddha niche. The A3 block in the Eastern Giant Buddha niche exhibits the most acute instability

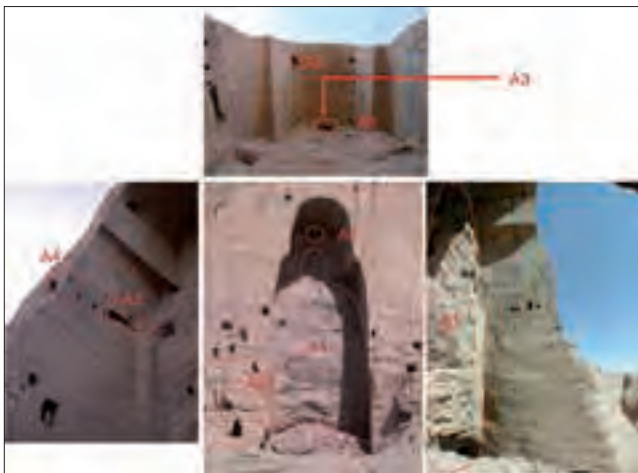
In the Western Giant Buddha niche, the major blast effects were the collapse of the statue and the consequent instability of the rear of the niche. A small rock fall occurred at the top of the niche (left side). Probably the greater thickness of the wall between the stairway going up into the cliff and the niche (about 1 m) inhibited the propagation of the blasting effects and resulted in less severe damage. A large crack, about 20-30 cm wide, is present in the corridor at the back of the head of the statue. Figure 9 shows the most critical areas found in the field inspection and/or identified by analyzing the different geological aspects investigated in this paper.

Fig. 9. Identification of the most critical instability areas in the Western Giant Buddha niche. The arrow points to a serious problem inside the niche. Other important areas to secure are A4 and the top of A6

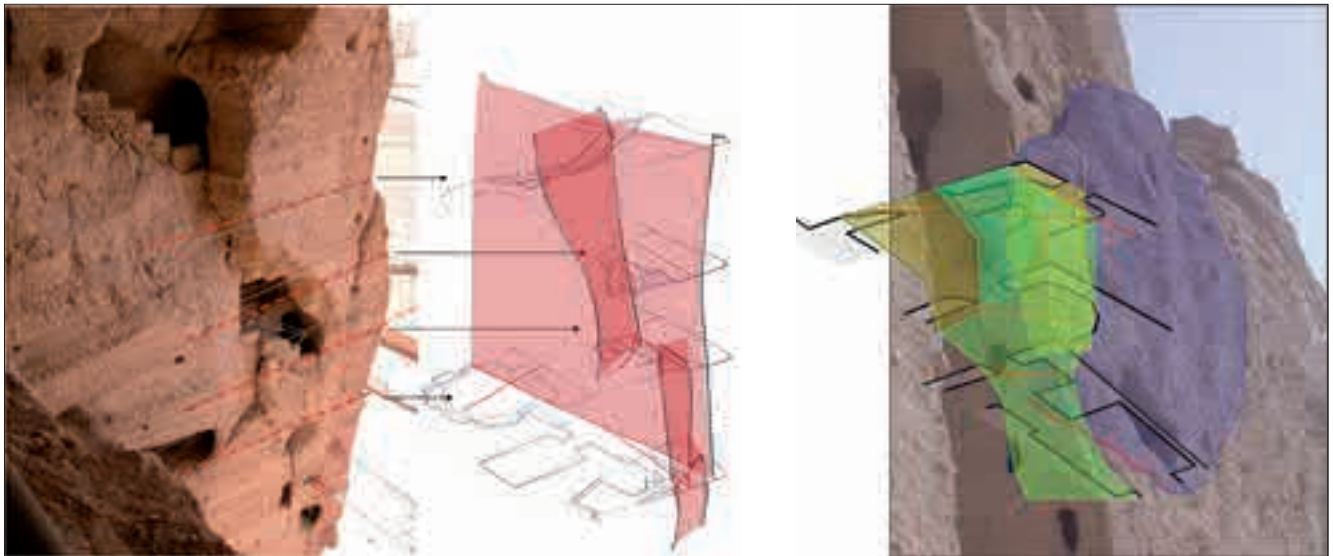
After the general strategy for stabilization, a follow up of activities was performed in September 2003, aimed to identify the potential negative evolution of the cliff and niches during winter 2003–2004. The result of a field mission suggested an immediate response to the upper east side of the Eastern Giant Buddha niche where the existing large fissures were widening and the risk of an immediate rock fall was estimated to be very high. This collapse could involve a large part of the upper eastern part of the cliff and then totally destroy the niche (fig. 10).

On the eastern side of the niche a large external block was prone to collapse (fig. 10), and many others in the inner part. A real time monitoring network was planned and realized to monitor the most remarkable cracks and discontinuities. 11 potentiometric crack gauges, 0–50 mm, 4–20 mA, fitted with couplings and connecting cable (total length 350 m) were supplied in the first phase in 2003, with acquisition system (data logger) and data management software. An alarm system to detect any deformation (movement) possibly induced by the works on the main cracks present in this part of the cliff was also installed. The accuracy of the gauges was requested in 0.01 mm, to allow an accurate measurement of even a small deformation. The position of sensors is reported in figure 12.

△ Fig. 10. Pattern of existing discontinuities at four different stories (left) and reconstructed unstable blocks in the upper east side of the Eastern Giant Buddha niche (right)

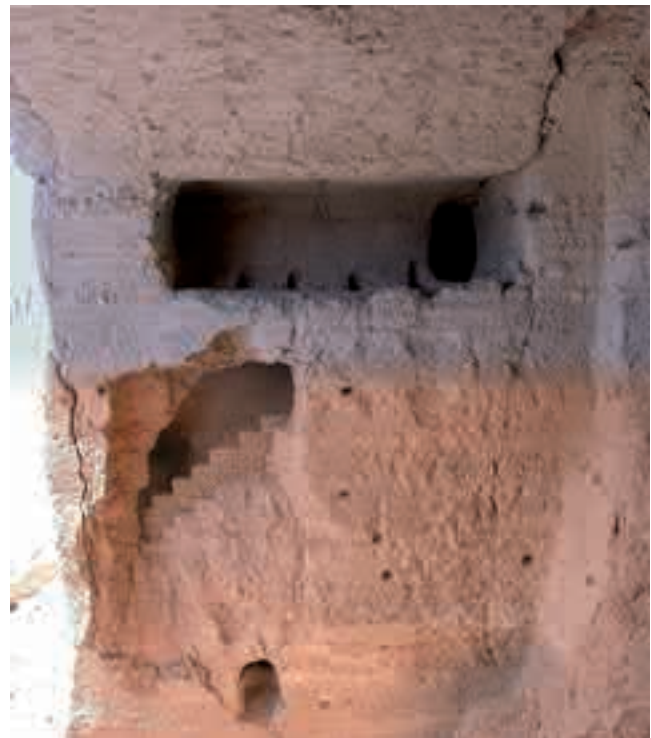
Fig. 25. The most unstable element (pillar) on the western side of Eastern Giant Buddha niche ▷

no. temporary steel cables have also been installed on the western side of the niche. Four of them were fixed through steel bolts on the inner/outer wall of the niche, whereas nine cables were circular cables embracing horizontally (6 no.), or vertically (3 no.), the rock pillar and the septum at elev. 2570.

3. Emergency intervention includes nails and grouting as follows:
 - a. Prior to starting the drilling works the large cracks in the area of the pillar at the left wall of the Eastern Giant Buddha were thoroughly filled in and grouted with cement. After the preliminary caulking, the main fissures were filled in using 0.96 m³ of low water-release cement grout, with some 1,200 kg of cement. Grout composition utilized was, as usual, C:W= 0.5 with superplasticizer.

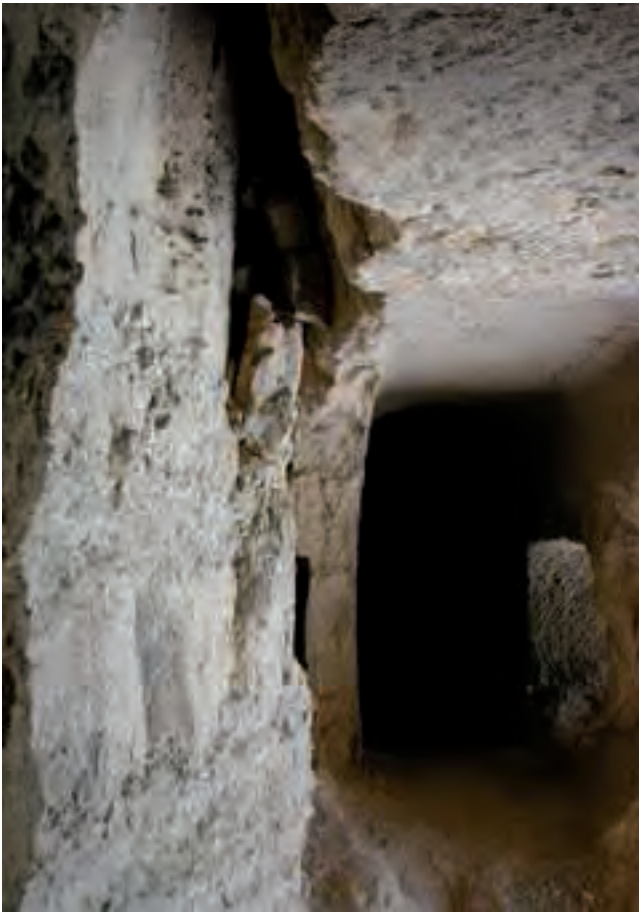
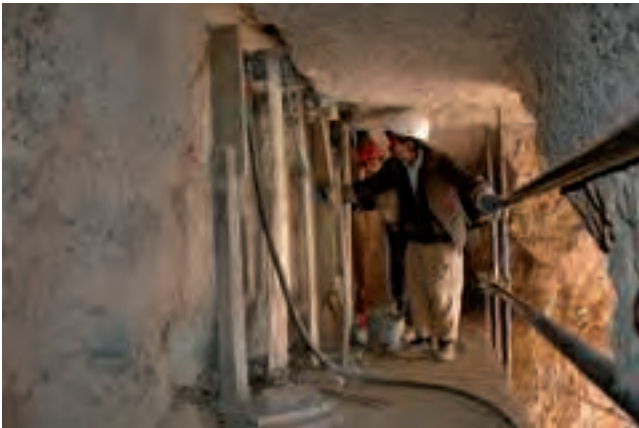
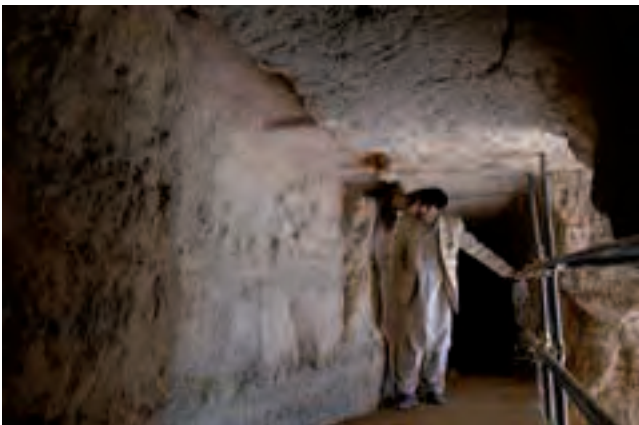
◁ Fig. 34a
Large crack in the corridor at the rear of the niche before the grouting

◁ Fig. 34b
Large crack in the corridor at the rear of the niche during the grouting

◁ Fig. 34c
Large crack in the corridor at the rear of the niche after the grouting

The grouting of the large crack at the rear of the niche was carried out from the inside as well as from the outside (top of the cliff). Initially, the fissure was grouted and closed in the internal part of the niche, in order to protect the niche from cement infiltration and leaching from the top. Small pipes were required inside the cement to avoid internal overpressure. From the top of the cliff, inclined drills were performed and, when the fissure was encountered in the perforation, it was grouted with the same mixture of cement and superplasticizer described in Margottini (2003/a). Major
