# A Victim of Fire: The 15th Century Manor Barn of Nettlestead Place, Kent

By Walter Horn and Ernest Born with radio carbon measurements by Rainer Berger.

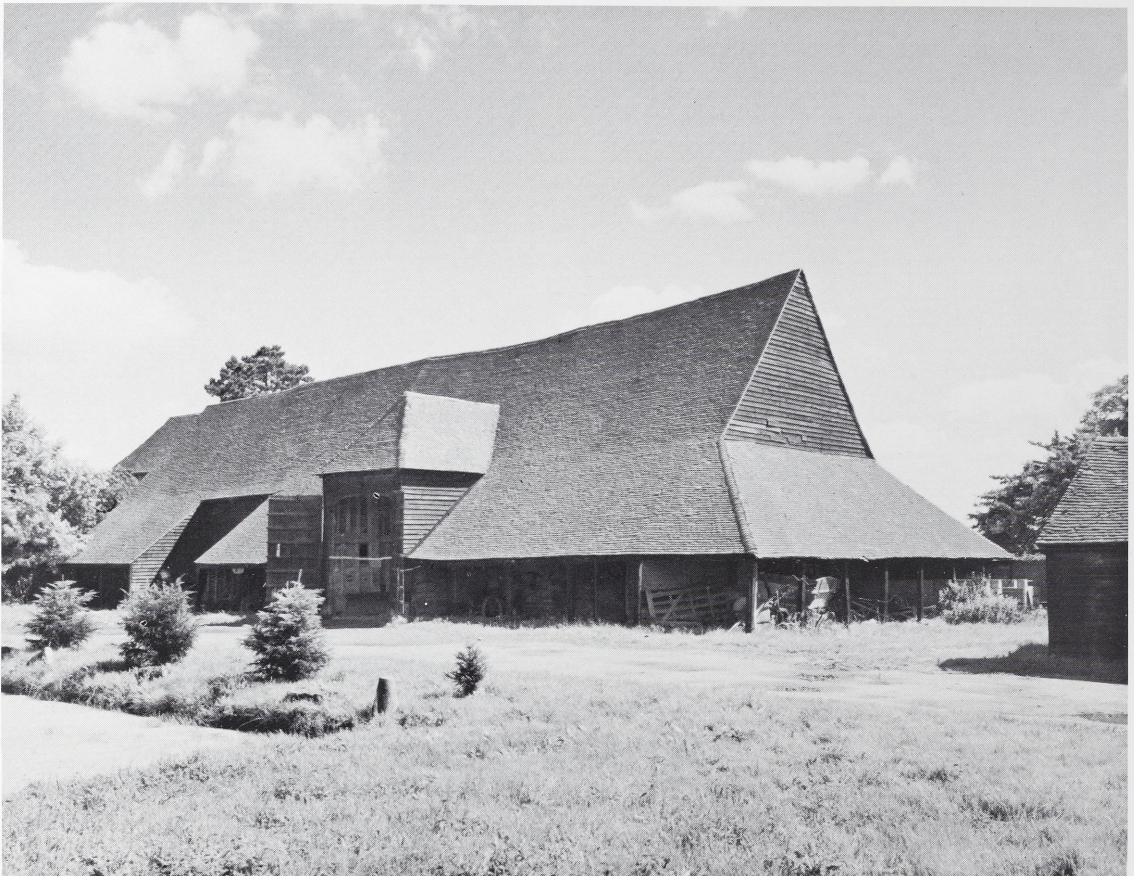
*Fig. 1*

*Nettlestead Place, Nettlestead, Kent, England. Manor Barn, ca. 1450, destroyed by fire in 1962. Exterior from west (Photo: J. W. Roberts).*

In the summer of 1960 Ernest Born and I investigated the barn of an medieval manor in Nettlestead, Kent, which had been brought to our attention by an article published in 1958 in the British monthly, *Country Life*<sup>1</sup>. The magnificent exterior view of this building (fig. 1), whose roof descends to only a few feet from the ground,

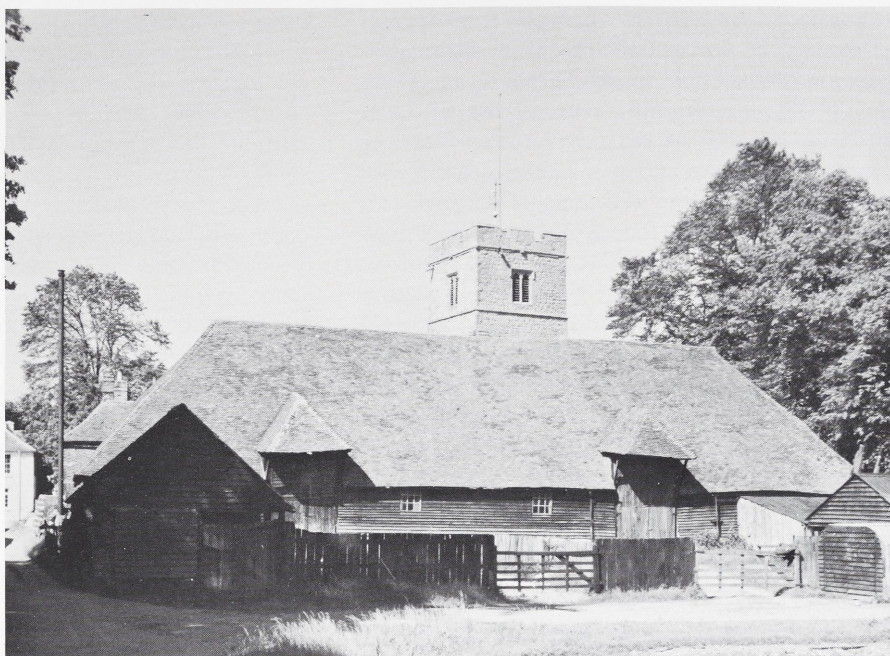
*Fig. 2*  
*Lenbam, Kent, England.*  
*Lesser Barn. After 1298.*  
*Destroyed*  
*by fire in 1964.*  
*Exterior from south*  
*(Photo: Philip Spencer).*

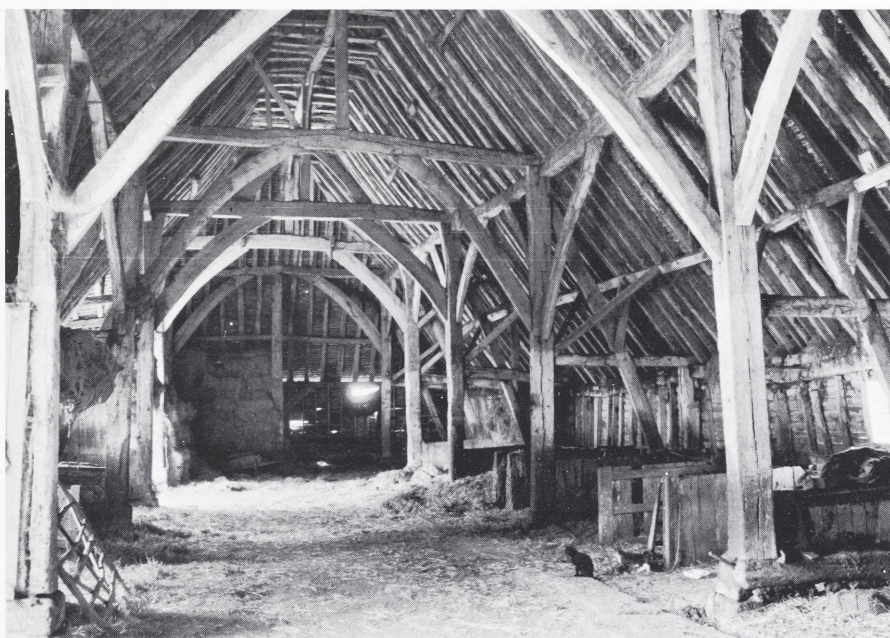
*Fig. 3*  
*Lenbam, Kent, England.*  
*Lesser Barn.*  
*Interior looking west.*  
*Destroyed*  
*by fire in 1964*  
*(Photo: Philip Spencer).*

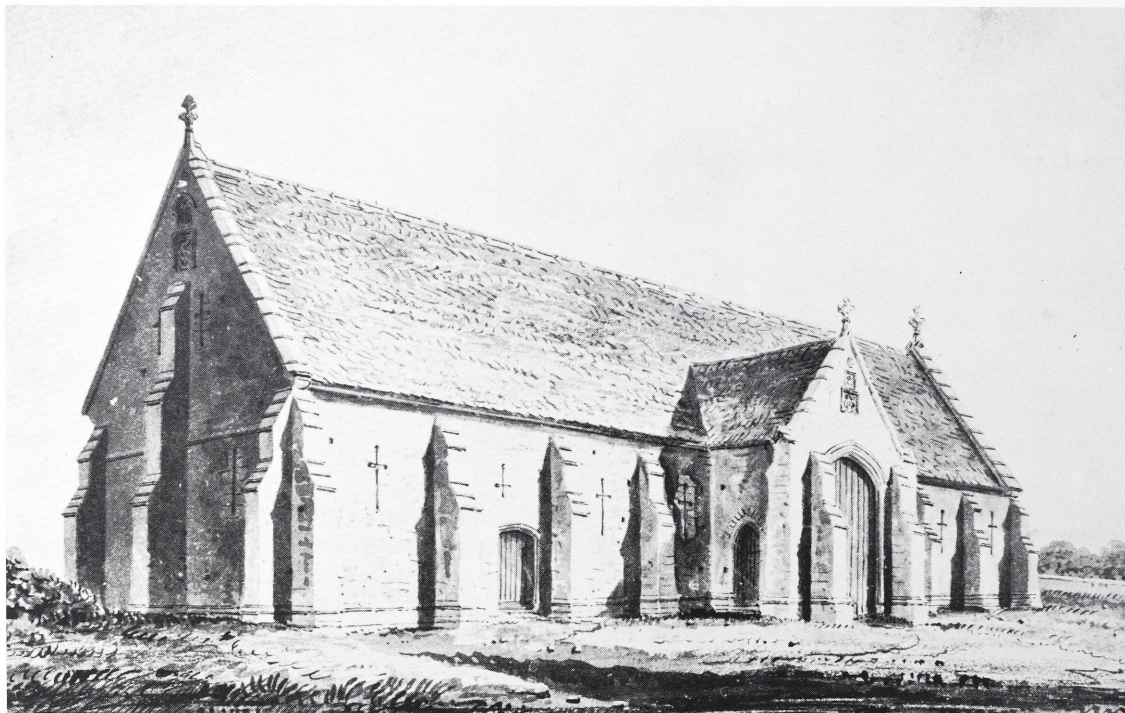
Fig. 4

*Pilton, Somerset, England, Cum Hill Farm. Barn formerly in the possession of the Bishop of Bath and Wells, 15th century; struck by lightning in 1964 (after a drawing by S. Constable in the Museum of Taunton).*

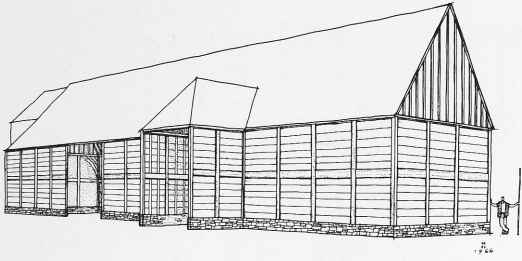
*Fig. 5*  
 Nettlestead Place, Nettlestead, Kent, England. Manor Barn, ca. 1450. Exterior from west. Reconstruction of original condition.

part of the original fabric (see inset drawing of the plan shown in fig. 7). Originally, the barn, only half as wide as today, was protected by a single span roof which rose from walls almost seventeen feet high (see reconstruction shown in fig. 5). The post-medieval additions did not detract from the beauty of the original structure, but rather added

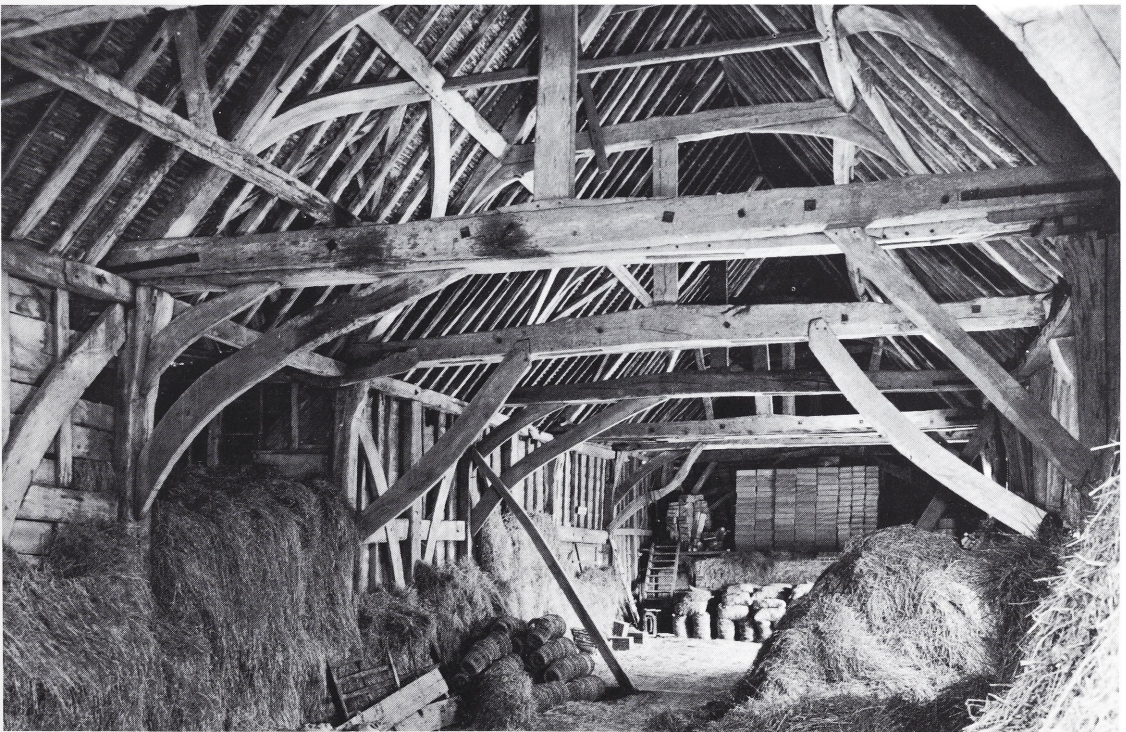
*Fig. 6*  
 Nettlestead Place, Nettlestead, Kent, England. Manor Barn, ca. 1450. Interior looking north (Photo: Country Life).

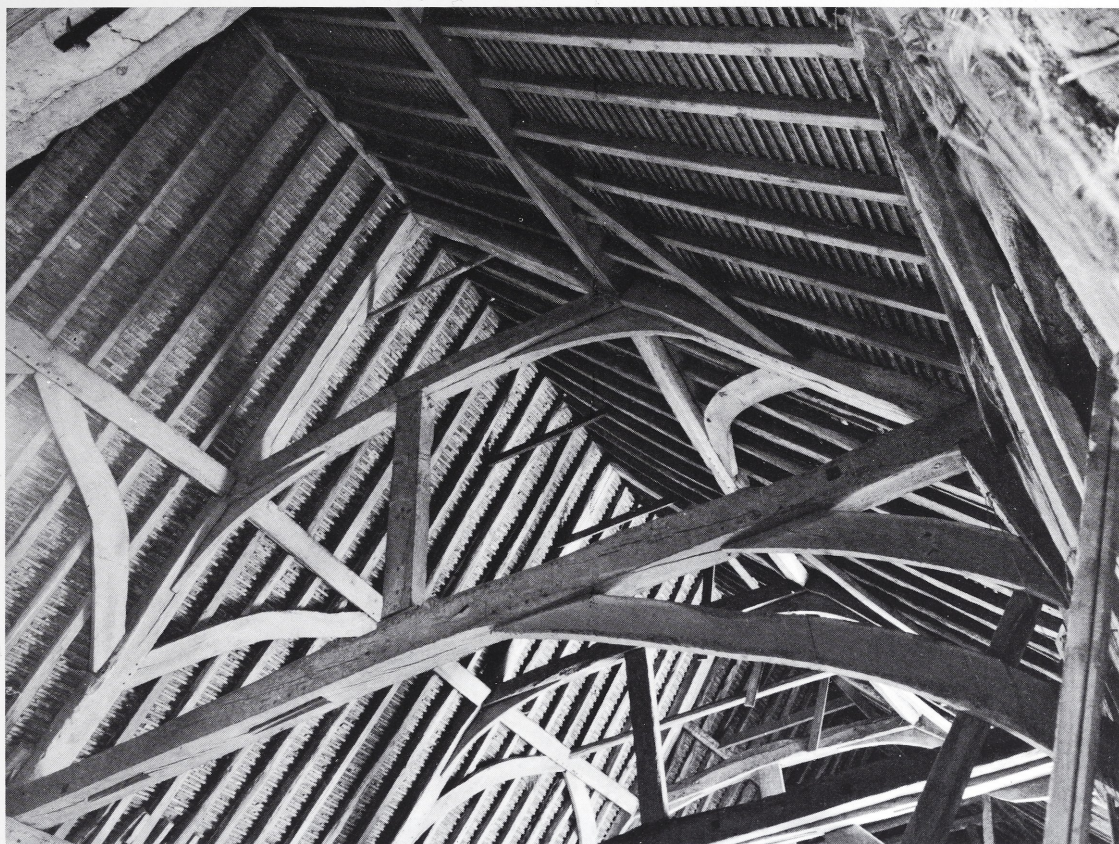
Fig. 10

Nettlestead Place, Nettlestead, Kent, England. Manor Barn, ca. 1450. Typical roof truss (Photo: J. W. Roberts).

curved, were fully preserved in three trusses only. In the others they had partially disappeared (fig. 10). Original wall bracing was preserved in seven bays. In the others it was broken out.

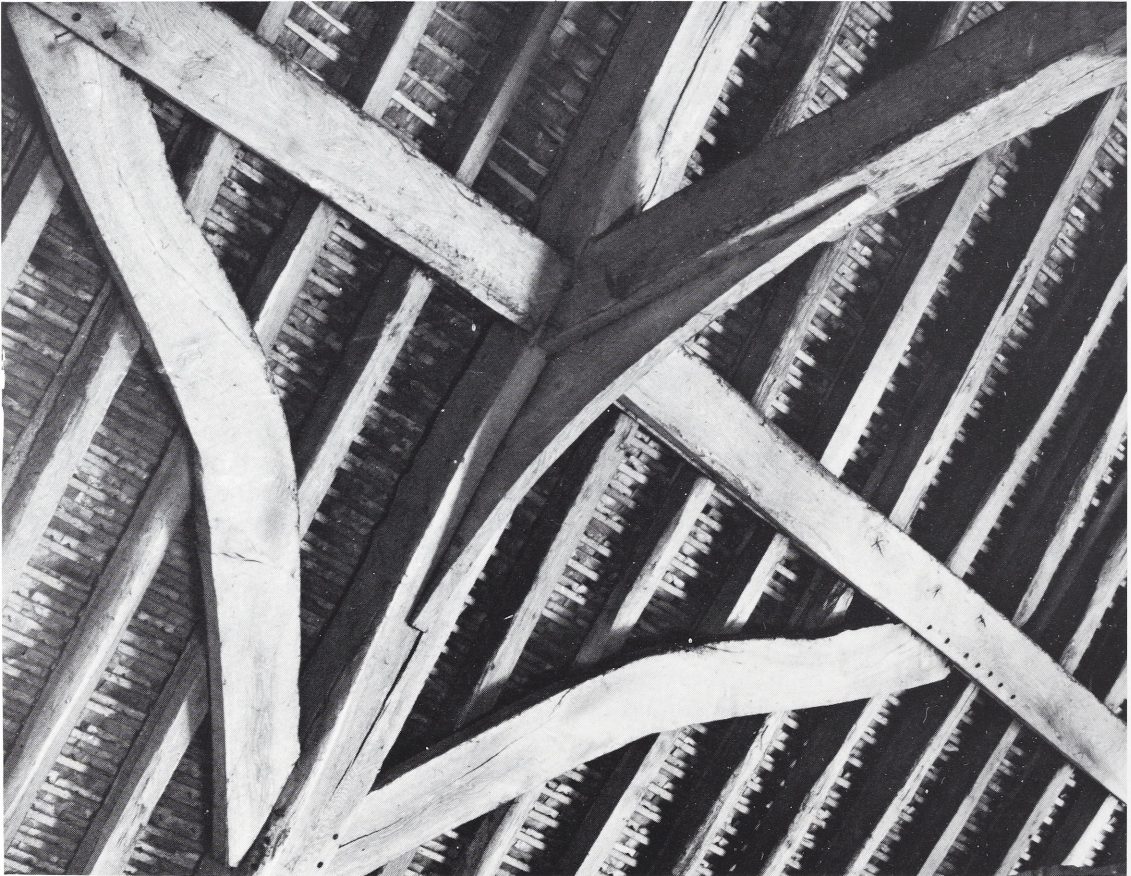
Fig. 11

*Nettlestead Place, Nettlestead, Kent, England. Manor Barn, ca. 1450. Assemblage of principal rafter, windbraces and collar beam (Photo: J. W. Roberts).*

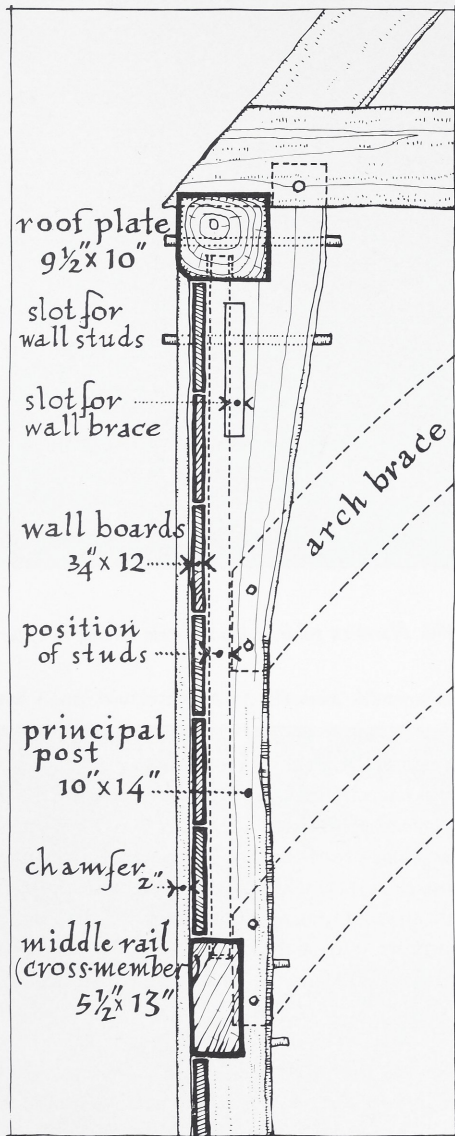
PLAN SECTION AT POST

DETAIL, SECTION

DETAIL, ELEVATION

Fig. 12  
Nettlestead Place, Nettlestead, Kent, England, Manor Barn, ca. 1450. Assemblage of principal post, wall plate and tie-beam.

curved braces (figs. 8, 9 and 12). Every second post carried a tie beam which served as base for the roof supporting trusses. There were nine trusses in all, including those of the gable walls. The latter rose in a straight plane up to the very ridge of the roof (fig. 5). Halfway up the wall, the posts were steadied by horizontal beams which were tenoned and pegged into the vertical members, and halved over the curved wall braces (fig. 8). Intermediate studs of more slender scantling helped to keep the weatherboarding in place. The ground sills were 11 by 11 inches. The wall posts averaged 10 inches by 14 inches (fig. 12). They were chamfered on the outside and this chamfer was taken up and continued in the plates above them. The weatherboarding consisted of planks 12 inches wide and  $\frac{3}{4}$  inches thick, seated in slots (1 inch -  $1\frac{1}{4}$  inches wide, and  $1\frac{1}{2}$  inches deep) cut into the wall posts at a short distance from their chamfered edges (fig. 12).

The head of the posts was jowelled, and tenoned and pegged into the tie beam. The roof plates rested in a recess cut into the outer half of the post jowel and were locked into the tie beam with the aid of a dovetail joint. An interesting detail of this assemblage was the assymetrical position of the tenons at the head of the posts as well as the assymetrical shape of the dovetail in the bottom section of the tie beam.

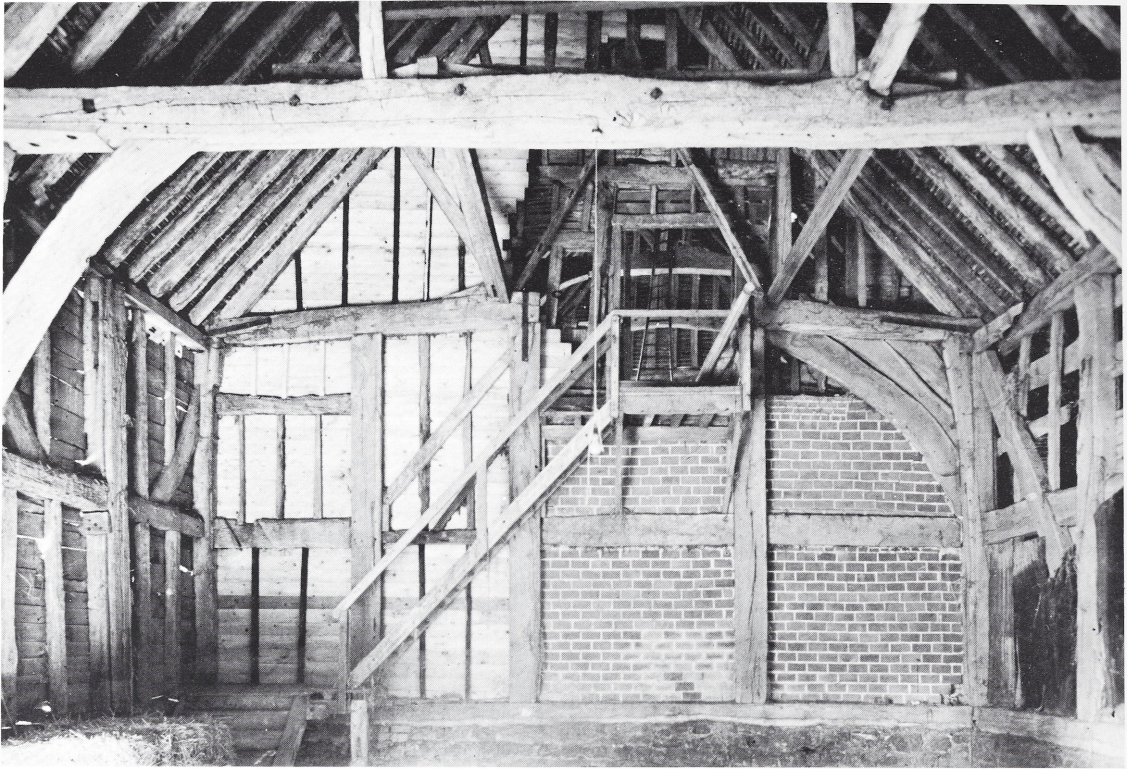
Fig. 13

*Nettlestead Place, Nettlestead, Kent, England. Manor Barn, ca. 1450. Northern gable wall with stair leading to upper level of Gate House (Photo: J. W. Roberts).*

Another noteworthy detail was in the design of the northern gable wall. The posts of this wall were not evenly spaced (figs. 9b and 13). The first two posts (counting from left to right) are spaced at intervals of six feet; the last two posts at intervals of a little over eight feet. This is clearly in adjustment to the dimensions of the contiguous south wall of the gate house, which was so close that it could be used as a

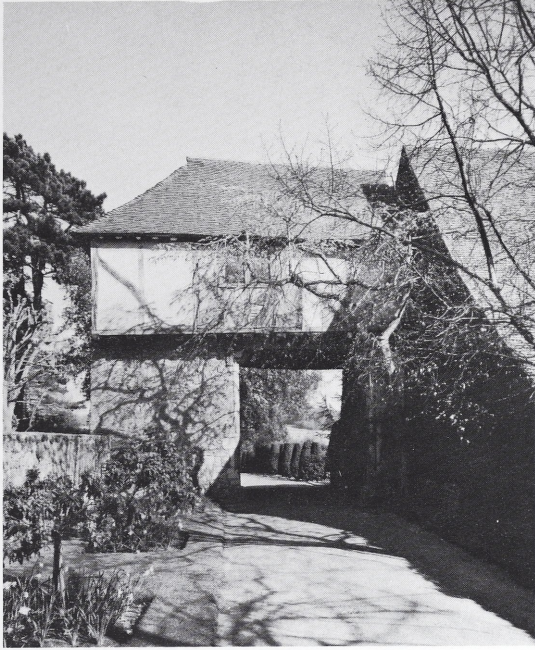
Fig. 14  
 Nettlestead Place, Nettlestead, Kent, England. Gate House,  
 14th century, Exterior from west (Photo: Country Life).

Since the date of the barn depends to some extent on that of the gate house, against which it was built – and which miraculously escaped the fire of 1962 – we cannot bypass this building (figs. 14–18). It consists of a lower masonry chamber with walls of local rag stone, and an upper room with timber framed walls and an exquisite roof (figs. 16–17). This room extends over the masonry part of the house as well as the wagon entrance beside it. We had full access to the upper room which can be reached from the interior of the barn (fig. 13), but could not obtain any information on the inside of the masonry chamber, which is reached by a narrow door (fig. 18) that was locked and, in the owners absence, inaccessible.

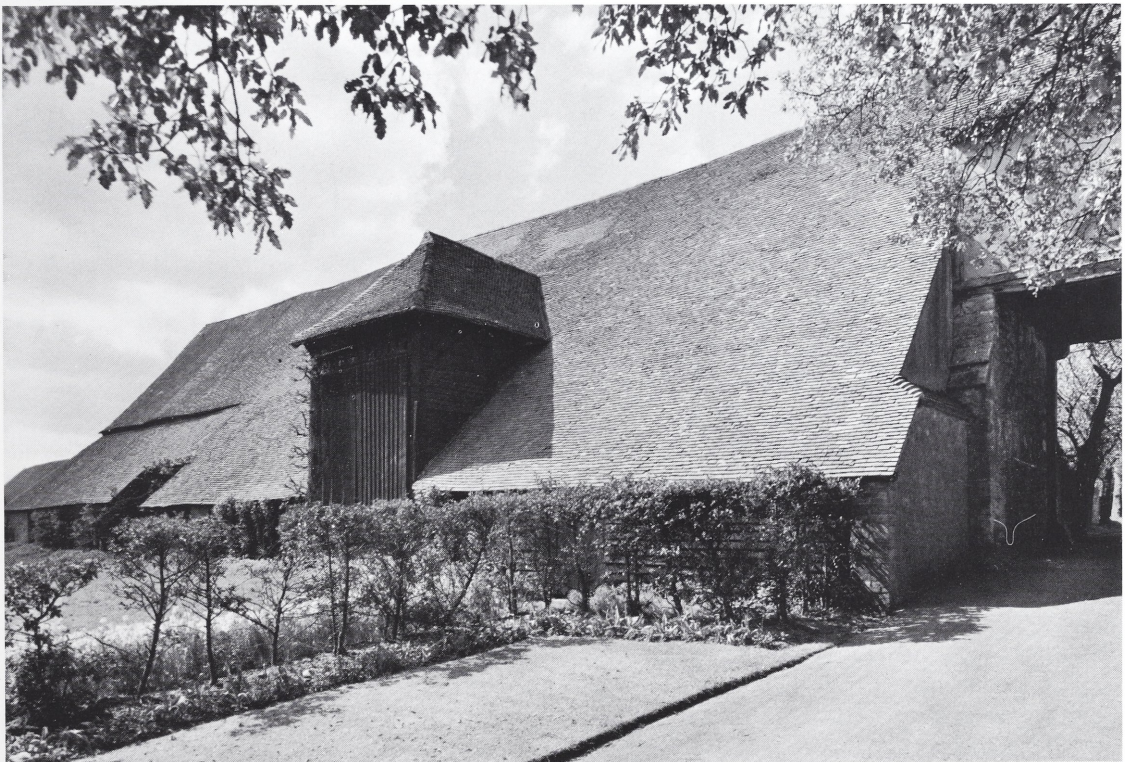
Fig. 15  
 Nettlestead Place, Nettlestead, Kent, England. Manor Barn with Gate House, Exterior from east (Photo: Country Life).

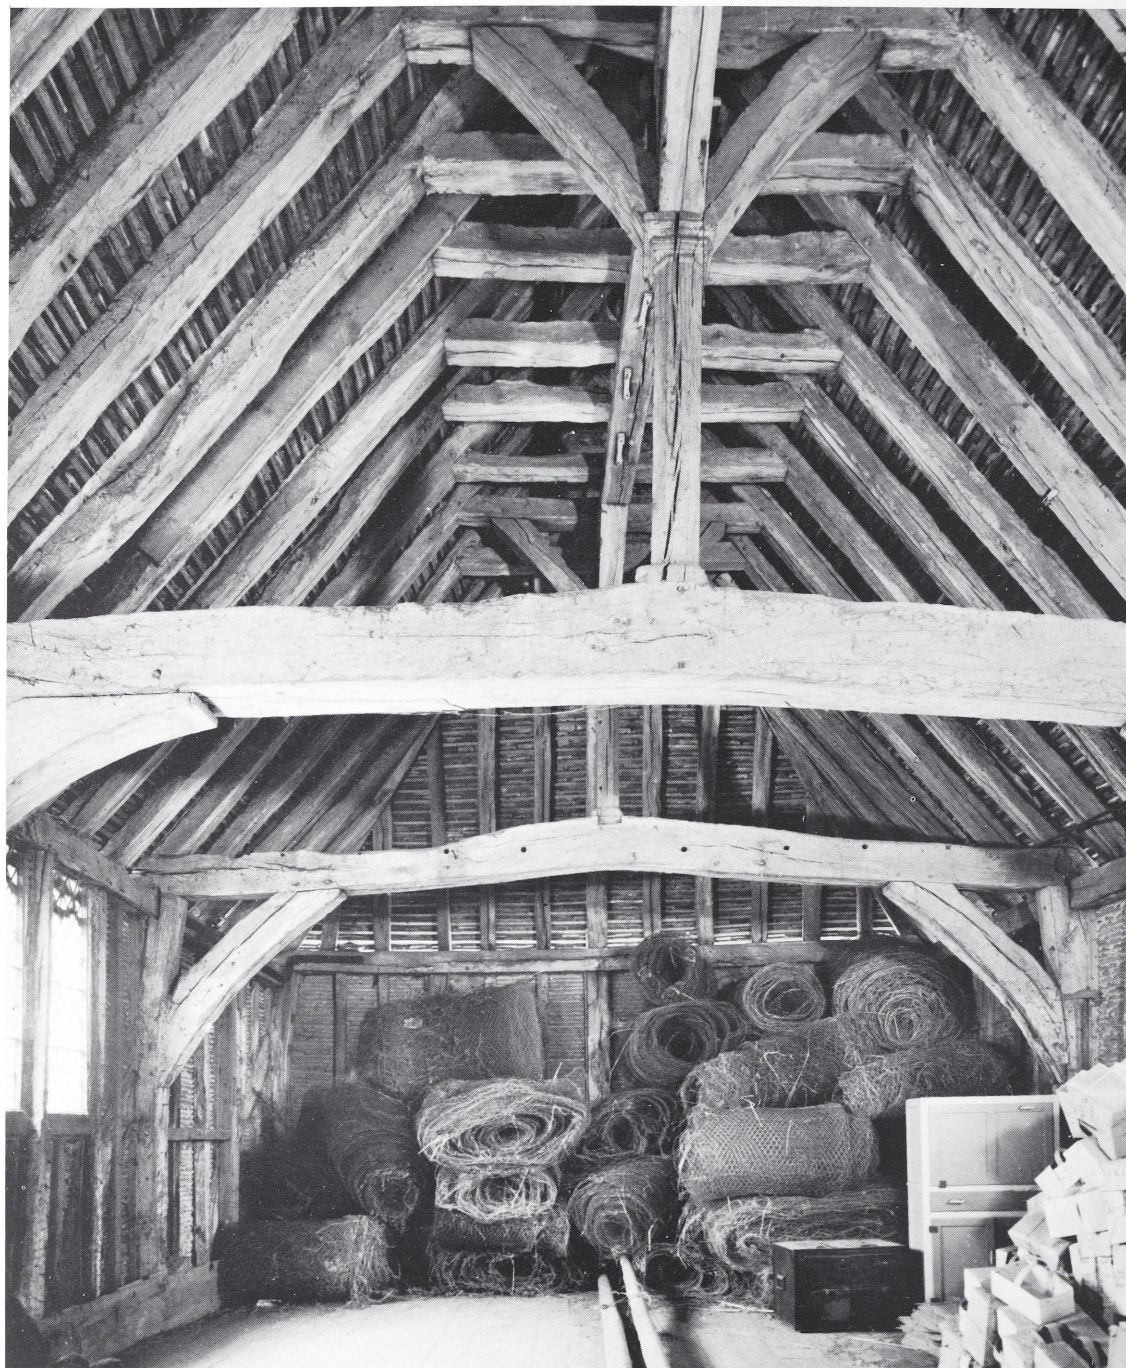
*Fig. 16*  
*Nettlestead Place, Nettlestead, Kent, England. Gate House, 14th century, Room over gateway, looking north (Photo: Country Life).*

of kingposts with hexagonal shafts and four-way braces rising to purlin and collar. The posts rise from the middle of two sharply cambered tie beams. They are decorated with a relatively simple base, but a very elaborately moulded capital (figs. 16 and 17). The treatment of the walls is not dissimilar to that of the barn. Each alternate post is surmounted by a tie beam held in place by two curved wall braces which spring from the foot of the intermediary posts to a little above the middle of the principal posts. There are three windows in the east and west walls. The panels between the posts are filled with plaster walls held in place by intermediary studding visible on the inside only. A noteworthy architectural detail of the masonry of the gate house is the doorway shown in fig. 18.

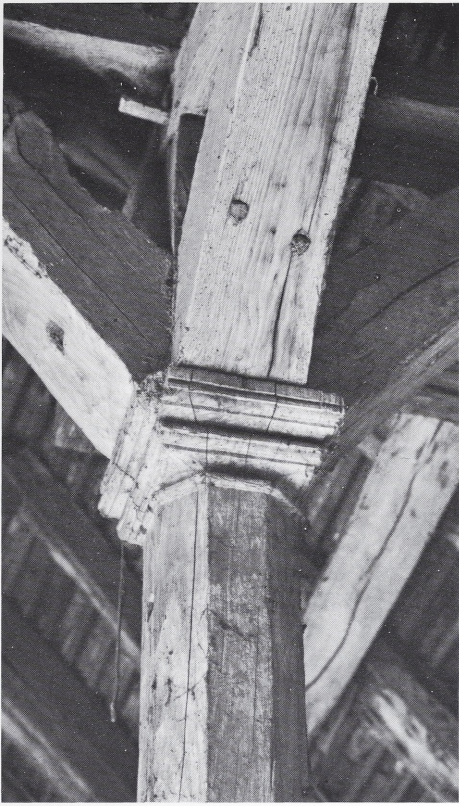
Fig. 17  
*Nettlestead Place, Nettlestead, Kent, England. Gate House, 14th century, detail of king post in room over gateway (Photo: J. W. Roberts).*

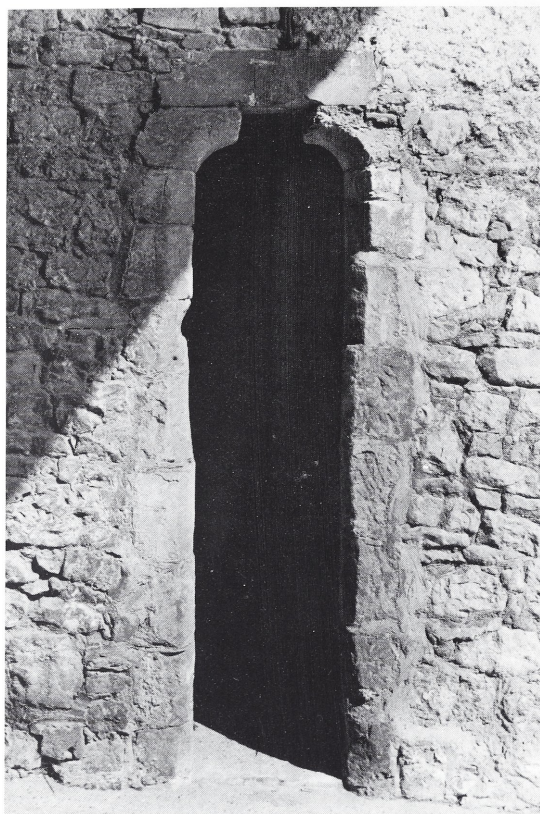
Fig. 18  
*Nettlestead Place, Nettlestead, Kent, England. Door with shoulered arch giving access to lower chamber of Gate House, 14th century (Photo: Country Life).*

Arthur Oswald, in his article on Nettlestead Place, points out that the shouldered arch of the doorway of the gate house is of a type »that was first extensively used in Caernarvaron Castle toward the end of the thirteenth century« and suggests an early fourteenth century date for the gate way.<sup>9</sup> He assigns the roof of the barn to »the latter part of the fifteenth or the first half of the sixteenth century.«<sup>10</sup> The Reverend C. T. Spurling on the other hand, in a note addressed to the editor of *Country Life*, wrote that the barn »is believed to date from about 1360.«<sup>11</sup> In order to more accurately date the structure, samples for radiocarbon measurement were collected by Rainer Berger and myself in 1965 from one of the charred sill beams which survived the fire of 1962 and were processed in the radiocarbon laboratory of the Institute of Geophysics and Planetary Physics at the University of California at Los Angeles. The result of this experiment suggests that the barn was built around 1450. Because of the importance of this analysis and the complexity of the methods involved we are removing this portion of the study to an appendix.

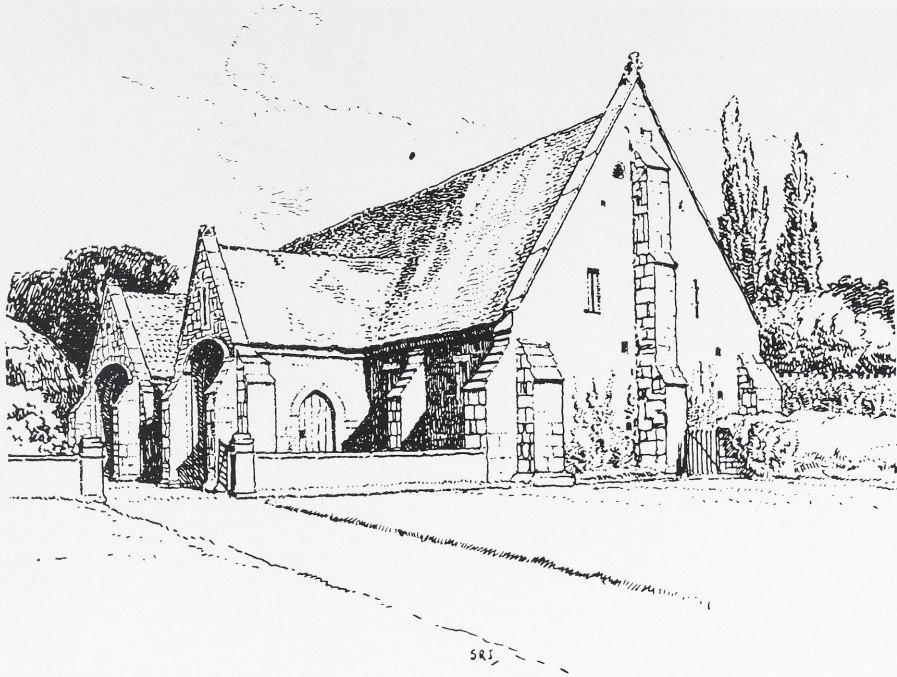
Fig. 20  
 Douling, Somerset, England. Barn formerly owned by the Abbot of Glastonbury, 14–15th century  
 (after Ditchfield and Jones).

- <sup>18</sup> For Pilton, see the literature quoted in note 3 above.
- <sup>19</sup> The drawing shown in fig. 20 is after P. H. Ditchfield and Sidney R. Jones, *The Charm of the English Village* (London, 1908), p. 135. For further mention of this barn, see Andrews, *op. cit.*, p. 31; Olive Cook and Edwin Smith, *English Cottages and Farmhouses* (London, 1955), p. 42 and Fig. 204; and J. D. U. Ward, »Tithe Barn Survivals«, *Country Life*, 1950, February 24, pp. 514–515.

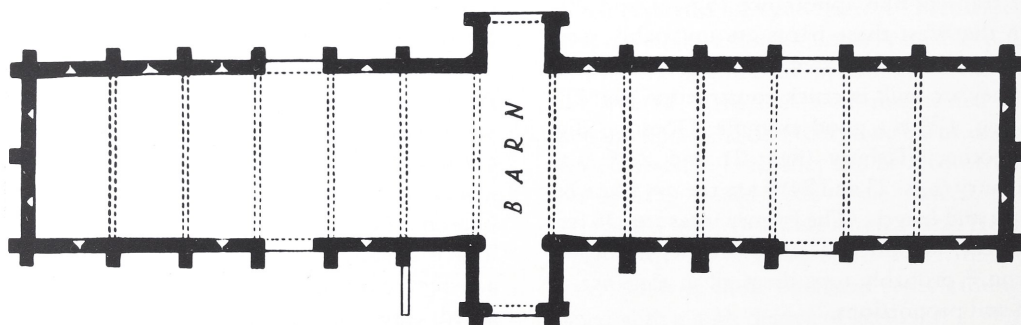
Fig. 22  
Place Farm, Tisbury, Wiltshire, England. Plan of Barn (after A. R. Dufty).

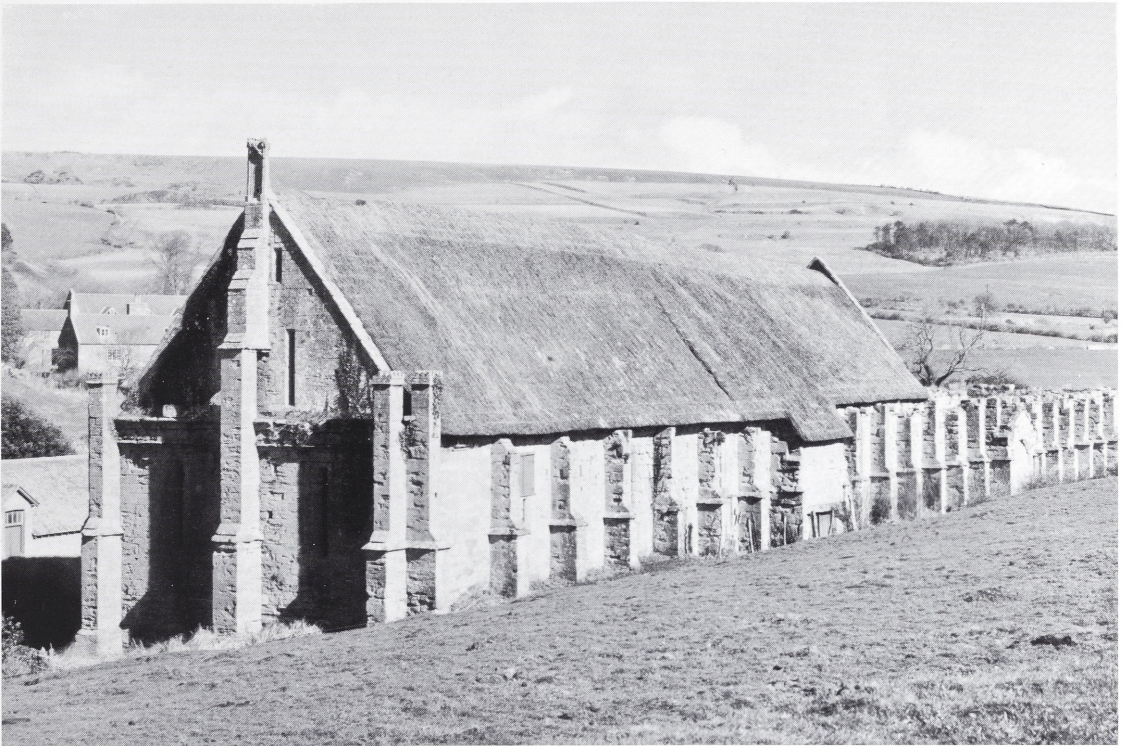
Fig. 23  
Abbotsbury, Dorset, England. The Abbey Barn from southwest, 14th century (by courtesy of Her Majesty's Stationary Office).

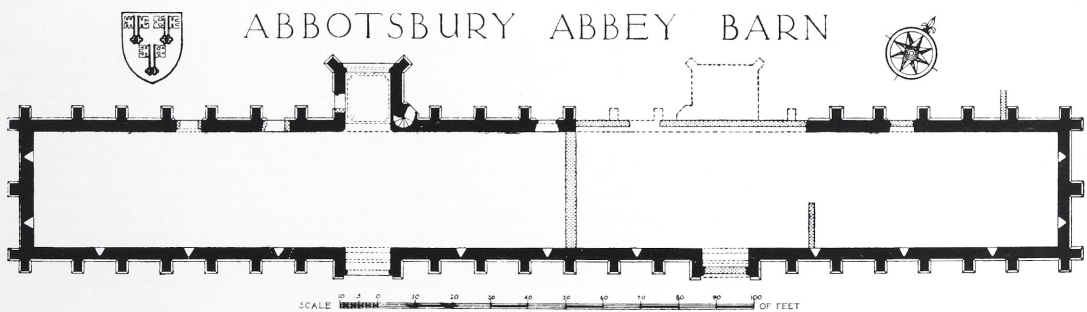
Fig. 24  
Abbotsbury, Dorset, England. The Abbey Barn, Plan (after Royal Commission on the Ancient and Historical Monuments).
