ARMENIA

Castle Amberd

The technical state of the citadel and the palace

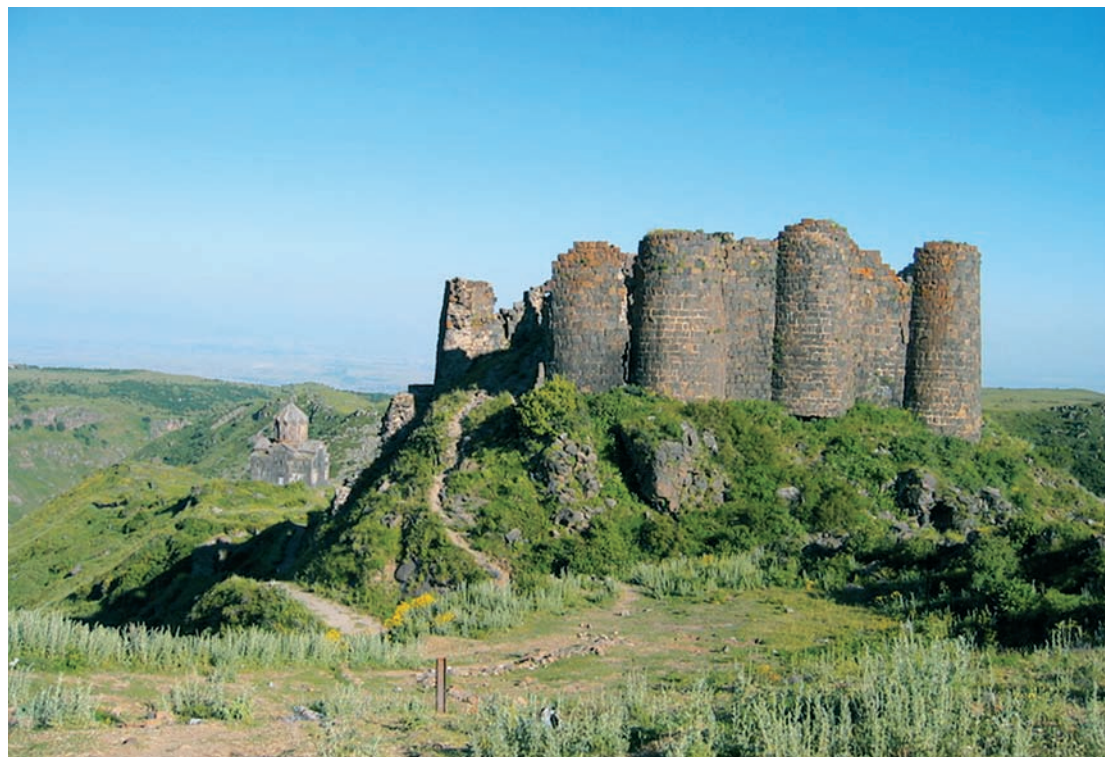
View of the citadel (Photo: Edward Grigorian)

The stone walls have been constructed directly on natural shale rock foundations. The walls are built of huge solid basaltic stones with mortar filling. There are numerous cracks in the walls, which are the result either of earthquakes or of the deterioration of the foundation stones. The rock surfaces have been wind-beaten because of the climate. The temperature varies between 35° C in summer and minus 35° C in winter. Due to the destruction of the foundations, the north-east tower has collapsed and fallen into the nearest canyon. The wall originally adjoining this tower is now in danger of falling into the canyon as well. The crack between the wall and the next tower is growing wider and wider, threatening the already damaged wall.

Recent research has proved that the damage to the northern and southern walls have occurred in the last 50 to 60 years. This is shown by old photos, where we can very distinctly see that there

were no cracks then. The main difficulty and problem are that the walls of the citadel and the palace have lost the constructive bond. The walls of 12 to 13 metres height, which have stood for several centuries, have lost their stability, and the process of intensive destruction has begun, endangering the existence of the monument.

As a result, the existence of this monument of unique historical-cultural value is endangered. An urgent and immediate intervention will be necessary to stabilise and preserve Amberd Castle.
