ROMANIA

Follow-up on Roşia Montana and the Preservation of its Cultural and Natural Heritage¹

First Results in Safeguarding the Transylvanian Saxon Architectural Heritage

The Threats to and the Protection of the Architectural Heritage of Manor Estates in Banat

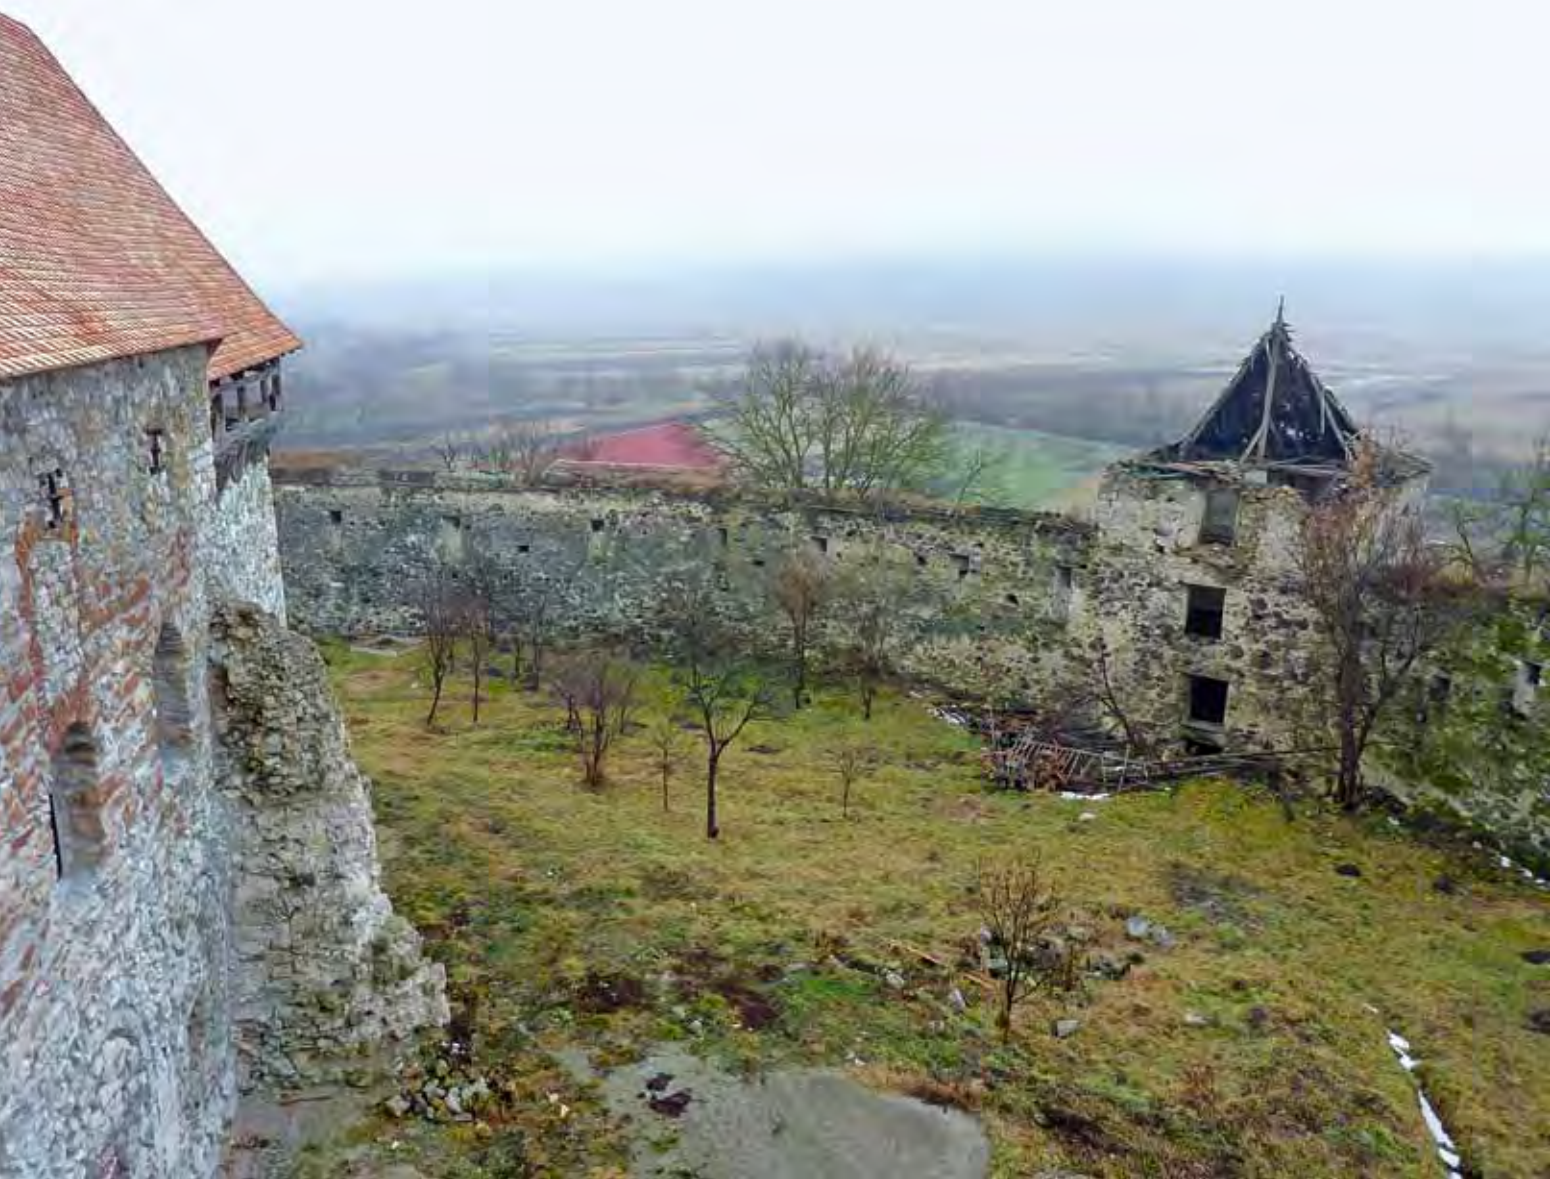
The fortified ensemble of Drăușeni/Draas

Different is the actual state of conservation of the fortified ensemble in *Drăuşeni/Draas*, with one of the oldest and most important three-nave buttressed basilicas erected around 1280 in a transitional late Romanesque/early Gothic style. The village was mentioned as the north-eastern corner of the first German colonisation of Transylvania in the 13th century. Shortly before 1500 the church building was fortified itself by demolishing the aisles, raising the walls of the choir to the same level as the nave and adding to both a defence storey with half-timber parapets, erecting a defence gallery on the western tower and surrounding the churchyard with a circular defence wall with six towers. In the early 1970s the German population of the village left and the already bad condition of the church worsened due to a lack of maintenance. The recent conservation works started in 2010

within the framework of a special funding programme provided by the European Union. However, at the end of 2011 the conservation work stopped and since then the fabric of the church once again has to be considered to be at risk: The plaster was completely removed from the church facades to “prepare” the naked masonry for a sort of reconstruction by making all the historic details of the building clearly visible and approachable. The plastering of the rubble masonry always has been and still is a very important protective layer not only for the masonry, but in the case of Drăușeni especially for the mural paintings inside the nave. There a cycle of scenes can be found illustrating the legend of Saint Catherine of Alexandria, the only one in Transylvania, painted around 1380. For the mural paintings no preventive conservation measures were taken, while on the south-western bay of the aisle a new defence gallery with timber-framed parapets has been built, which obviously never existed in the past. Meanwhile the towers of the ring wall are in danger of collapsing. Several – unsuccessful – attempts have already been made to convince the responsible authorities, i.e. the Romanian Ministry of Culture, to continue the conservation works for the entire ensemble. These works should start with the urgently needed plastering of the church facades, but should also include the conservation of the mural paintings and ensure at least a minimal protection for the fortification walls and towers, which are in danger of collapsing.

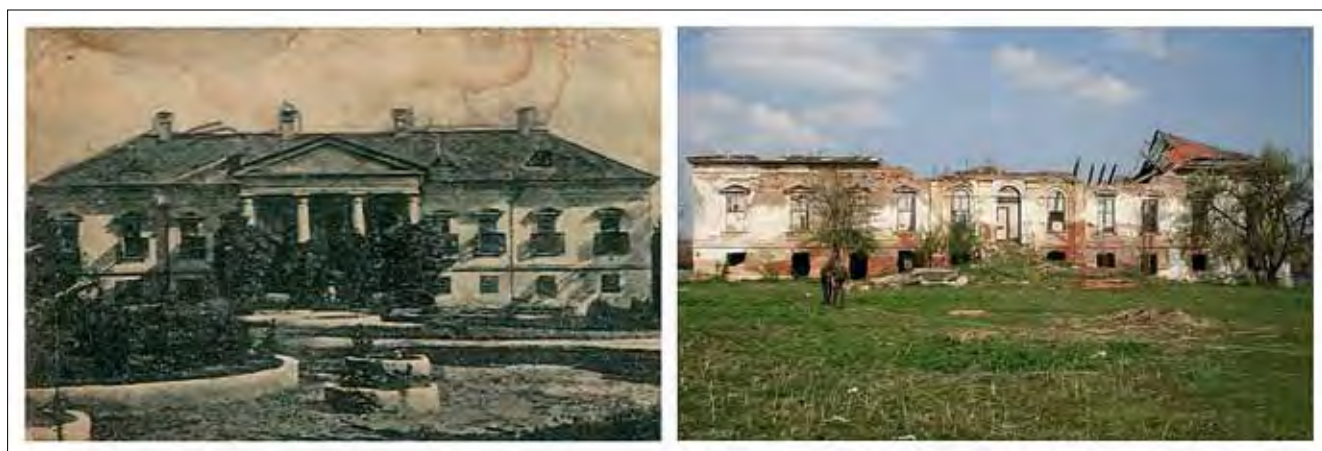
Athanasievics Residence (Valeapai, Caraș-Severin County) was built around 1840 by brothers Marcel and Emil Athanasievics. During the Communist regime, the palace was used as a Birth House, then as C.A.P. headquarter (Agrarian State Cooperative) and accommodation for seasonal workers. After 1989, it was abandoned leading to its gradual decay, thus becoming one of today's most affected manor estates in Banat. Without a roof and brought to a state of collapse, the former manor is nowadays subject to brick thieves and iron collectors. A lack of protection and the postponement of emergency interventions to consolidate the still existing structure will have as an inevitable effect the disappearance of this historic monument in the near future.

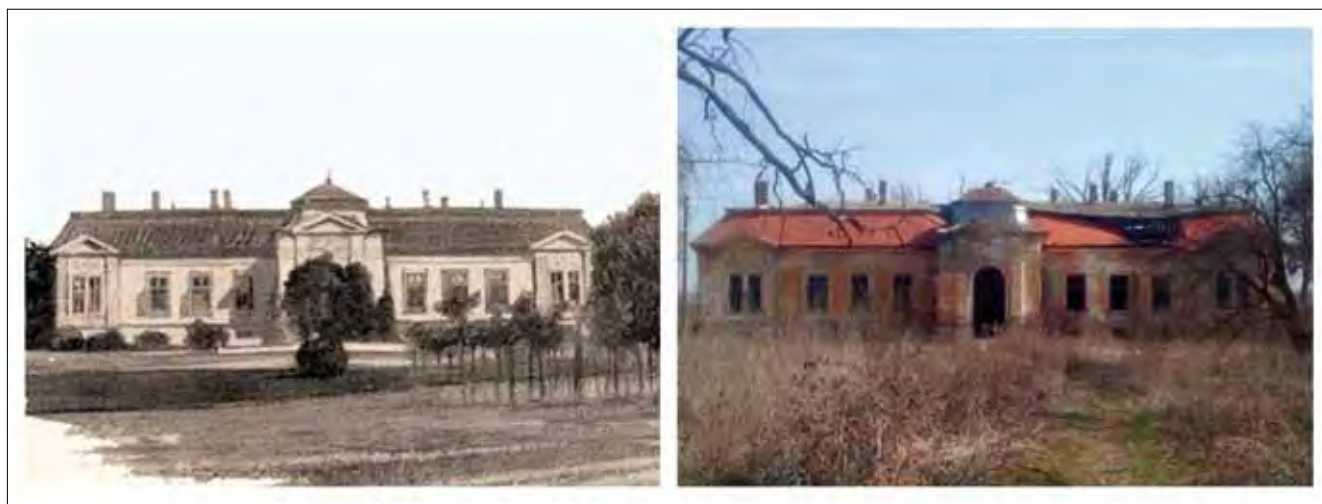
Ronay Manor (Utvin, Timiș County) was built by Kovács Ákosé in 1896 and bought in 1904 by Rónay Mihály. After the nationalization, it hosted a series of inappropriate functions, and after 1989 despite its historic and architectural value the ensemble was never classified as a historic monument. What is more, it was quickly abandoned. The state of advanced decay is the result of the local community's carelessness and the ineffectiveness of public heritage safeguarding policies.

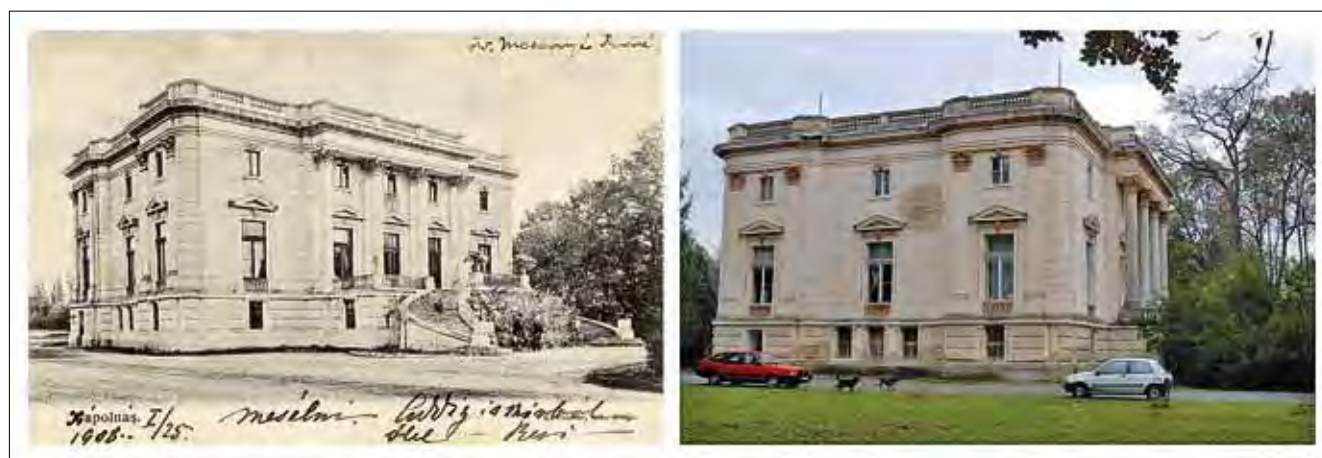
Teleki-Mocioni Mansion (Căpâlnaş, Arad County) was built between 1876 and 1879 most probably by Kallina Mór after plans made in 1867 by Viennese architect Otto Wagner, under the patronage of Ecaterina Mocioni and her husband, Mihai Mocioni. In 1947, the estate was nationalized and the palace was transformed into a children's tuberculosis preventorium and later into a psychiatric hospital, which it is until today. The building shows structural degradation, especially because of rainfall infiltration, negligence in repairing the rainwater drainage system, a superficial care of framing and of water installation systems, leading to capillarity by an inadequate use of concrete plasters.

As these buildings represent remarkable heritage assets the Direction for Historical Monuments during the 1960s and 70s decided to carry out preservation works at several manor estates (Căpâlnaş, Bulci, Banloc etc.). However, these measures ended in December 1977 when the Direction itself was disbanded. After December 1989 there were no more restoration works with public funding in Banat. Being state property (e.g. the Mayoralty of Sânnicolau Mare – the ex-residence Nákó from Jimbolia, Timiș county), in the administration of public institutions (e.g. the Psychiatry Clinic Hospital Arad – the former residence Teleki-Mocioni from Căpâlnaş, Arad county), or private property, the built heritage represented by the former manor estates in Banat has been badly managed. Also, along with the decline of these ensembles formerly belonging to the old nobility, a disintegration of their anthropic and natural context followed, thus resulting in a profound degradation of the entire surrounding cultural landscape. The estates were arbitrarily fragmented, according to local interests, and the ensembles lost their unity and specific coherent landscape.

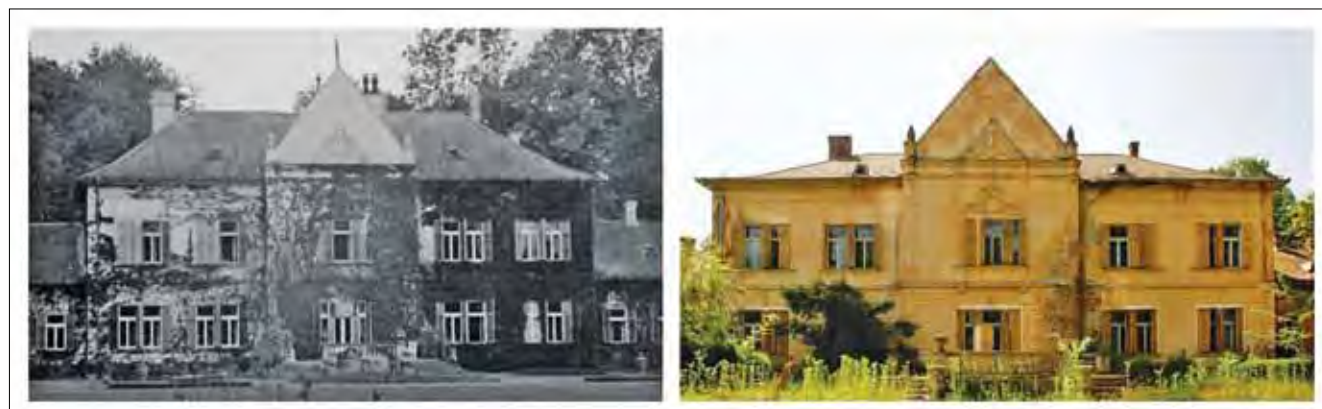
Built in a first stage at the beginning of the 19th century, the Mocioni ensemble (Bulci, Arad County) was gradually extended under Antoiniu I Mocioni de Foen and his son, Zeno. After the nationalization it functioned as a neuro-psychiatry hospital and later as a tuberculosis preventorium, a function it kept until 2011. Due to a legal dispute since the beginning of the 2000s, the ensemble has intentionally been brought to an advanced state of degradation, which has led to the partial collapse of the roof because of humidity and rainfall infiltration.

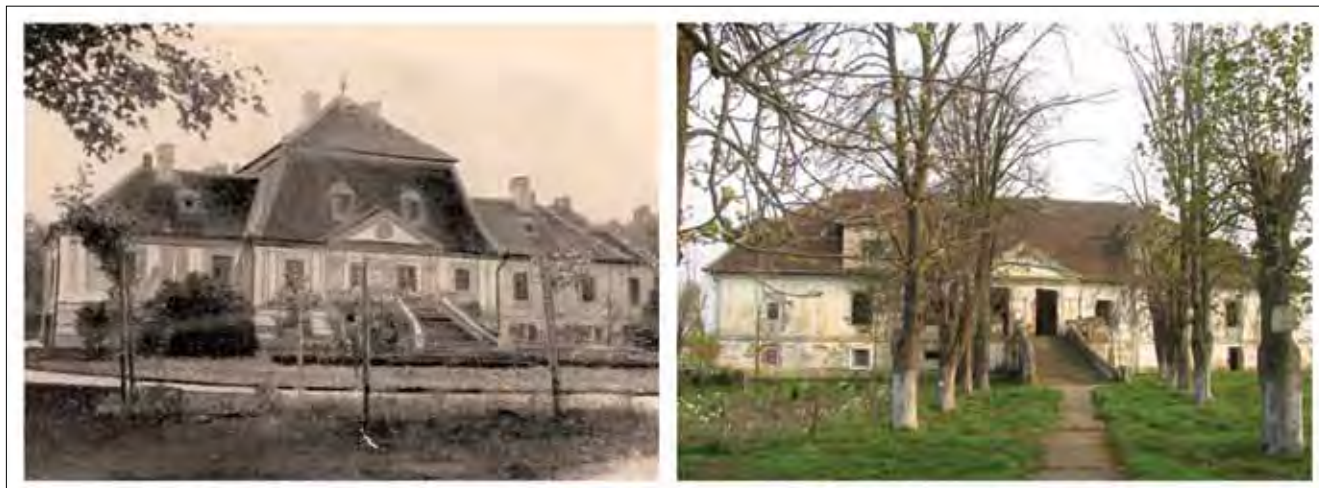
The Nikolics ensemble (Rudna, Timiș County) was built at the end of the 18th century by Baron Ioan Nikolics. After the installation of the Communist regime, the family crypt was used as an observation point of the Serbian border, and the palace became the home of the border patrol troops. In 1964, it became a CAP headquarter. After 1989, the ensemble was privatized and an amateur restoration site was set up. However, its lack of sustainability led to the abandonment of the works and a profound alteration of the former manor estate's values.

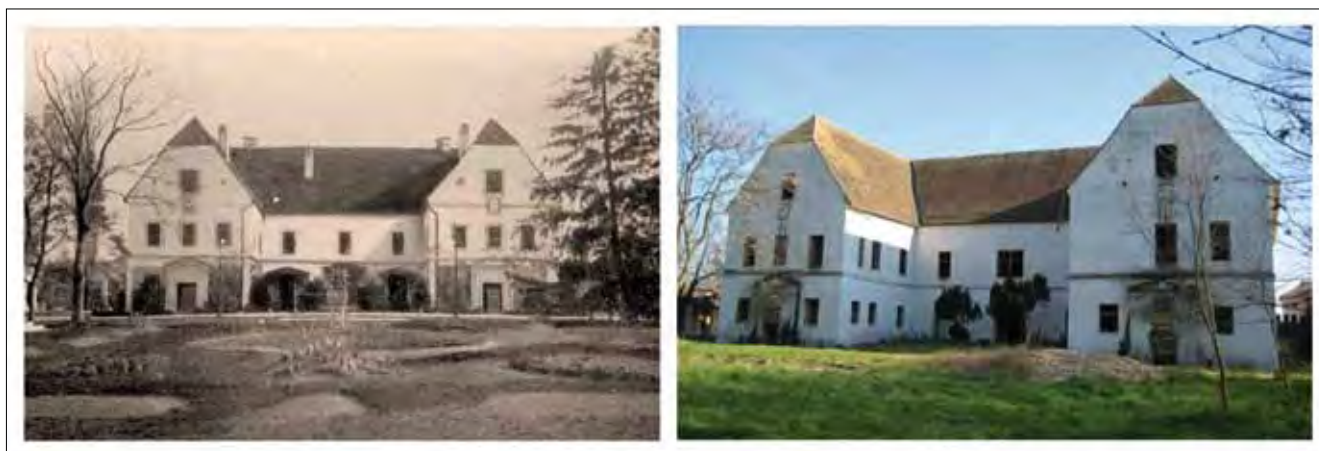
Karátsonyi Palace (Banloc, Timiș County) received its final shape around 1793, during the time of Lazăr Karátsonyi, when the English park was laid out. It included a tea pavilion, a gloriette and a chapel. After the First World War, the Serbian occupation forces devastated the ensemble and in 1935, the last count, Karátsonyi-Keglevich Imre, sold what was left of the domain to Queen Elizabeth of Greece, sister of King Carl II of Romania. She renovated the entire complex, the ensemble reaching its final period of glory. In the course of its nationalization, the ensemble functioned as local GAS (Agricultural State Household), forestry, home for the elderly, orphanage and school. After 1989, it was abandoned, until 2009, when it was leased for 49 years to the Banat Orthodox Mitropoly. A large-scale restoration began, but due to a lack of funds, the works were interrupted and abandoned, the ensemble now being in a continuous process of degradation.

Recent preservation or restoration measures carried out with private or non-reimbursable funds mostly had an adverse or even destructive effect. An indication of this situation is the status of the old Karátsonyi ensemble in Banloc, where the Orthodox Mitropoly of Banat, as concessionaire, opened a large restoration site in 2009 and later abandoned it – a fact which sustained and accelerated the process of degradation.

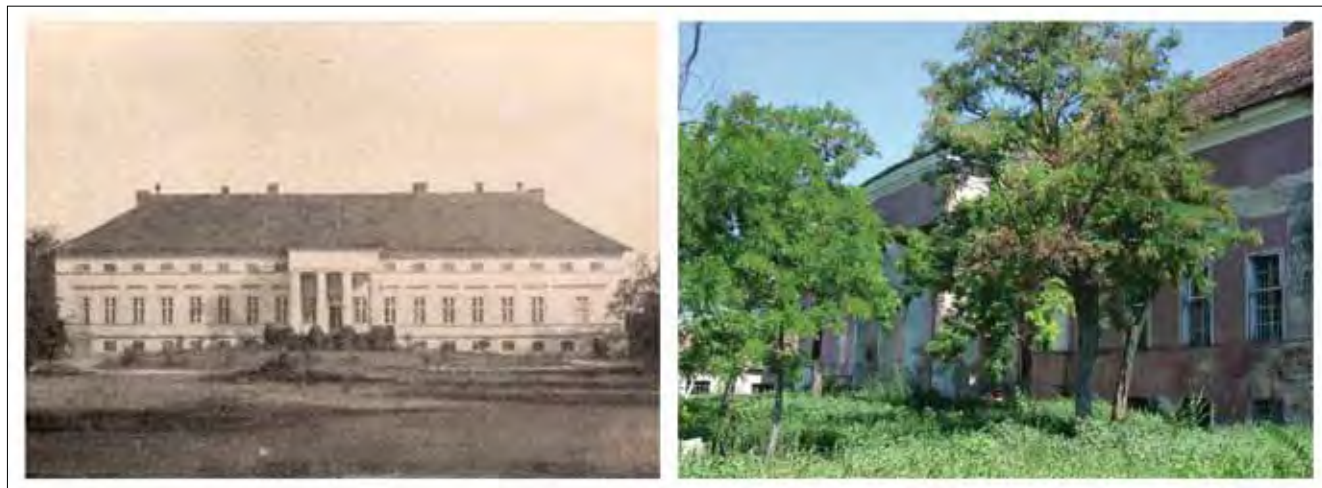
A first Baroque mansion was built at the end of the 18th century at the site of the current residence by the Foeni branch of the Aromanian aristocratic family Mocioni, after settling on the Foeni estate in Timiș County. Considered a trademark for the entire Foeni aristocratic branch, the ensemble was then completed and extended, and at the end of the 19th century it became one of the most imposing manor estates in the region. Given to the local community by the last descendent of the family, the ensemble is used until today as school, kindergarten and local cultural centre. Following the rainy season in 2005, the level of the Timis River, running close to the village, rose, putting pressure on the upstream dyke. On April 20, the dyke collapsed, and the flood affected even Mocioni Palace. The lack of ulterior restoration interventions increased the building's state of decay.
