## ALBANIA

### The Mesi Bridge at Shkodra on the Kir river

ICOMOS Albania

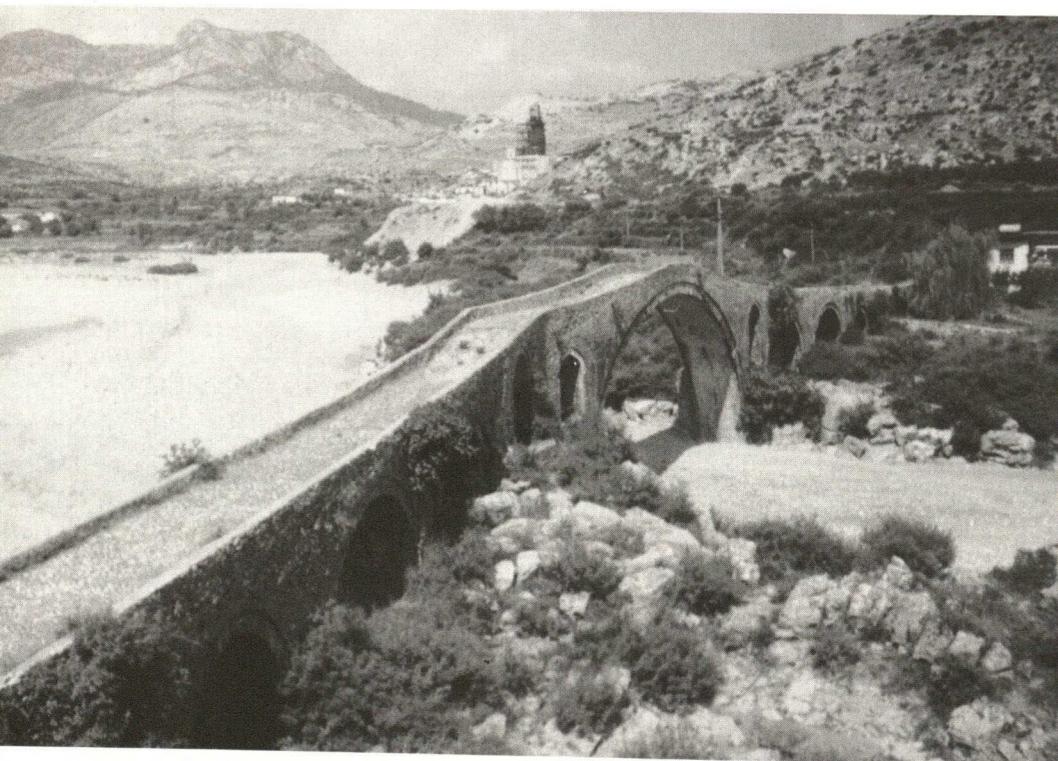
Today the bridge consists of 13 arches. The biggest is in the centre, with a span of 21.5 m, created by a double vault rib 108 cm wide. The bank is paved in river stones and is very uneven, later being reinforced with side bastions built of river stone.

Technically, the bridge has been damaged over time by devastating floods. Such conditions have resulted in floodwaters cutting away at the arches on the right side. This has caused cracks in the hang of the arch. Even the main arch has suffered from cracks that also jeopardise the bridge's stability.

View of the Mesi Bridge at Shkodra

The consolidation of the piers, the infill of the cracks from below and the creation of a hydrological system on the bridge in case of floods, are seen as necessary conservation actions. Doing these particular and technical works is pressing because of the eventual deterioration of this bridge.
