## Preserving the Mediaeval Walls of Nicosia

### The Roccas Bastion

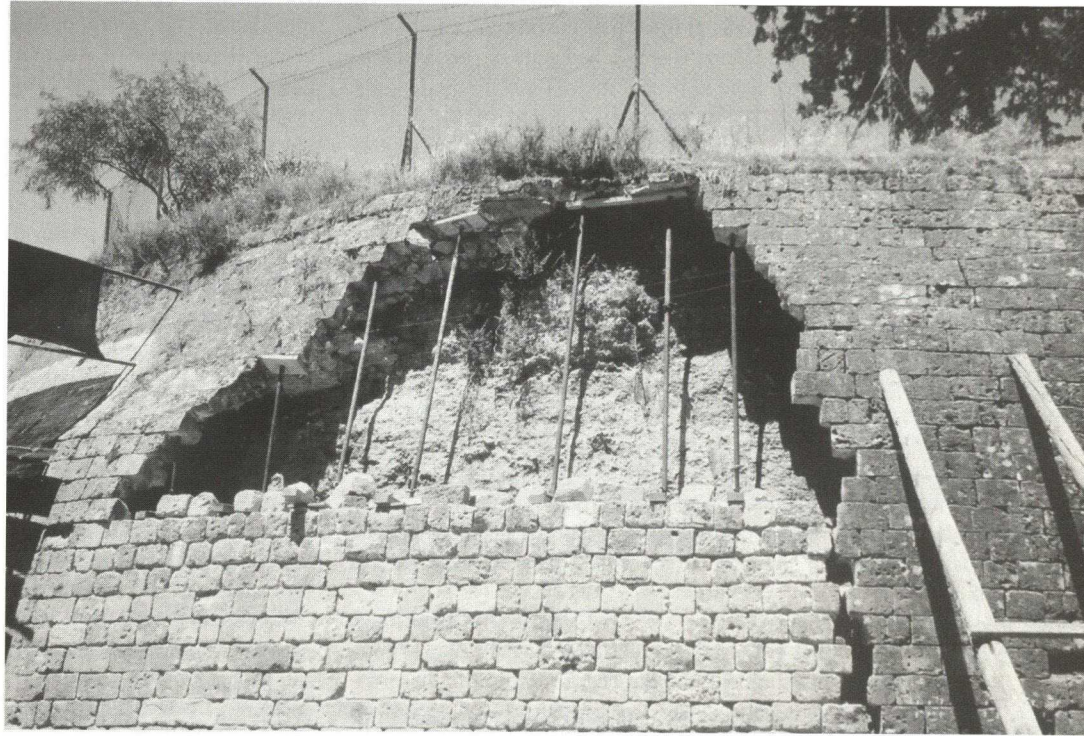
The Roccas bastion after the destruction caused by rainfall

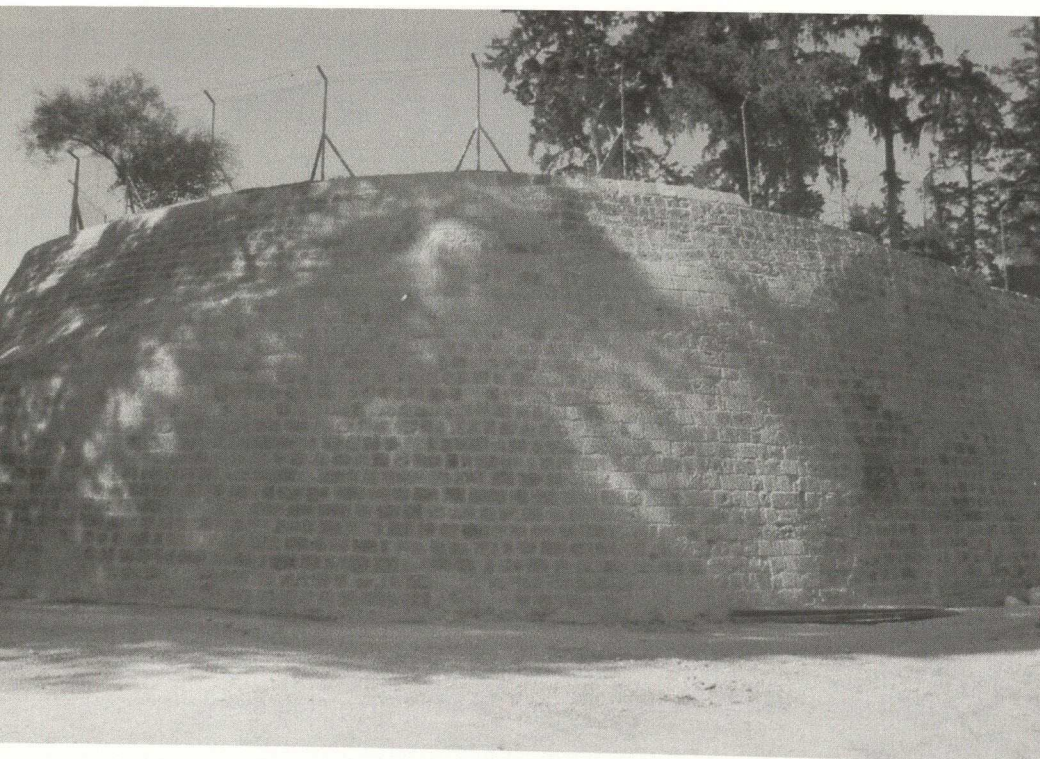
The Roccas bastion after conservation

The actual restoration work of the 40-square-metre collapsed section of the Roccas bastion and 55 square metres of the part of the curtain wall between the Roccas and the Tripoli bastions overlooking the Paphos road consisted of the following activities: cleaning all plant growth; fixing and consolidating the rubble stone-faced section; removing the badly eroded stones or the architectural blocks belonging to older Gothic buildings that were used for the construction of certain parts of the bastion, and replacing new stones where needed; grouting and consolidating the remaining revetment stones; cleaning the existing revetment stones with mechanical means; filling the hollow parts (between the rubble stones and the revetment stones) where needed with a mixture of water, lime and a small amount of cement; and, lastly, constructing a stone pavement measuring between 50 and 85 centimetres running along the top on the bastion, in order to prevent the water infiltration – one of the main causes of deterioration of the Walls.
