TURKEY

Threats from Development

Case Study: Küçük Ayasofya Mosque

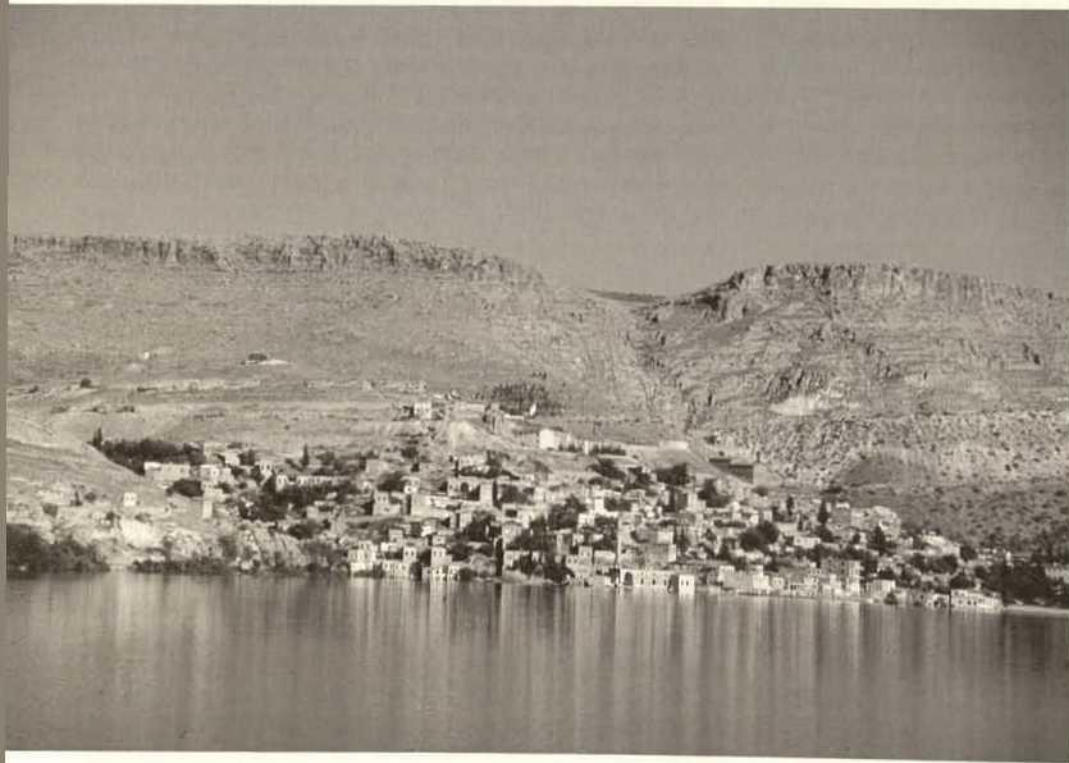
Halfeti was a spectacular hillside settlement on the Euphrates valley. The rising waters swallowed large parts of the town. Many houses and the 19th-century bath are under water now.

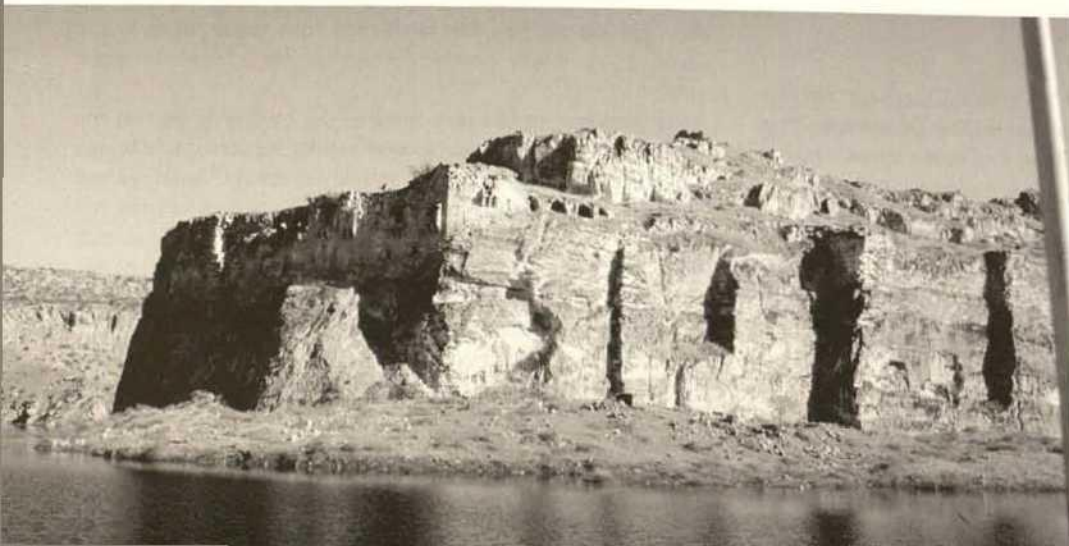
Located 5 kilometres to the north of Halfeti, Rumkale is a medieval fortress which was strategically located on the caravan route leading from northern Mesopotamia to inner Anatolia. The castle was totally deserted around the mid-19th century. Remains of some houses, a big cistern, churches and monasteries are still visible. The rising waters of Birecik Dam have changed the landscape around the castle drastically. Now the waters touch the foot of the hill on which the fortress rises.

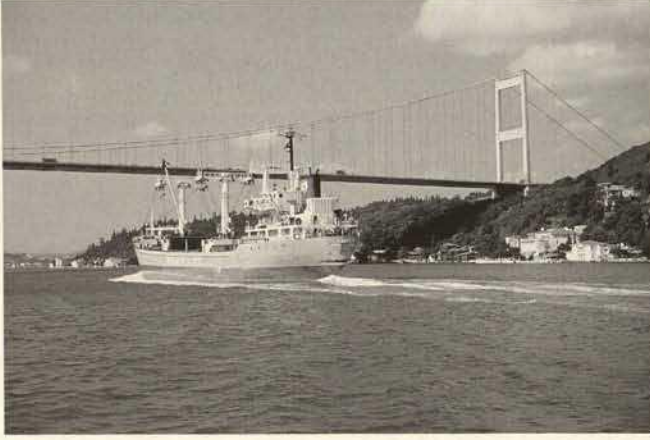
The danger of fire and explosions emanating from tankers is a growing threat for Istanbul. Tankers 250 meters long and weighing 100,000–150,000 DWT are passing through the Bosphorus without asking for guidance from the local naval office. Along the eastern shoreline (right side) of the photograph there are some timber houses that were designed as summer residences during the Ottoman period. There is a great contrast between the scale of the old architecture and the second Bosphorus Bridge. Construction of bridges over the Bosphorus has encouraged encroachment around the woodlands of the Bosphorus shores. Although protected by law, due to mass migration and population increase it is a difficult task to preserve the natural and historic assets of the Bosphorus.

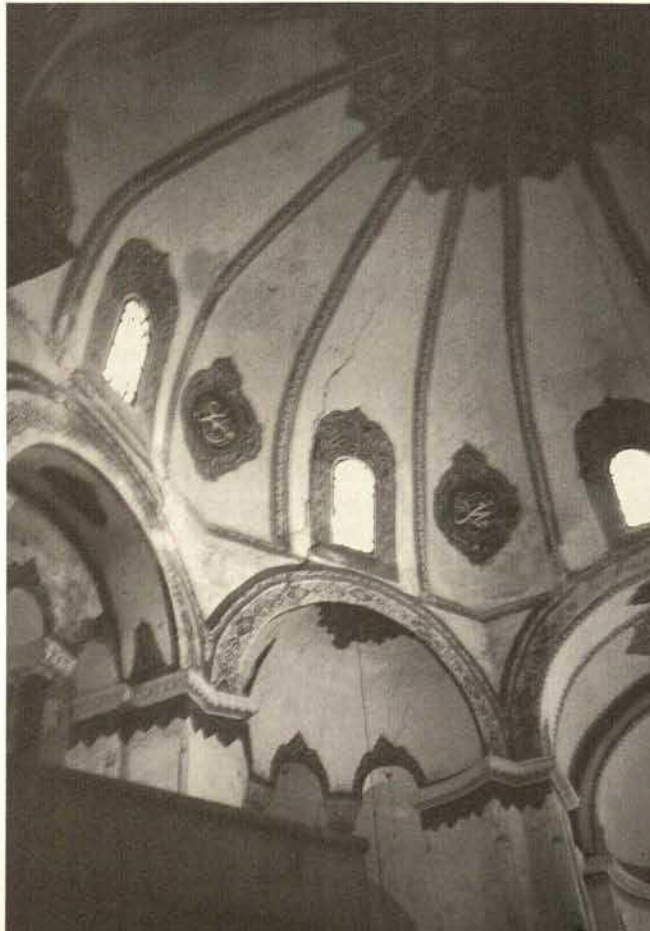
The existing vertical cracks on the north-east and south-east corners through the dome as evidenced on the interior plaster surfaces have increased in width since the earthquake of 1999. This suggests that cracks through the masonry behind may have also increased; therefore, there is a danger of partial collapse, especially during future seismic activities. Other damage may exist that is not easily discernible that might also contribute to this safety concern.

The cracks are mainly related to soil settlement and, in particular, outward rotations of the walls probably produced by rising water in the soil.

As a consequence of this phenomenon, in addition to the cracks, the dome has suffered significant deformations and, in some zones, reduction of the original curvature; it is particularly this factor that has reduced the safety margins of the structure and produced risky situations.

The Church of Saints Sergius and Bacchus (now Mosque of Kucuk Ayasofya) in Istanbul is suffering from structural problems. The growth of the cracks on the dome, arches and walls of this important monument from the 6th century needs careful study and treatment.

Some temporary restraint needs to be provided as a matter of urgency. This would entail the installation of temporary tension devices on the exterior of the structure, beneath the dome; the provision of scaffolding on the interior to protect visitors; close-up inspections, and the shoring of areas of the dome as necessary to prevent partial collapses. However, there is insufficient information at present to design any permanent strengthening measures. We recommend that, having provisionally placed the dome in safety conditions, no further work be undertaken until full examination of the structure has been carried out to enable these measures to be properly designed.
