EGYPT – HERITAGE @ RISK!

Case Study 1 – Cairo: Fatimid Town Centre and Tombs of the Caliphs

Case Study 2 – Restoration of the Azhar Congregational Mosque

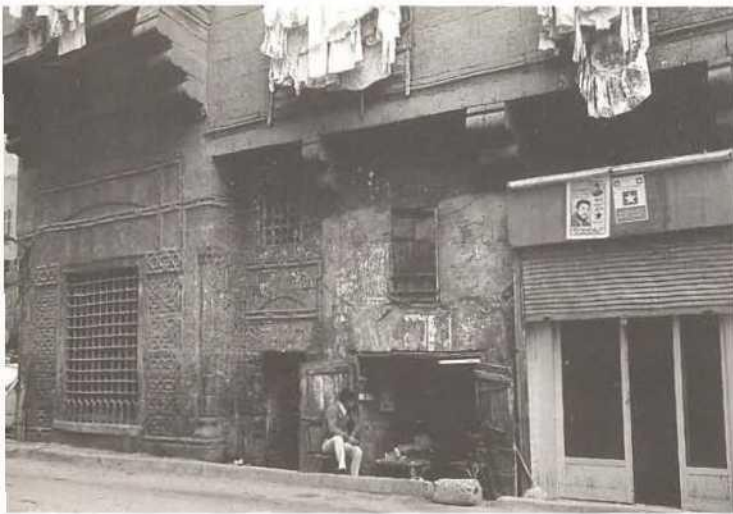
Islamic Cairo, endangered houses in the old part of the city

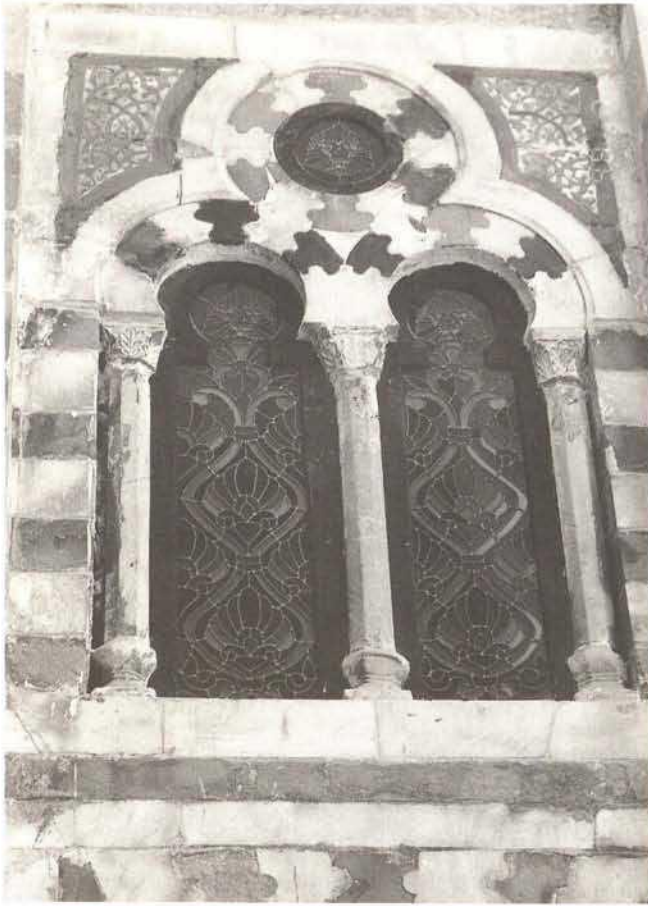
Azhar Mosque in Cairo, Fatimid Riwaq after “restoration”: new reinforced concrete base with marble facing (complete renovation)

Three years ago the mosque was completely renovated. It has therefore lost its original spirit, its distinguished Fatimid style as well as its historical value. The mosque is now almost a new one because of the works done without taking into consideration either the authenticity of the original material, craftsmanship or the originality of the design, regardless even of the Egyptian Law of Antiquities (Law no.117/1983) as well as of article no.58 of the Operational Guidelines of the World Heritage Convention. The traditional continuous wall-footings were consolidated by an underpinning using micro piles; a very radical solution which is also very expensive.

There was no real monitoring to control and evaluate the cracks and soil deformation, therefore it was not possible to put in the minimum reinforcement necessary for the foundation and to control the structural behaviour before and during work. Instead of repositioning the leaning columns using flat jacks, the main Fatimid aisle was demolished and reconstructed, losing the oldest stucco floral decorations. The wall-filling was grouted with Portland cement mortar, so now conductive salt-efflorescence is a normal feature of the wall surface. Stone façades were cleaned using dry sand blast, and now more stone surface deterioration can be noticed everywhere. Regrettably the mosque was a field for experiments for unqualified architects and contractors.

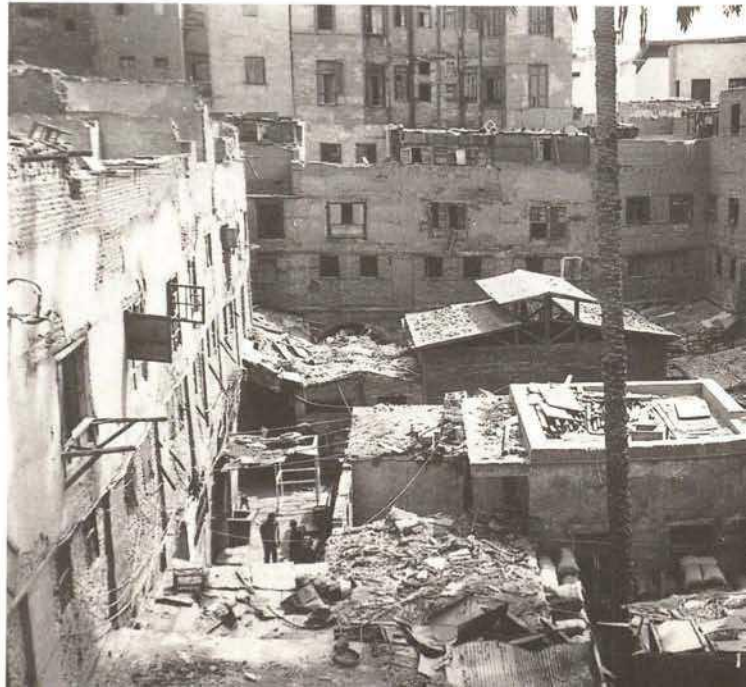
Caravanserai Uda Pacha, lack of maintenance and bad use
