Umm er Rasas, a World Heritage Site, Mysterious and Hidden. Preventive Measures against Damage from Earthquakes and Heavy Rains

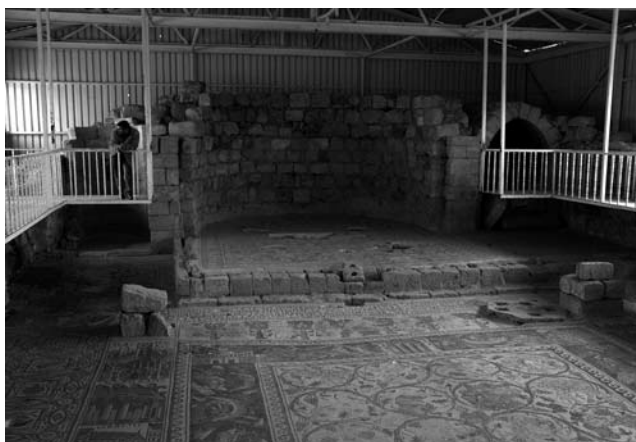
Fig. 1 The complex of the Church St. Stephen

The military nature of the locality is underlined by the name *Kastron* (fort) *Mefaa*, which is recorded three times in the Greek inscriptions of the Church of Saint Stephen and is also found in the mosaics of the Church of the Lions. The complex of Saint Stephen's is located north of the *Kastron*. Excavation of the mosaic floor in the church revealed a work of creative genius (fig. 1 and 2).

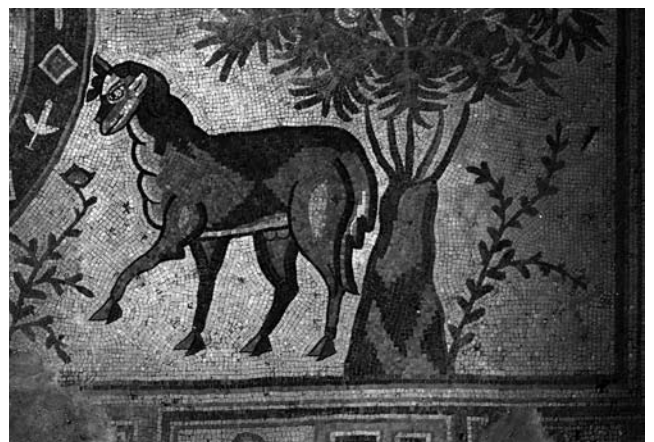
Fig. 2 Mosaic floor, Church of St. Stephen. The mosaic floors are of the highest quality and the inscriptions important for biblical research.

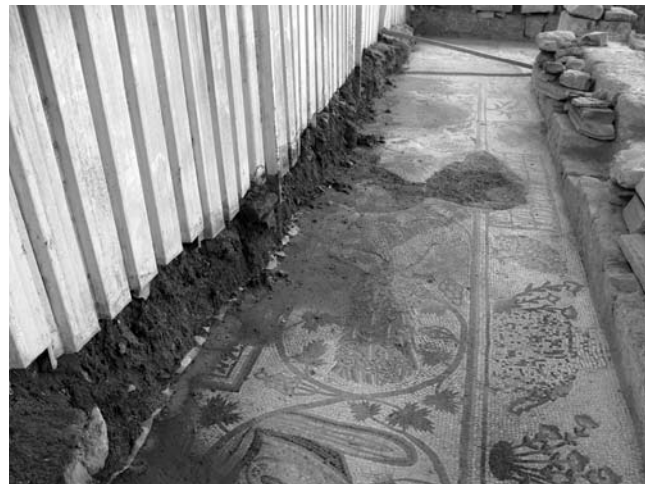
After nearly nine months of the year without rain, there is often very heavy rainfall. The antique site becomes flooded within hours. The soil draws up water, swells and the floor with the mosaic buckles. Soil pushes against the mosaic floor (fig. 3).

Fig. 3 After the soil dries up, salts, natural cover and hollows are visible.

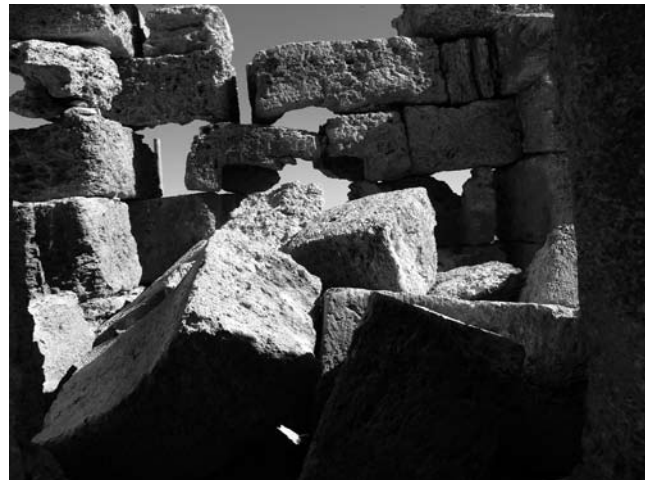
The cell of the holy Stylite with its broken lintels and fallen roof construction is in danger (fig. 4 and 5). Because of the unstable situation there is a permanent risk that more damages and losses could occur in future earthquakes and in heavy rainfalls with stormy wind conditions. A conservation and consolidation is planned for 2007 with assistance from UNESCO. The consolidation will strengthen the cell construction to stop the trend toward further deterioration. The idea is to reinforce the cell construction inside with carbon fibre straps and to renew the broken and weathered lintels and some stones. Renewal of the static construction elements is given

Fig. 4 and 5 The Stylite tower (Byzantine) exhibits earthquake damages.

higher priority than conservation because of the required security for visitors as well as in order to keep the tower together. During the consolidation work the possibilities of an anastylosis of the roof can be studied.

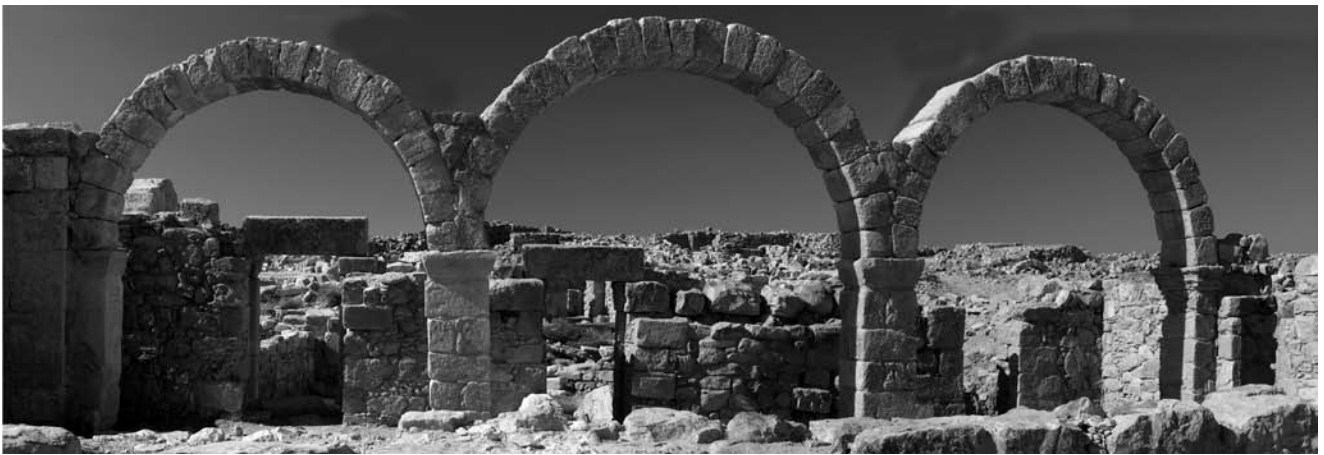
Fig. 6 During the last decade excavation work concentrated mostly on the period between 200 and 900 A. D. There is now evidence of more than 50 churches.

Useful shelters and modest and simple roof constructions are required for the site (fig. 6). The problem of what to do with the large amount of rainwater falling over a short period cannot be solved by drainages because of the unexcavated archaeological parts of the site. At the moment a discussion is in full swing concerning the possibilities of filling the ancient cisterns, as in former times. The idea of reconstructing and revitalizing the open water channels would be very attractive for visitors and could show how the ancient water management system in a settlement on the edge of a desert was constructed (fig. 7).

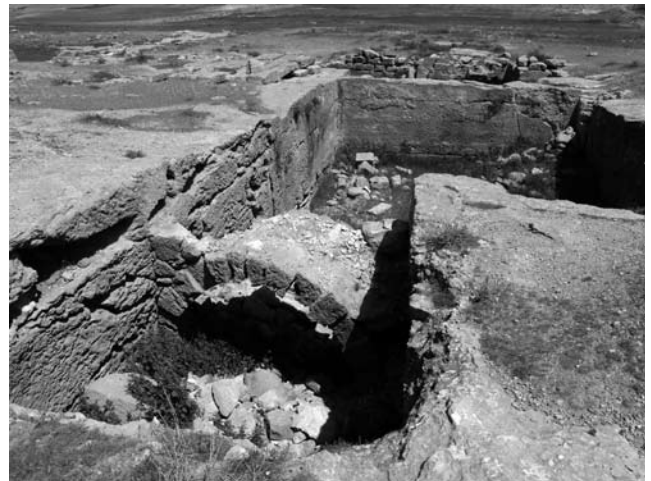
Fig. 7 Cisterns and a very intelligent historic water management system were preconditions for surviving in the desert and dry zone of Umm er Rasas.

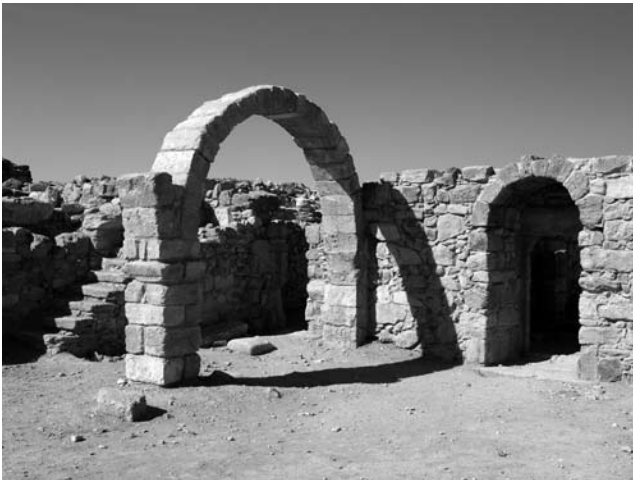
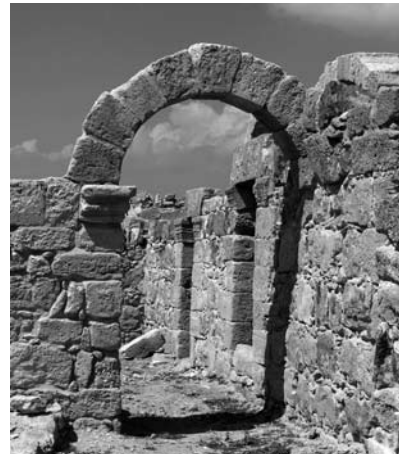
In any case, it is doubtful that individual reconstructed arches are able to give visitors an idea about ancient architecture and provide information in a third dimension for visualization of a complete building (fig. 8). The »arch architecture« of Umm er Rasas, which has become a rather

frequent phenomenon, exemplifies the questionableness of anastylosis measures in terms of safety for visitors as well as with regard to the preservation of antiquities during seismic activities. It is not possible to reinforce the anastylosis of these arches to make them stable against earthquakes; sufficient crosswise stability is not guaranteed. The idea of dismantling these arches again could not be put through. What can we do to safeguard the site and to protect visitors during earthquakes? Build carefully planned walkways. Since the implementation of the first Site Management Plan for Umm er Rasas walkways at the site no longer go under the instable arches.

Fig. 8 (left) and 9 (right) Anastylis is visible at nearly all excavated locations

The new Site Management Plan, which includes all future measures at the site, will not allow further unnecessary anastylosis and reconstruction of arches.

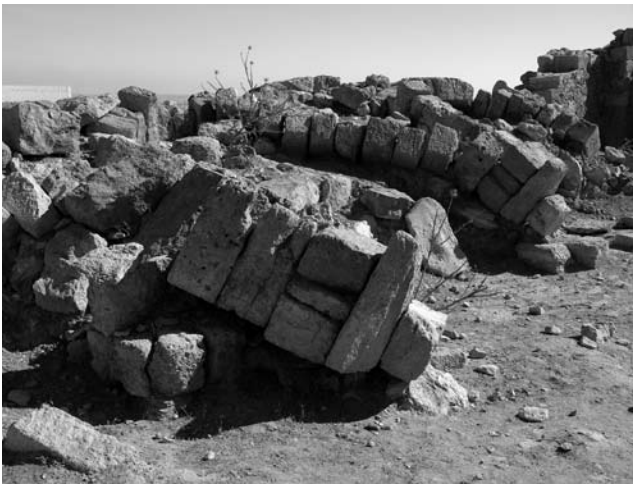
Visitors will be given an idea of what architecture looked like in ancient times by means of models and panels. One of the great educational possibilities is to study in situ the results of heavy earthquakes with horizontal acceleration of the structures. At Umm er Rasas there are also a few structures that exhibit only minor damage, even after 1300 years and heavy earthquakes; they may have been consolidated.

Fig. 10 Very few structures at Umm er Rasas exhibit only minor damages

We should use all technical possibilities to safeguard and protect the antique site against natural disasters and catastrophes, to the extent that these do not disturb the setting and are acceptable as conservation measures (fig. 10). In many cases protection from natural disasters is implemented much more easily through careful organisation and planning of sites than through technical measures. Investigation, maintenance, analysis of possible situations, emergency organisation and training of staff can reduce the risk to people and heritage considerably. An anastylosis should be discussed critically, especially because in most cases only part of the architecture would be reerected. The static situation of anastylosis is often dubious, i. e., in many cases the stability is problematic.
