# INTERNATIONAL POLAR HERITAGE COMMITTEE

## Heritage at Risk in the Polar Regions

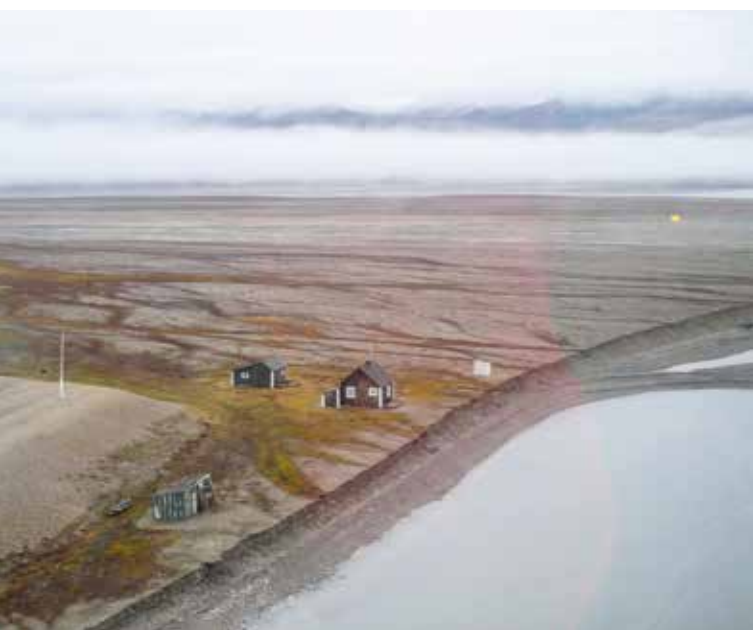
Fig. 1: The historical trapping station 'Fredheim' in Svalbard was moved in 2015 to the ridge to be seen on the left in order to escape from the rapid shoreline erosion (photo Susan Barr)

Physical intervention at an erosion-threatened heritage site can consist of barriers of stone, concrete, sandbags, or other methods to stop the water eating away at the shoreline. This may be effective but is certainly a huge impact on the appearance of the site itself. In the polar areas, there are usually logistical challenges that add to the infeasibility of this approach. In the last instance, if the heritage is a standing structure and not an archaeological site such as a burial area, the structure might possibly be moved to a better-protected site nearby. Two such examples among several are from Herschel Island, Canada in 2003 and Svalbard, Norway in 2015. In 2003 a small building belonging to a whaling and trading company that acted in the Canadian Arctic area at the beginning of the last century was moved back from the shore even as the sea was already lapping around its base.<sup>12</sup> In Svalbard a highly-prioritised historical trapping station from 1927, consisting of three small buildings, was moved 37 metres in from the erosion edge and placed in the same pattern on a raised ridge in order to keep it for, hopefully, a good number of years to come.

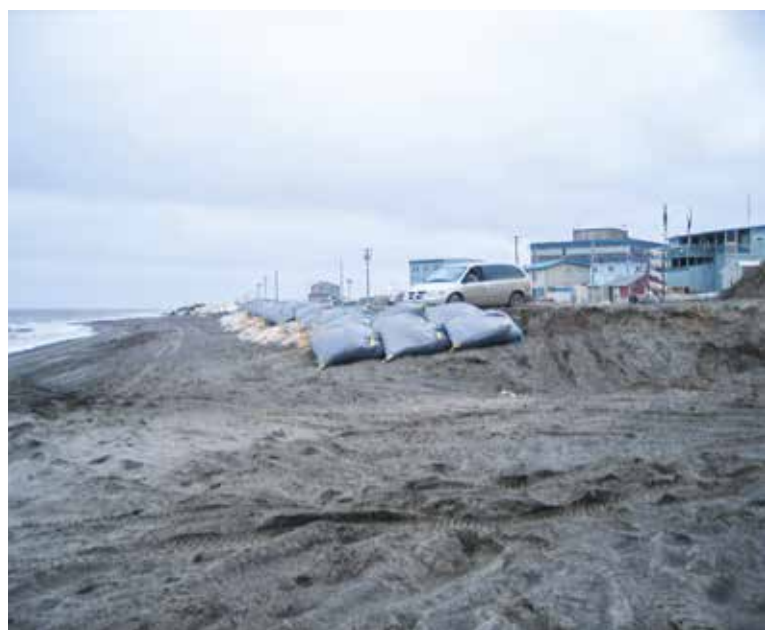
Fig. 2: Attempts to stop coastal erosion in Barrow, Alaska (photo Susan Barr)

Three methods currently used in the face of rapid erosion of cultural heritage sites are emergency excavation, digital documentation and physical intervention at the site. Jensen has worked for many years out of Barrow, Alaska on emergency excavations to salvage paleoenvironmental information and indigenous heritage from the rapidly eroding coastline. Amongst several multi-year projects, she has worked with local students to excavate a threatened major Thule cemetery (c. AD 1000–1500) at Point Barrow, Alaska, where the northernmost Ipiutak (c. AD 300–400) occupation in the world was recently discovered.<sup>10</sup>

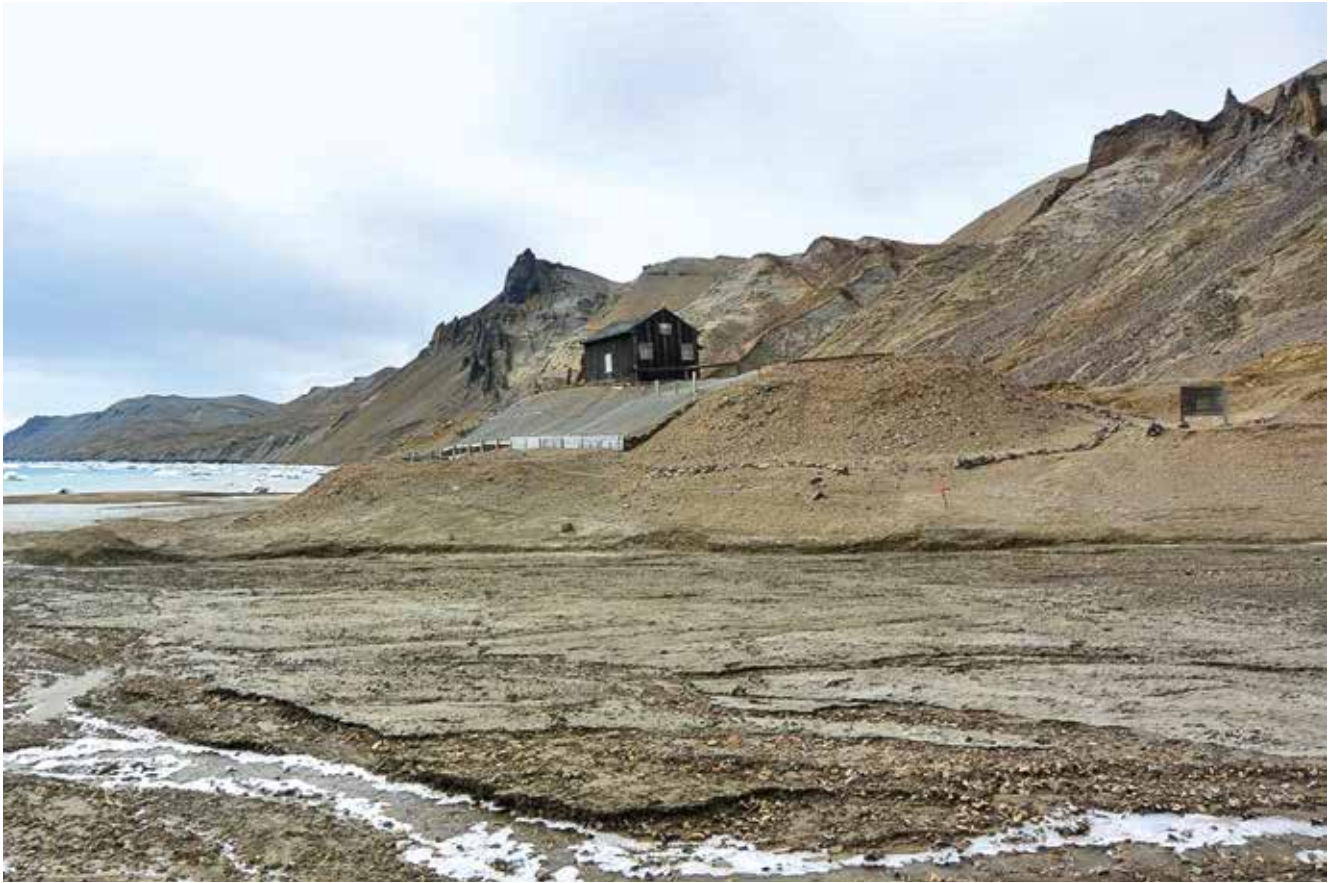
Fig. 3: Snow Hill historic hut in Antarctica showing an attempt to stop increasing erosion of the gravel mound it sits on (photo Mike Pearson)

A large percentage of heritage sites in the polar regions are situated near to the coast. For many indigenous people in the Arctic the sea was a major source of food and necessary materials for much of what they needed in life through the food, skins, bones and sinews they could get from seals, small whales, fish, shellfish and polar bears. For explorers, trappers, scientists, sealers and others who travelled to the polar regions, ships and boats were a major means of transportation and dwellings and other structures were naturally established by the coast. Coastal and riverbank erosion has happened throughout time, but the recent accelerated temperature rises, permafrost thaws and diminishing sea ice are causing a rapid increase in erosion which is taking many heritage sites with it to be lost in the sea or river. IPHC member Anne M. Jensen has extensive experience with archaeological challenges in the face of rapid coastal erosion on the north coast of Alaska,<sup>9</sup> while Antarctic colleagues are anxiously debating how Snow Hill hut, one of the six “Heroic Age” huts on the continent, can be saved as the sediment mound on which it was situated in 1902 becomes destabilised owing to thawing permafrost.
