ARMENIA

Erebouni Fortress

Technical state of the citadel structures

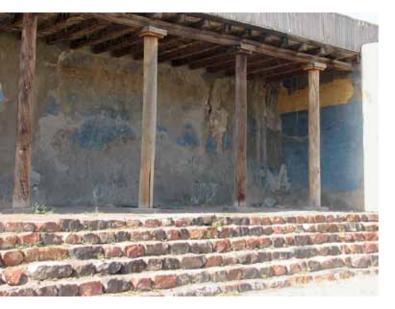
Erebouni Fortress, portico

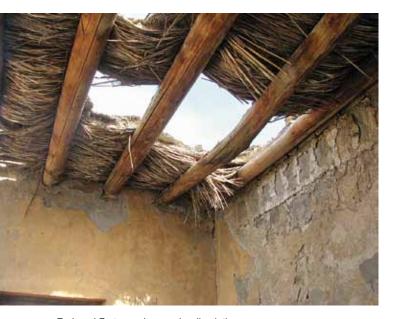
Erebouni Fortress, damaged wall paintings

As the monument has been exposed to the weather for a long period, it is in quite a ruinous state. Some parts of the fortress wall around the monument have collapsed, the wall of the portico (guest hall) has cracked, also damaging the repainted copies of the frescoes. The roof of the Khaldi temple has collapsed, the walls have decayed and cracked, and the repainted frescoes have almost disappeared. The raw brick walls of the structures which were 2.5-3 m tall after the excavations no longer exist and only the stone foundations remain.

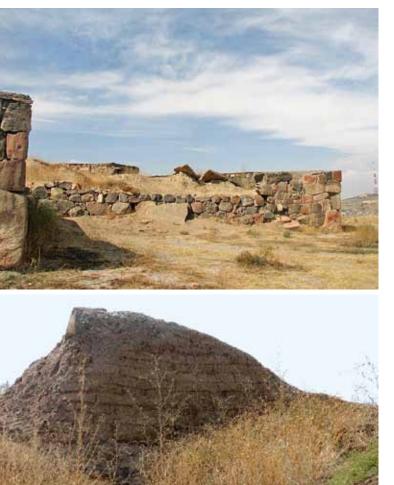
Ruinous state of the surrounding walls

Although an agreement was signed between the French archeological expedition and the management of the Erebouni historicarchaeological museum-preserve that parallel to the excavation work a reinforcement of the excavated parts and a restoration of the damaged sections be carried out, the existence of the historicarchaeological preserve is in danger. The 3 000 year-old citadel needs to be restored, reinforced and protected immediately.
