GREECE

The Ancient Diolkos

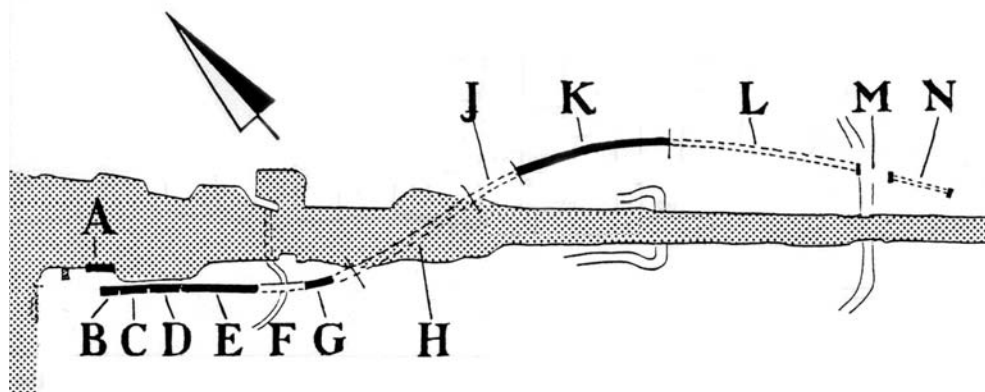
A plan of the Diolkos by Walter Werner. The letters C and D correspond to different states of disruption at the time the plan was drawn.

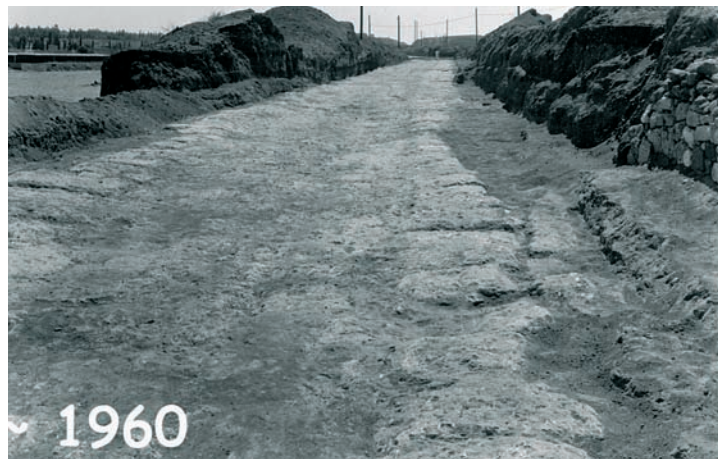
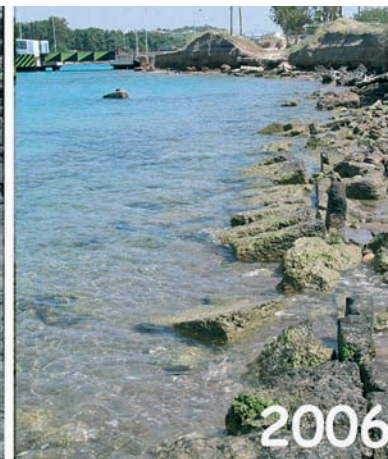
The Diolkos around 1960, in a photo of the En Athinais Arhaiologiki Etairia and the same part in 2006.

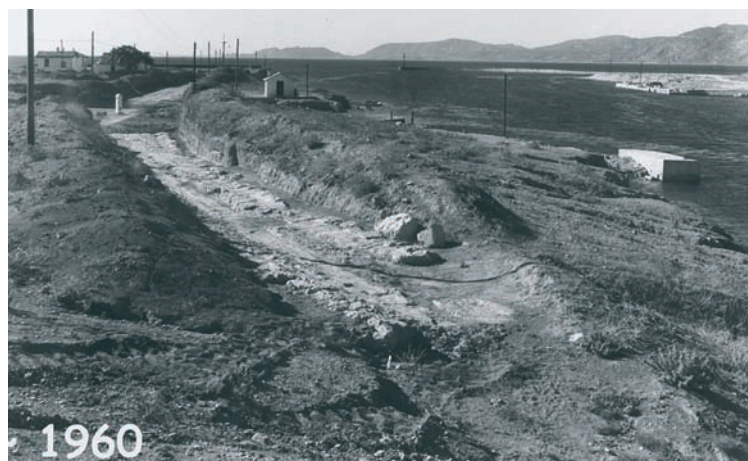
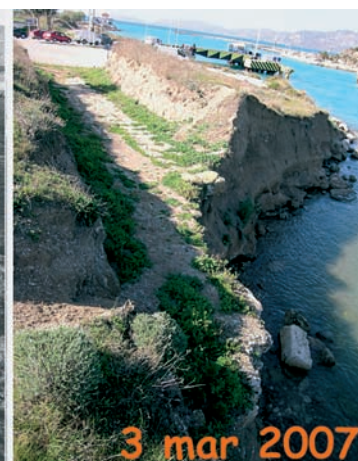
Sector "G" (according to Werner's description) as it was after the excavations (in a photo of the En Athinais Arhaiologiki Etairia) and in 2007. An internal report by an antiquities' guard in 1992, saying that the erosion was approaching this part of the monument and urging the local ephorate to take measures, was disregarded.

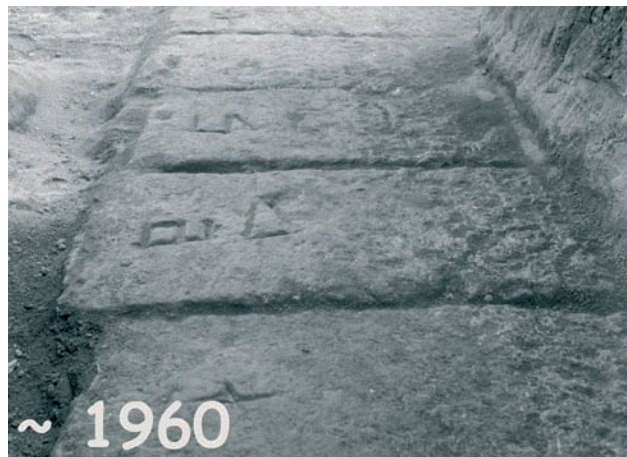
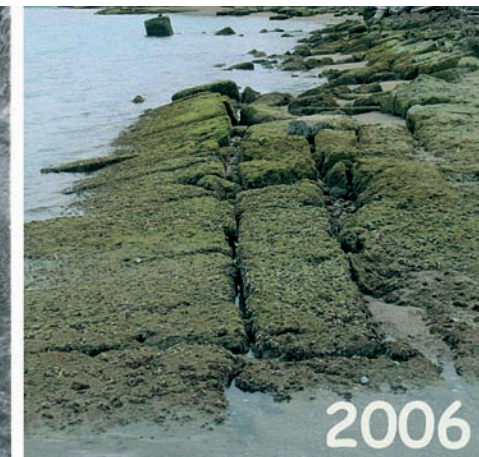
An interesting feature of the Diolkos, engraved letters which appear with increasing frequency near its western terminal (as can be seen in a photo of the En Athinais Arhaiologiki Etairia taken during the excavations), lies in the sea.

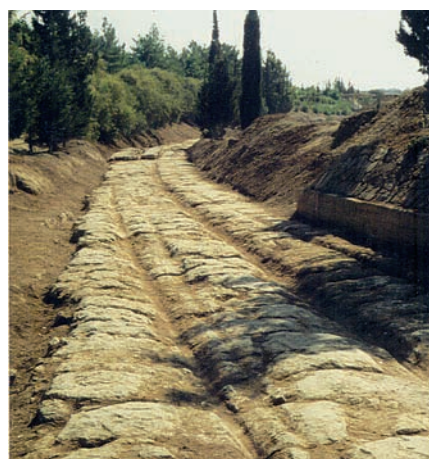
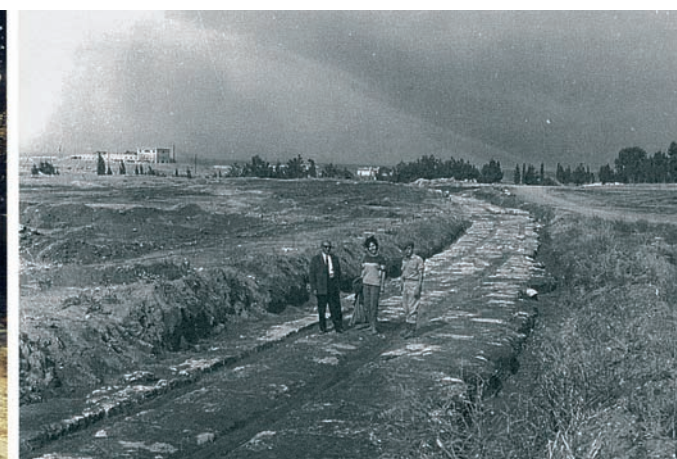
Two preserved parts of the monument, on the Sholi Mihanikou grounds, in images taken by Walter Werner (in color, 1978) and the En Athinais Arhaiologiki Etairia (around 1960). This second part is visible today only in its general form, since it has been covered by natural growth.

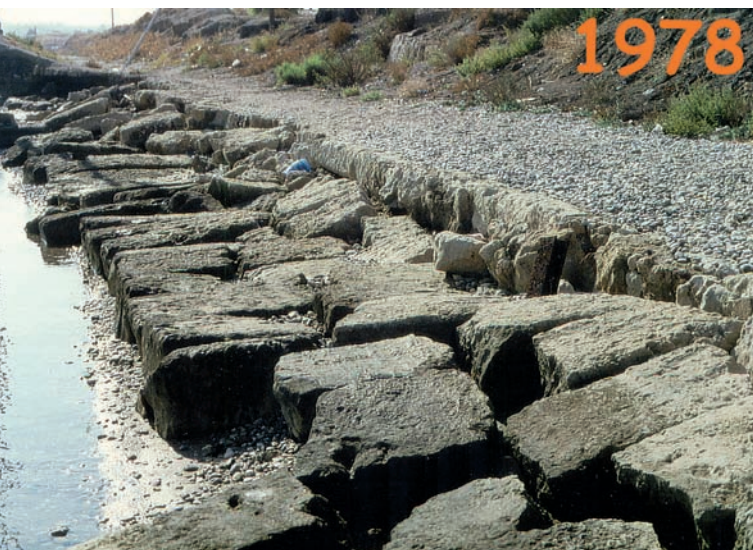
An image taken in 1978 by the German researcher Walter Werner shows already serious erosion.

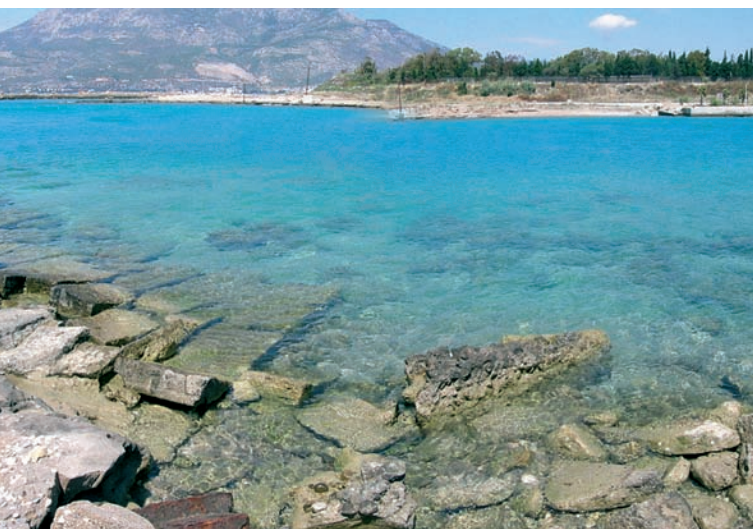
The extended platform which once constituted a part of the western terminus of the Diolkos today lies in ruins.

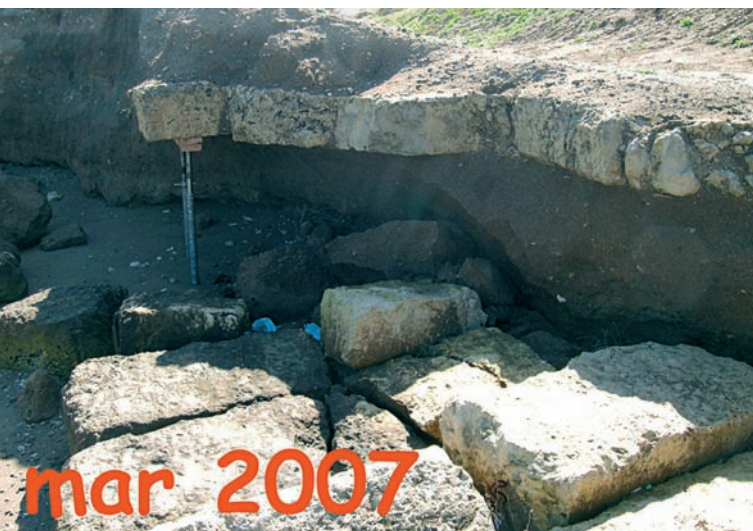
One of the two points supported at the beginning of March 2006 by the Direction for the Restoration of Ancient Monuments.
