KENYA

Case Study One – Mtwapa Heritage Site

Report compiled by staff at the National Museums of Kenya

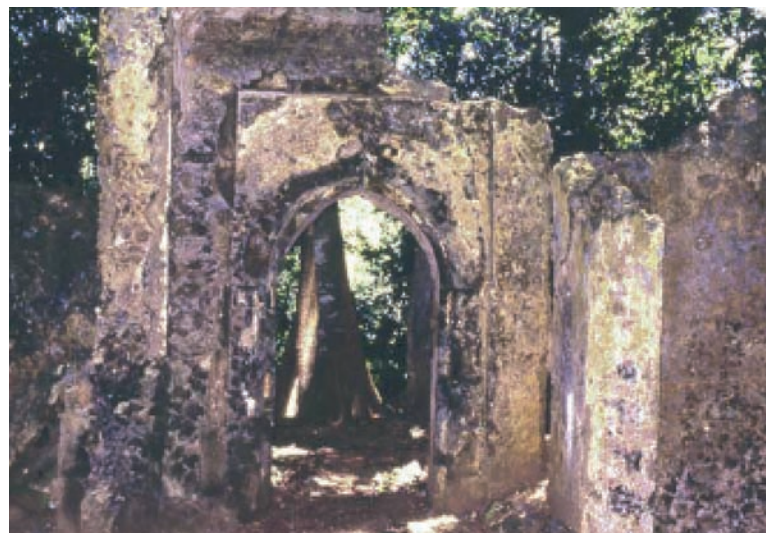
Mtwapa Heritage site, part of the ruins (Photo: National Museums of Kenya)

Several issues need to be addressed with regard to a thorough preservation and protection of the Mtwapa Heritage Site. The main concern is the development of a thorough and comprehensive management plan that is proposed to adopt a multidisciplinary approach and involve all the relevant stakeholders. A thorough implementation of this management plan is necessary to realise this positive move towards this site's conservation.

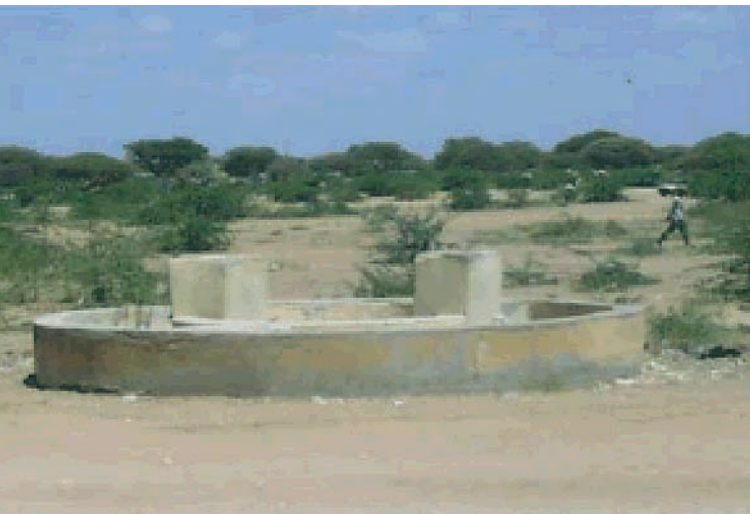
One of the Qorahey wells (Photo: National Museums of Kenya)

The wells need to be protected by law by having them gazetted under the *Antiquities and Monuments Act* Cap 215. There is also need to educate the local inhabitants of the importance of protecting the wells as an essential component of their heritage.
