GEORGIA

The Sioni Church near Ateni

Bagrati Cathedral, Kutaisi

Shchusev’s IMEL in Tbilisi is Endangered

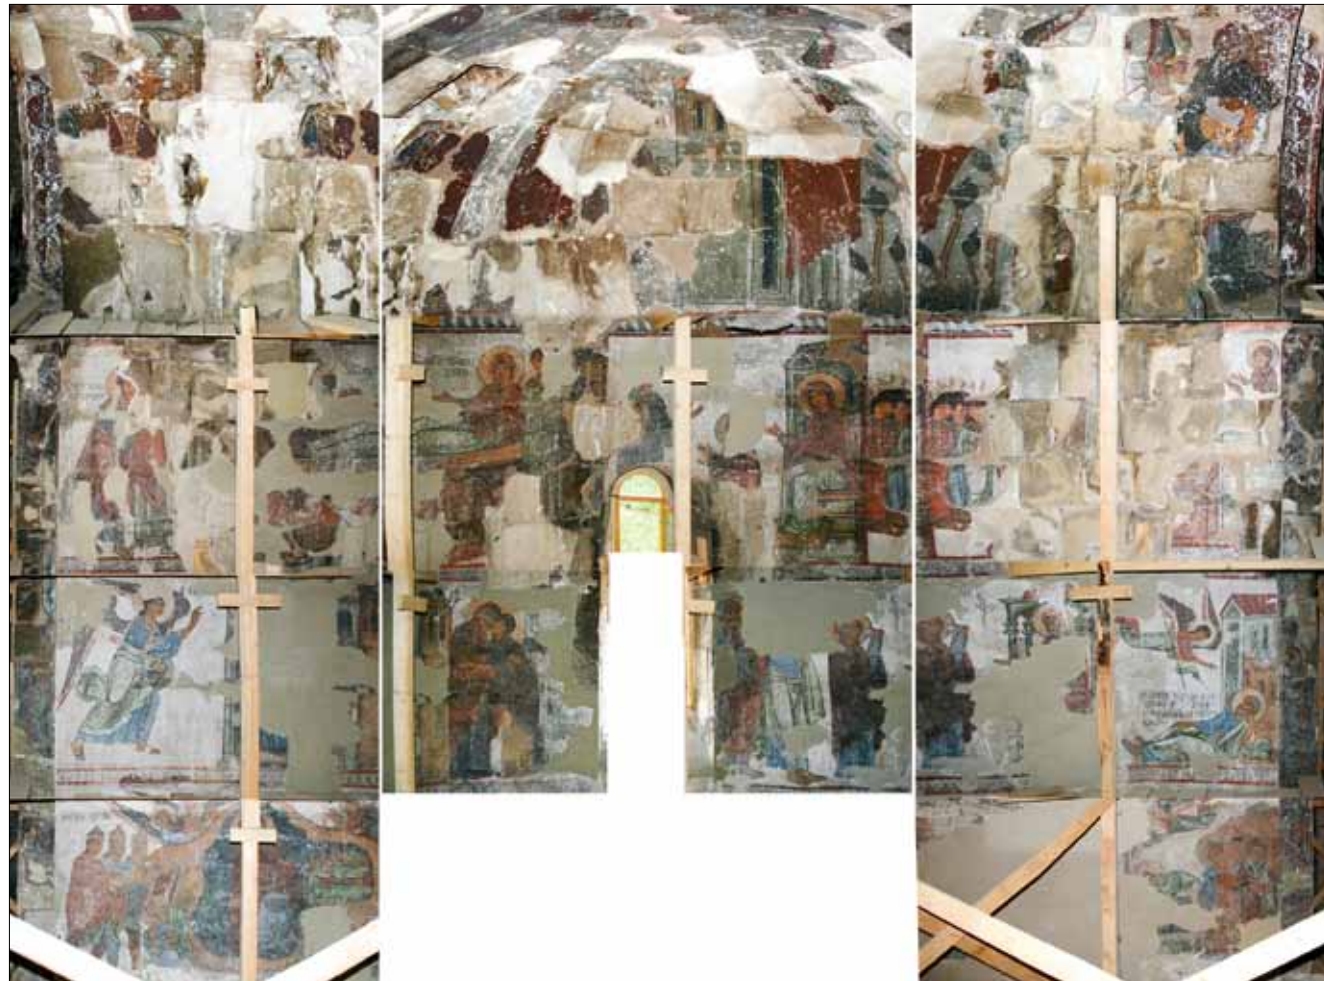
Sioni Church, painted interior of the south conch (photo: Barthel & Maus)

The present damages at the southern conch are part of these general structural problems: After a successful consolidation of the main cupola in the second half of the 20th century, structural ele-

ments in the south began to tilt – a development that has not stopped to the present day. The consequences have been cracks and a local overstress of the masonry, which in turn have led to serious damages to the shells of the wall structure and therefore to an acute endangerment of the medieval wall paintings in the areas concerned. Furthermore, the present condition of the abutment piers could result in static instability. A consolidation is therefore urgently needed.

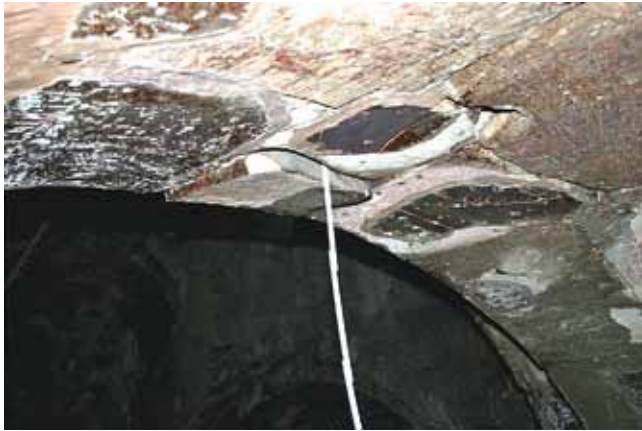
Sioni Church, cap stone in the vault of the south conch: the stone has sunk 30 mm (photo: Barthel & Maus)

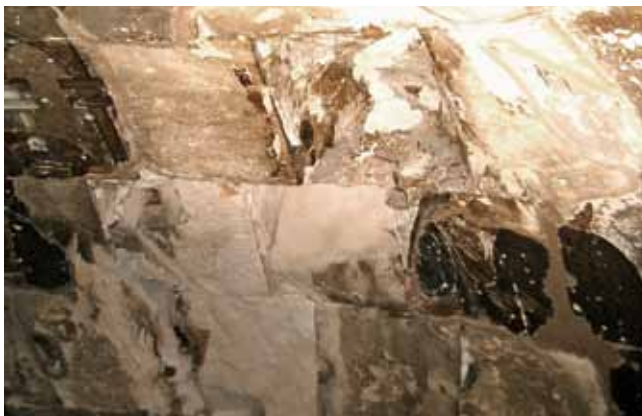
Sioni Church, vault of the south conch with fallen-off cap stone: the mortar shows an imprint of the lost stone trapezoidal in its cross section (photo: Barthel & Maus)

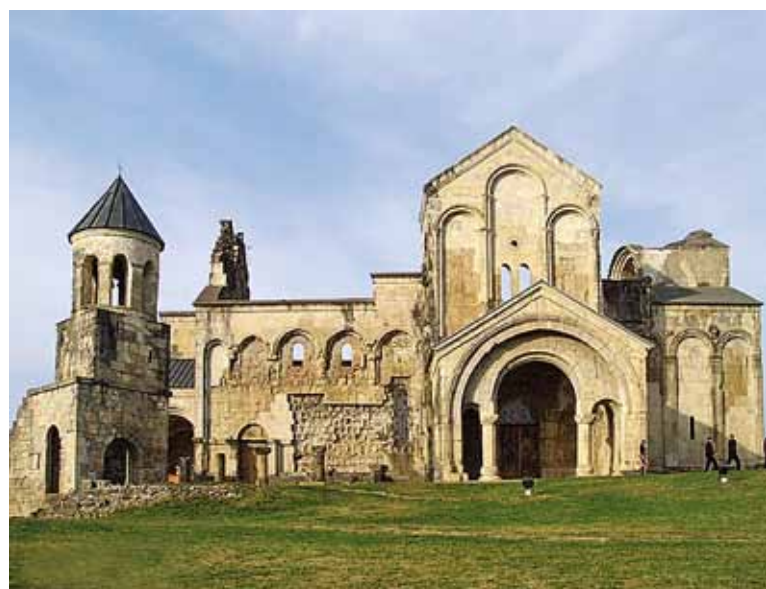
Bagrati Cathedral before the intervention

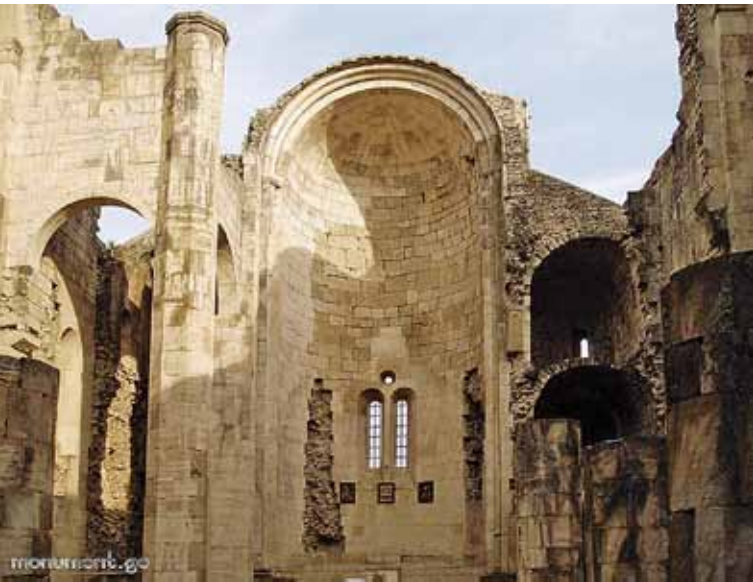
Bagrati Cathedral, the interior before intervention

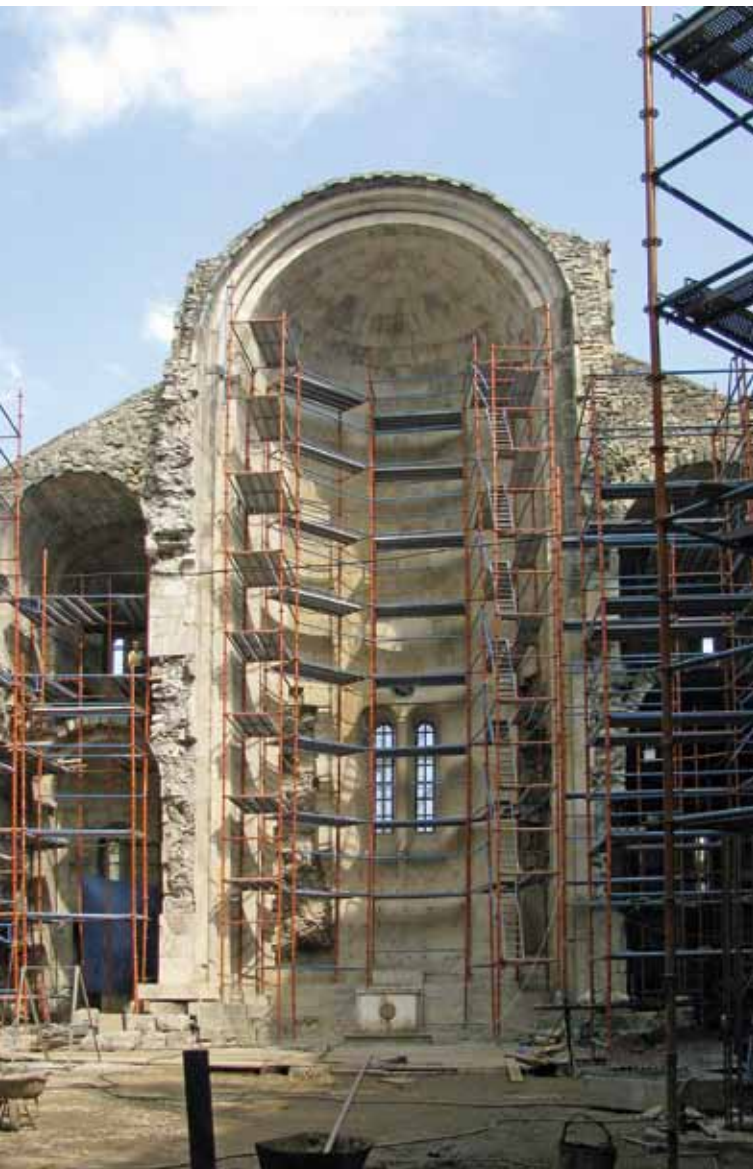
Bagrati Cathedral, the interior during reconstruction works in 2009

Works already carried out at the site are a very crude intervention into the authentic fabric, due to an excessive use of reinforced cement and an inadequate methodology: the reinforcement of the entire foundation by using massive reinforced cement has led to the destruction of archaeological layers; all columns and the arch in the interior were dismantled; the authentic bases of columns were perforated for the arrangement of concrete piles; the apse masonry was bored for cement injections, etc. The applied methodology is destroying the authenticity of the site and may lead to a loss of the site's outstanding universal value.

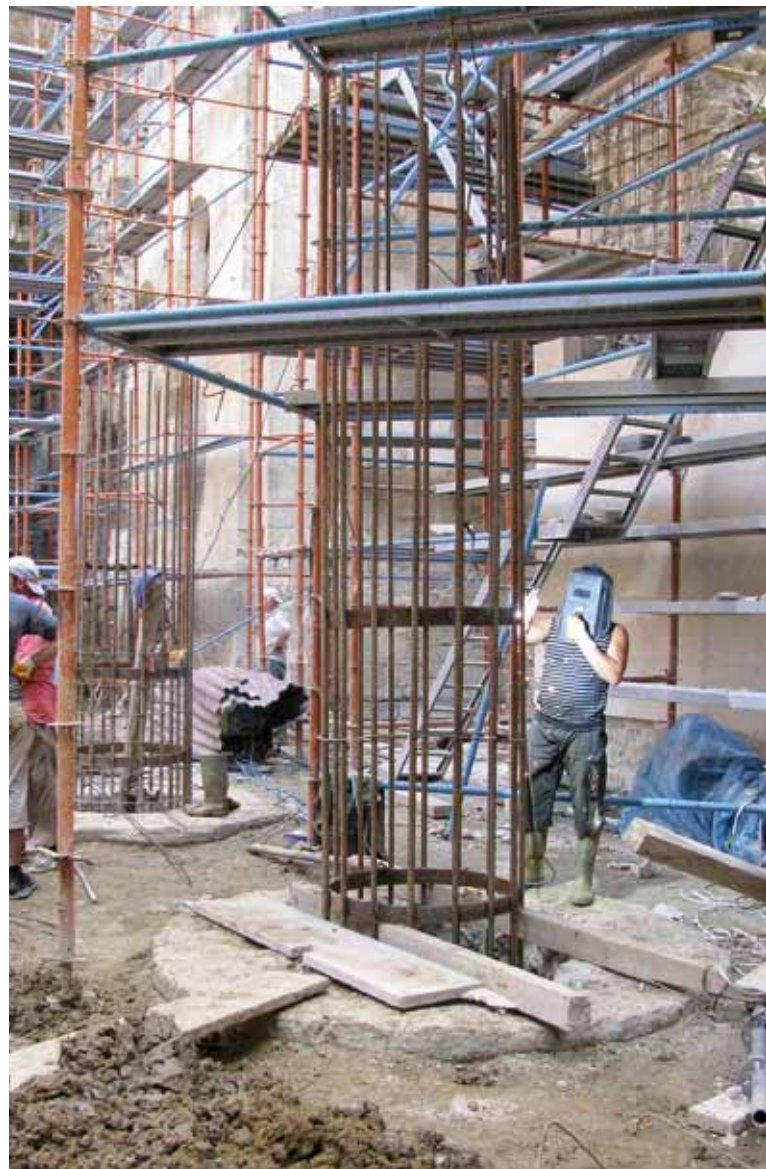
Authentic column bases perforated for the arrangement of concrete piles

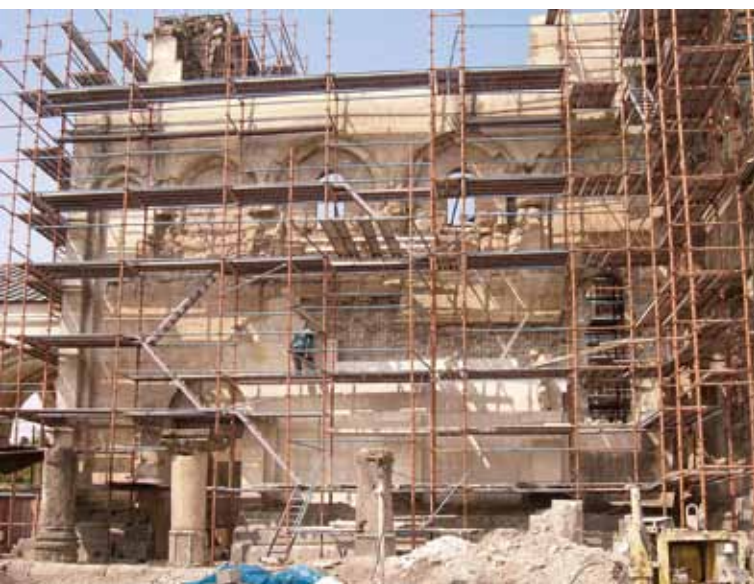
Restoration of the wall facing by means of a metal net and cement mortar

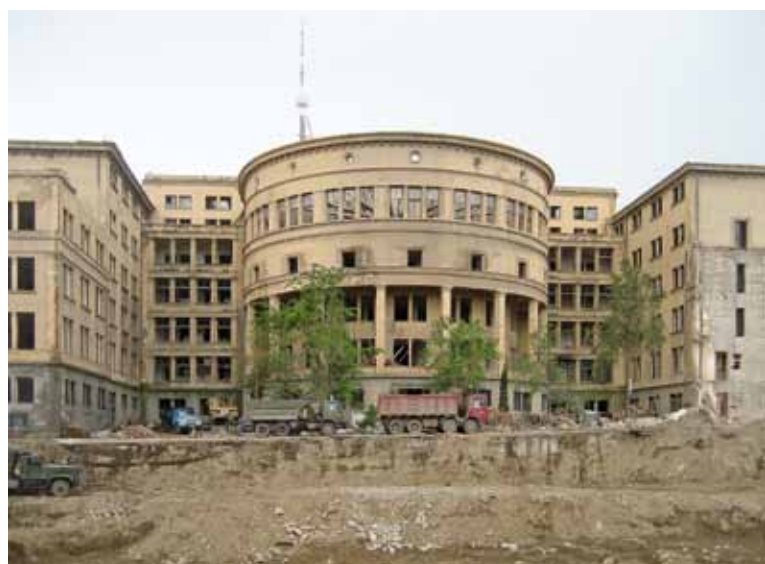
Despite strong protest from the heritage conservation community, which believes that the structure should be preserved in its authentic state, in September 2009 the demolition of the rear side wings started and has continued until today. The whole interior decoration has been lost. Therefore, an important example of 20th-century architecture is endangered.

IMEL building, back façade (photo: M. Mania)
