Logistic and Other Factors Constraining Conservation of Heritage Sites in Antarctica

Borchgrevink's huts – Cape Adare

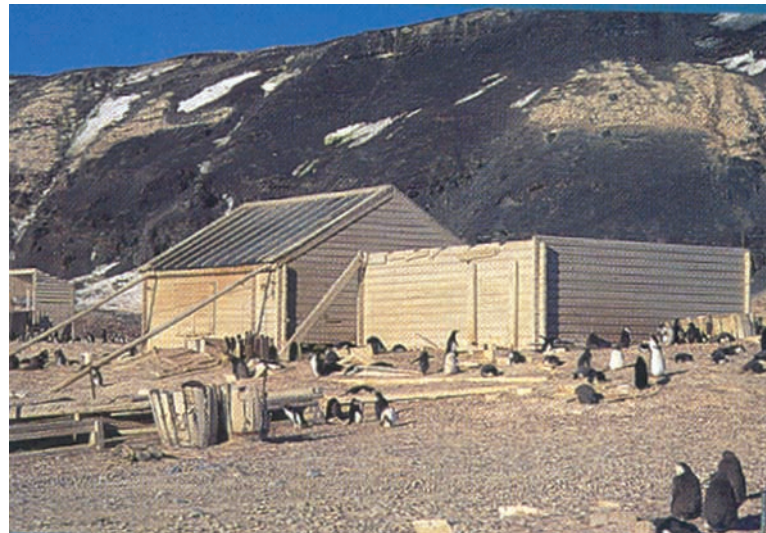
Cape Adare huts (Credit: Paul Chaplin)

Cape Adare is without doubt one of the world's most isolated historic places and where the first structures ever built on the Antarctic continent still stand. They were erected on the same rocky beach where, in 1895, the first documented landing on the continent took place. These two unique huts were built five years later by Norwegian Carsten Borchgrevink as his base for the

"British Antarctic ("Southern Cross") Expedition" - 1898-1900. This expedition became the first to winter-over on the Antarctic mainland. The two wooden structures, built side by side, were originally connected by an improvised annex.

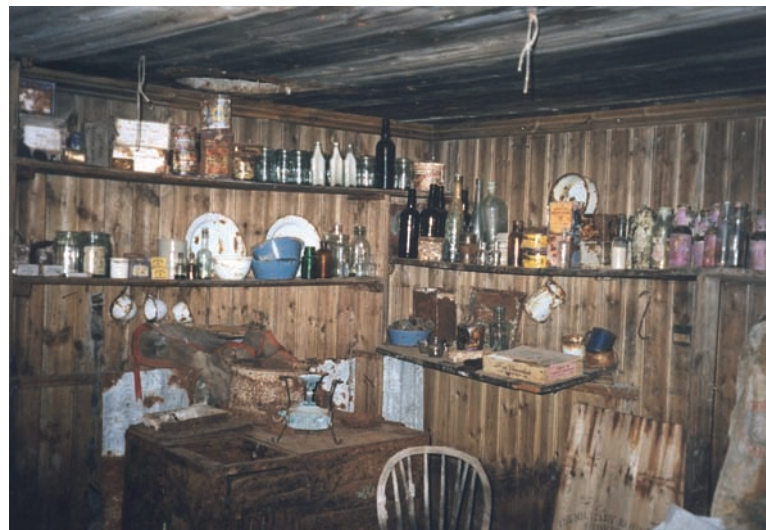
Interior artefacts (Credit: Paul Chaplin)

Wildlife. As previously mentioned the constant presence of penguins during the short months of summer hinders work because the prescribed codes of conduct mean that wildlife cannot be disturbed. A greater problem however comes from the guano they deposit. When the original human occupants departed they left many of their stores around the huts and these have now been buried under a thick layer of guano. The same guano provides a fertile medium for bacteria and other organisms that attack historic materials.

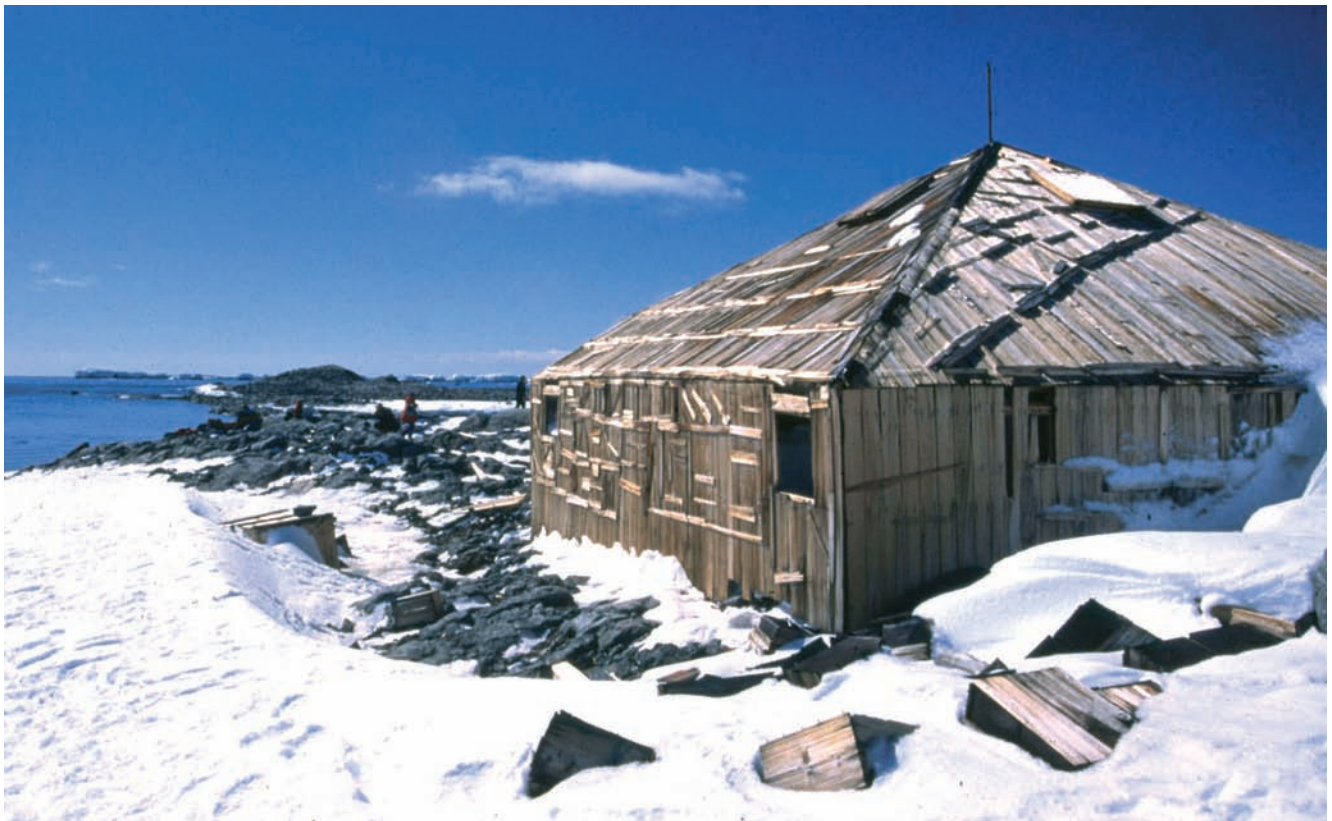
Mawson's hut (Credit: Geoff Ashley)

By way of providing a similar example of these problems, it is relevant to mention an equally difficult site built in 1912 by Sir Douglas Mawson for his "Australasian Antarctic Expedition (AAE) 1911-14". The huts he built remain at Cape Denison, in
