The Christchurch Earthquake

Heritage at Risk

This 2010 report continues to highlight significant New Zealand heritage at risk and supplements previous reports from ICOMOS New Zealand/Te Mana O Nga Pouwhenua O Te Ao. It discusses heritage protection mechanisms in New Zealand and recent legislative changes which have included heritage as a matter of national importance.

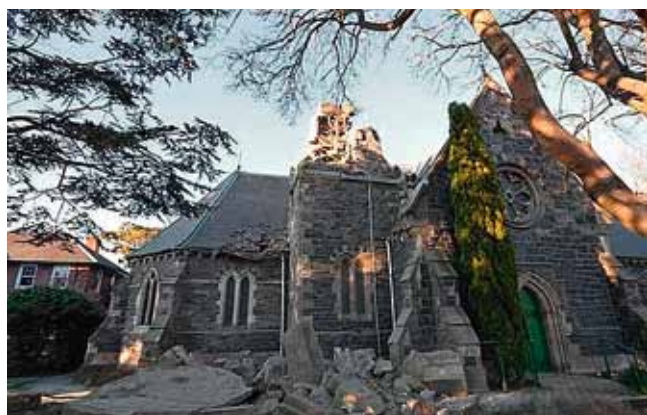
Christchurch, church of St. John's, Latimer Square

Unstrengthened stone buildings from the 1860s and '70s performed surprisingly well. There were no catastrophic building failures and damage has ranged from the collapse of the tower of St John's Church, Latimer Square (1864) to the more typical damage of the apex of gables falling, coping and capping stones being dislodged, and in some cases falling, and separation of walls at junctions between planes. It is anticipated that all the buildings in this category will be secured, repaired and where necessary, damaged parts restored or reconstructed.

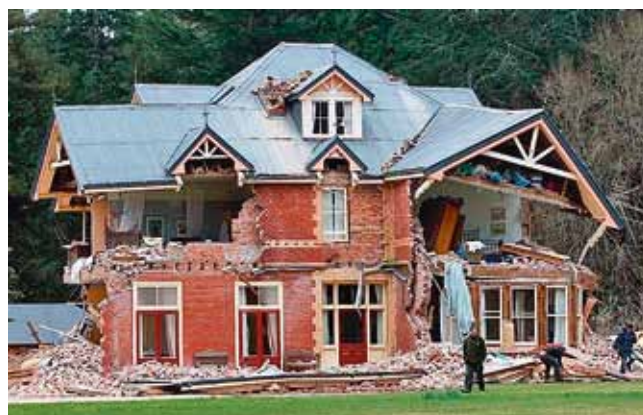
Christchurch, damaged private house
