ARMENIA

The Central Covered Market in Yerevan

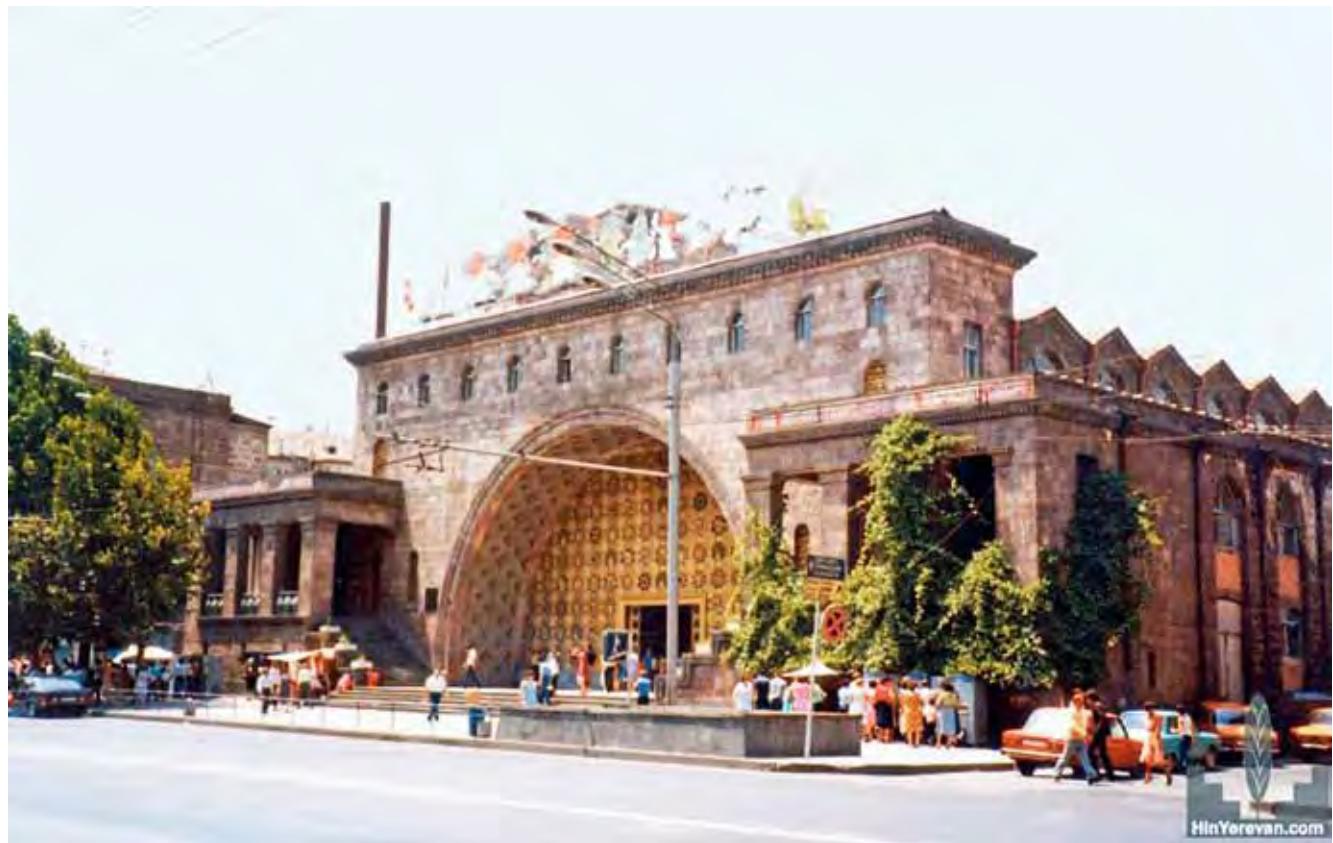
The Central Covered Market in 1985 (architect Grigor Aghababyan, engineer Hamazasp Arakelyan)

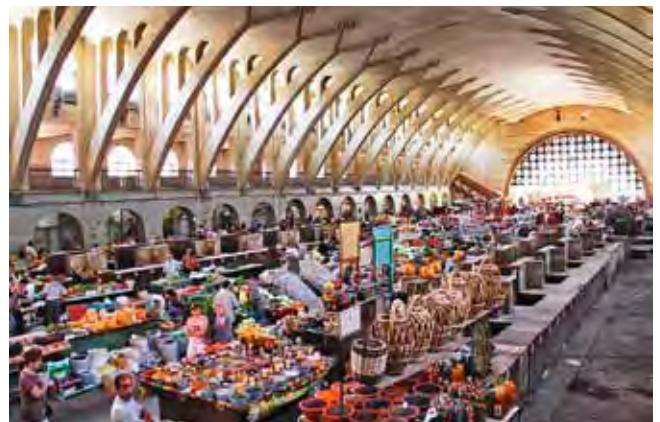
The authentic interior of the Covered Market

The building represented a two-level three-nave hall with larger central nave. The roof was supported by 19 concrete arches of 42 metres width (ten of which are now destroyed). The structural system of the building was clearly expressed in the interior. The supporting arcade was also the main means of artistic expression in the interior. The surfaces of the big arches were treated with gradually reduced additional arcs that visually give a lightness and elegance to the structure. Despite the huge size, the interior space had a very human scale, thanks to the masterfully drawn arch galleries of the side naves and to the interior details, like metal railing of the corner stairs and the higher tiers. The 34 stationary shops were located in the side galleries. The restaurant, café and medical centre were situated on an underground floor. At the main entrance there were the post office and the railway station office to serve the sellers – farmers from different regions.

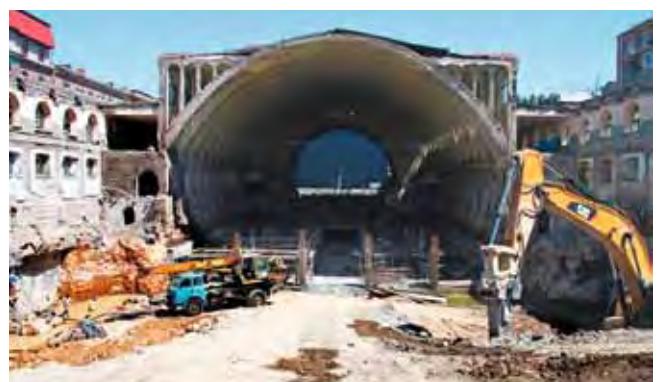
The demolition of the Covered Market started in 2012

renovation and construction of an underground parking area, half of the building was dismantled and replaced by a four-storey supermarket whose structures are incompatible with the authentic design and seriously endanger the Market's important heritage values. This vandalism was not stopped despite warnings from professionals and a powerful public protest movement. Since the beginning of the reconstruction a great number of architects and

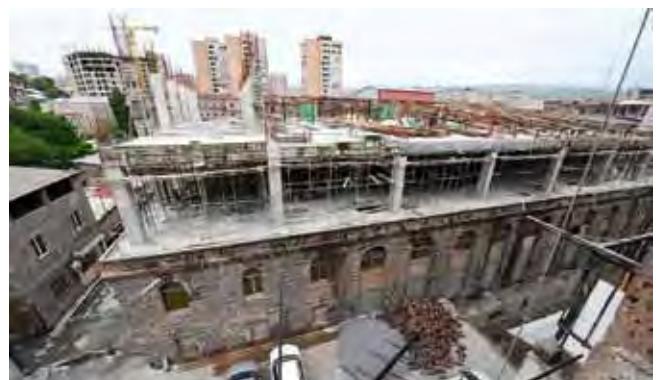
The new structures of the "renovated" Covered Market

Despite the fact that the valuable stained glass of the main facade and several supporting arches remained intact, the authentic structural and architectural integrity of the building was seriously damaged. The floors, escalators, and other incoherent elements of the newly built structure create a sharp dissonance with the remaining authentic part of the former Covered Market. This

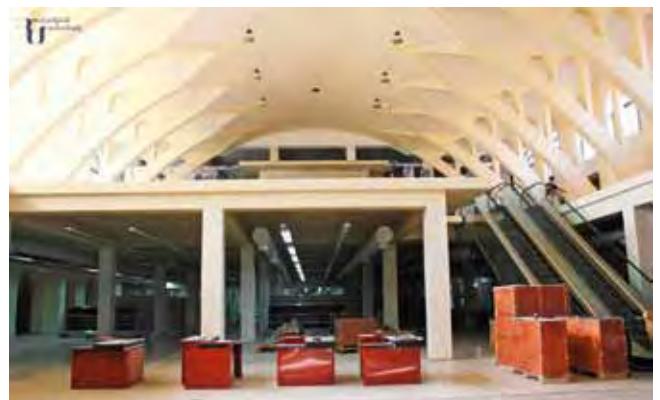
The interior of the former Covered Market in September 2013
