MEXICO

San Juan Cuauhtinchan, Puebla

The high altar of the church of San Juan Bautista, Cuauhtinchan

Vernacular Mexican Architecture in Danger

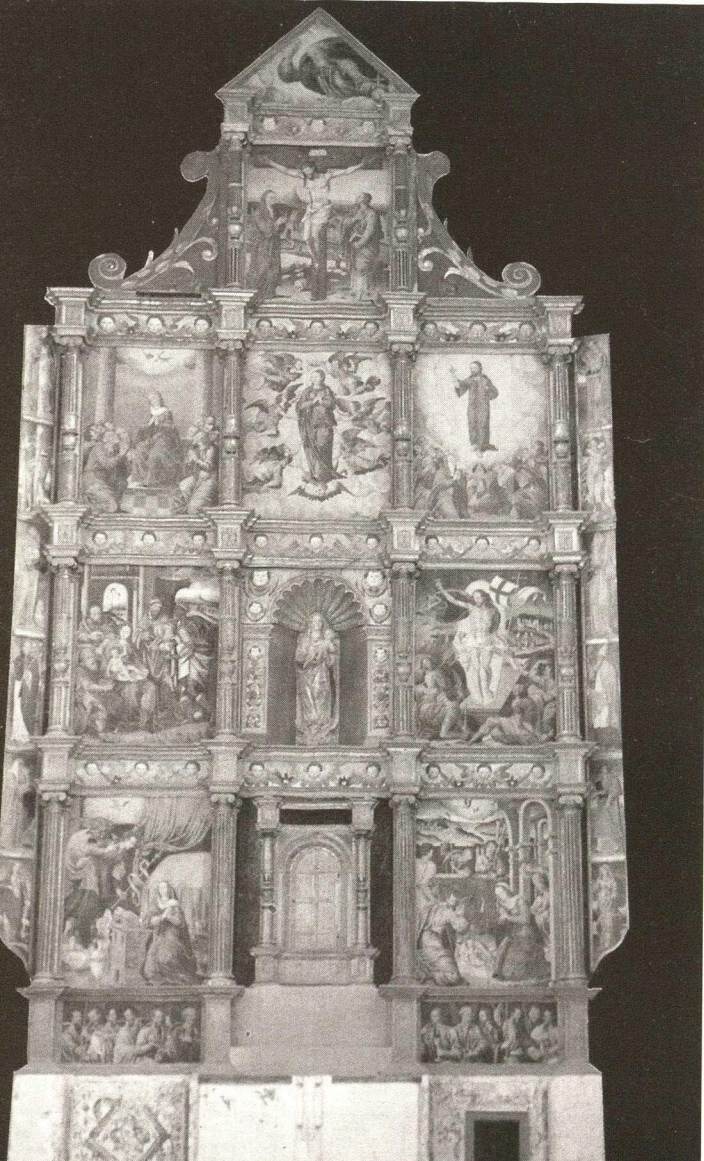
Structural cracks caused by changing humidity

Grietas en estructura por cambios de humedad

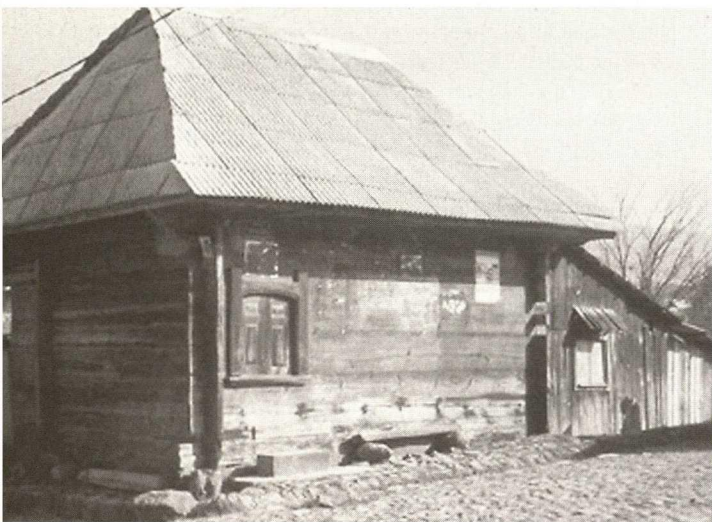
Wooden construction in Angahuan (Michoacan)

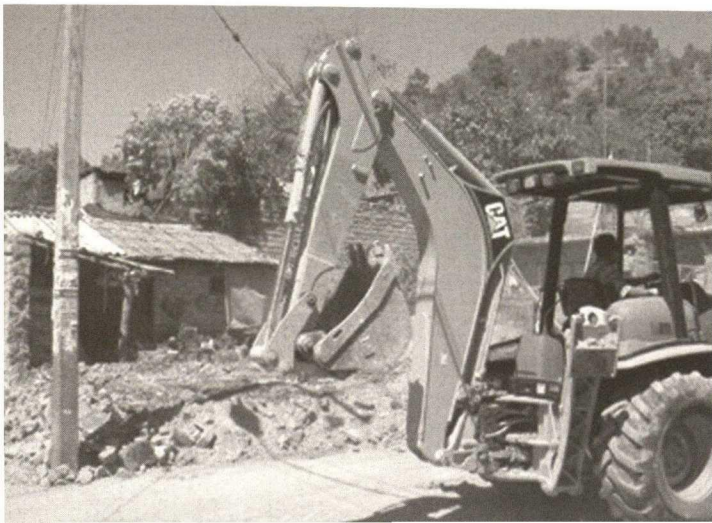
Destruction of adobe buildings in Hueyapan (Morelos)

As in the above case of the *troje*, the reasons relating to the destruction of this built heritage have a cultural background. They are also a result of the impact of the influence of the cement industry, poor housing programs and an absence of policy on preserving and improving the traditional vernacular houses of rural communities.

In fact, only 30% of the houses that existed ten years ago survive. They are quickly being replaced. Yet while local people accept that their adobe houses are much more comfortable to insulate against extreme temperatures, they claim: "But we need to feel modern".
