TURKEY

Churches built in Ottoman times

The present state of some of the surviving monuments

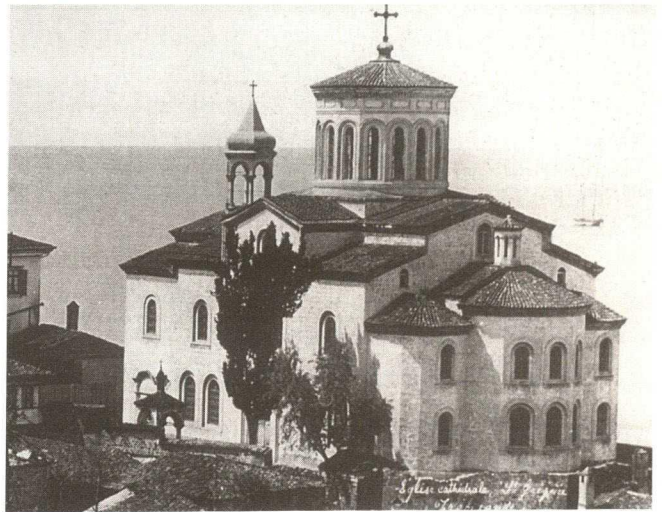
Trebizond, church 'Hagios Gregorios of Nyssa (1863), blown up in the 1930s

Anatolian churches were and are being blown up, destroyed and are still being used inappropriately. For example, the impressive cathedral-church of Hagios Gregorios of Nyssa built in 1863, that dominated the silhouette and skyline of Trebizond, was blown up in the 1930s to permit modern city development.

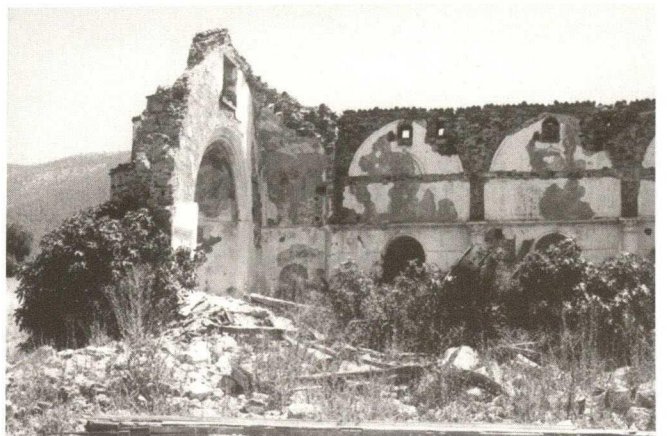
Yayla Köyü, area of Muğla (Caria), village church (19th c.): View from the north

Other reasons also lead to the total destruction of the often empty and ruined buildings: the destruction of the south-western Anatolian one-aisled 19th century village church of Yayla Köyü (the former Greek village of Hagios Antonios), near Muğla in the historical landscape of Caria, was caused by the collapse of its rotten wooden roof construction reported in 1998. It is mostly the domes and vaults of these churches that are structurally at risk, and such cracked masonry can clearly be seen in the village of Cunda on Cunda Adası (Greek: Moscho–Nisi) near Ayvalık

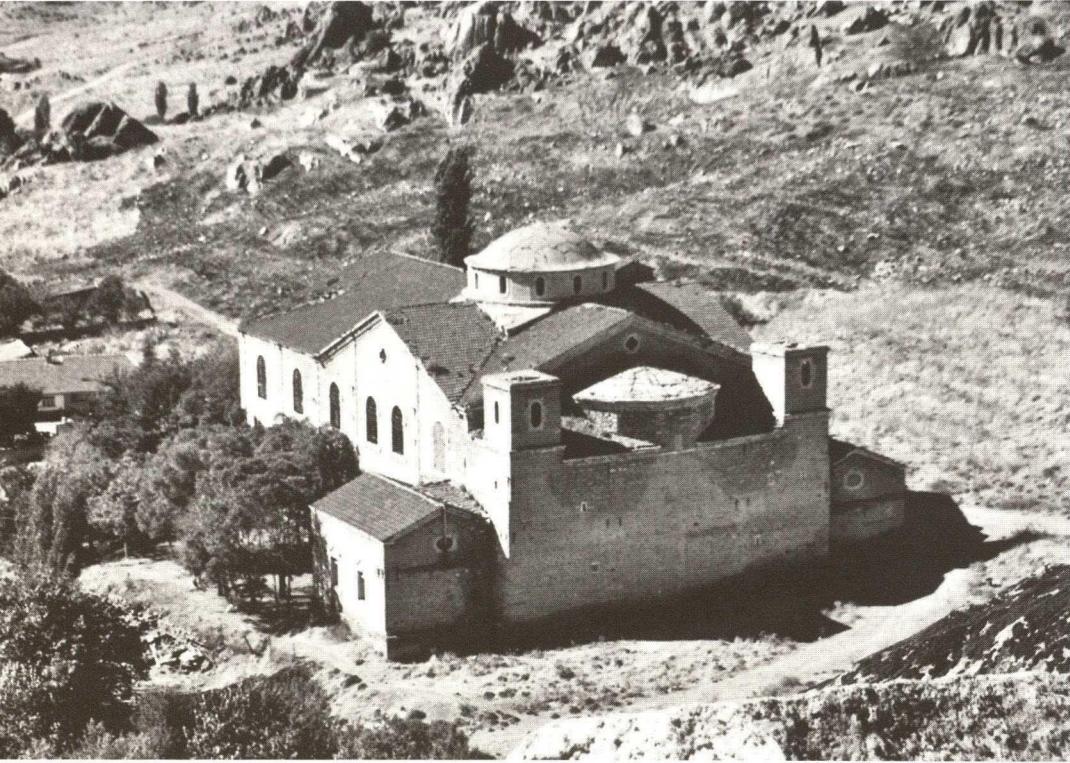
Sivrihissar, large Armenian domed basilica built in 1881 (2003)

Also architectural changes to buildings can be demonstrated and are causing damage to the original structure. The large Armenian domed basilica of Sivrihissar, built in 1881 some 120 km south-west of Ankara, was used as a factory for a long time and it was decided to add walls in the western interior, so destroying the concept and sense of its original architecture. The building now stands empty. Also the large basilica of Misti, built 1844 in southern Cappadocia, is now used as a storehouse for building materials such as sand, wood and stones. There is finally the non-religious use of a church as a farm-house as mentioned above.

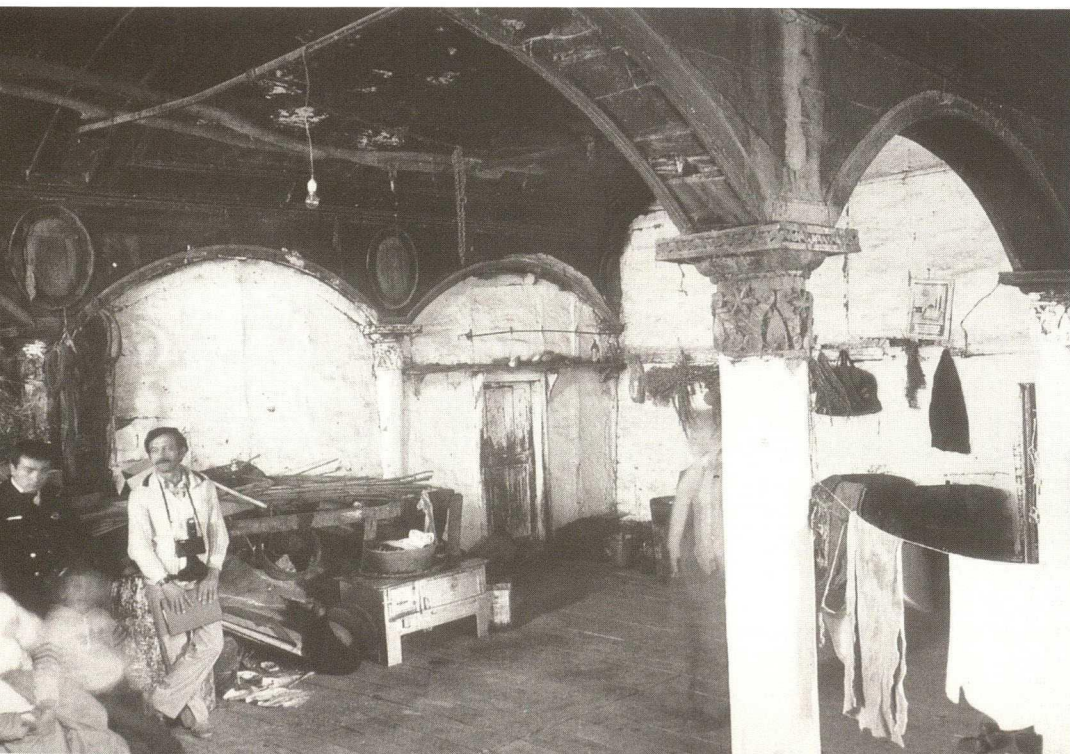
Çakıl – Michania, basilica inside, building used as a farm-house as seen in 1982

In Anatolia we face the same problems as those we found and are finding in the Balkans and in Greece. In some cases an Anatolian Christian church is now used as a mosque which ensures its survival as a building. Other examples verify a secular use of churches. For example in 1982, it was discovered that an 18th century village basilica was being used as a farm-house in the village of Çakıl (Greek: Michania), Bithynia, on the far eastern Kyziko

peninsula on the shores of the Sea of Marmora. Astonishingly two oval canvas paintings, of Christ and an Evangelist, which originally hung between the wooden columns of its *naos*, were at the time still being kept at the site by the farmers.

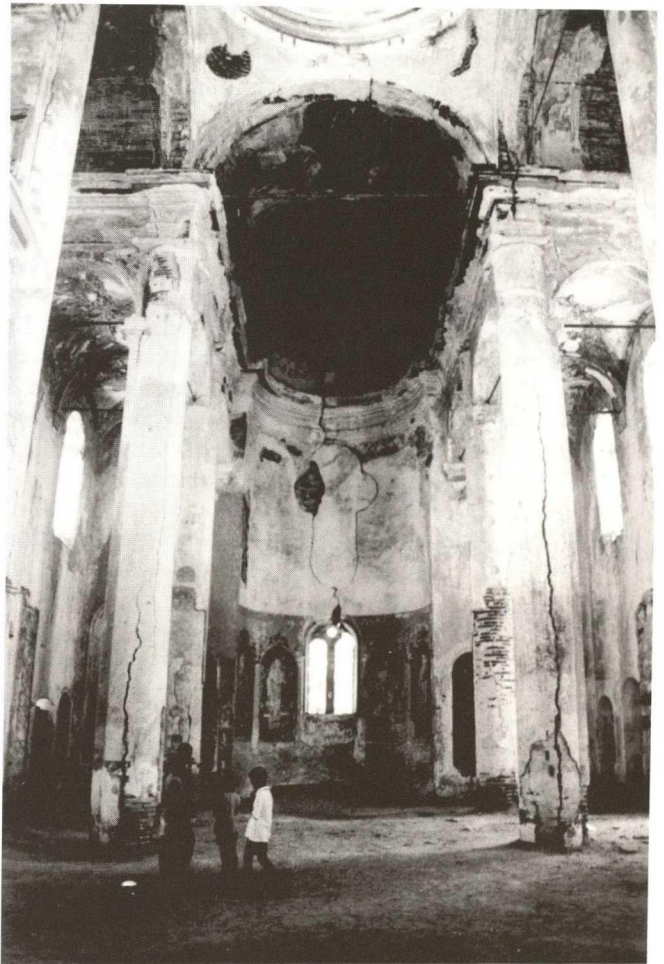
Cunda Adası, near Ayvalık, domed church, cracked brick-pillars and vaults

(Greek: Kydonia) on the West coast. The triconch cross-domed church of this village is in definite danger of collapsing. Cracks in the building's brickwork are undeniably threatening the pillars and the vaults, and this might lead to a total collapse of the building in the near future. As well as this, we still find remains of the church furnishing, such as the iconostases, which often were constructed of wood, and bishop's thrones and chancels, in a ruined state, for example inside the church of Hagios Archangelos Michael in Sille near Konya in Phrygo-Lycaonia. In addition, stucco decorations

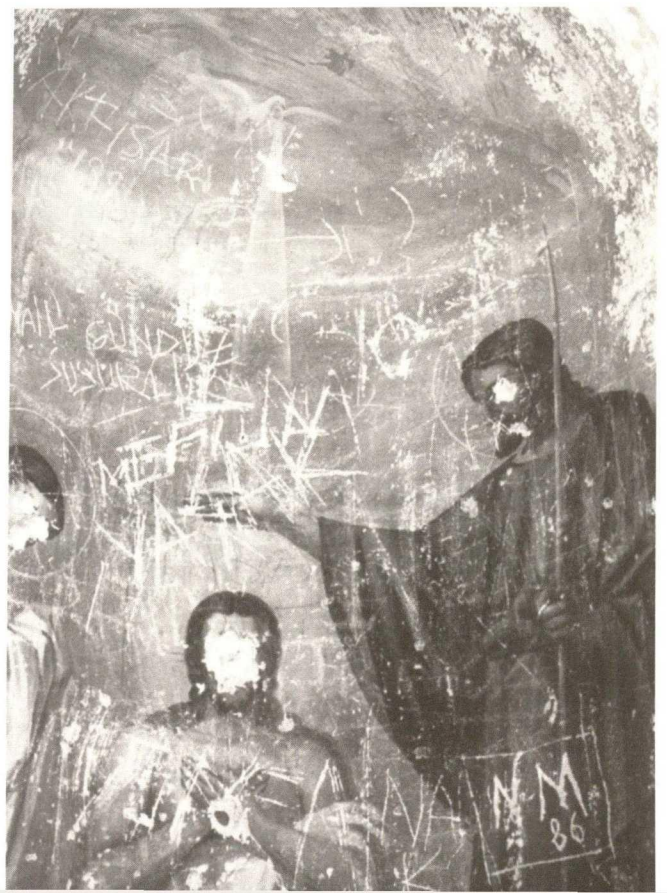
Cunda Adası, domed church, vandalised niche painting 'Baptism of Christ'

and wall-paintings of the churches are particularly at great risk of total loss and destruction, mostly because of vandalism to the lower parts of the unused buildings. Consider for example the 19th century painting 'Baptism of Christ' in a niche on the south of the eastern apse of the domed triconch church in Cunda, Cunda-Island off the coast of Ayvalık–Kydonia. Another risk is water, which can pour through leaking vaults and roof constructions and cause the loss of painted and decorated plaster.
