Heritage at Risk 2004/2005

UKRAINE

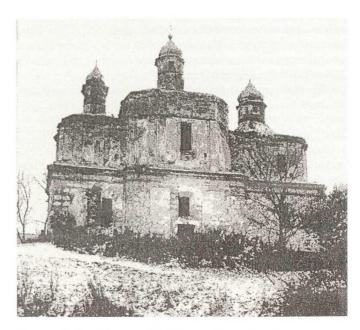
The Church is situated at the end of the village, on a hill above a small river. This place of worship is tripartite, two-tiered, with three cupolas. The first storey is built of stone, the second tier and the drums are of brick.

Church of the Transfiguration of the Saviour, village of Polichyntsi

The heritage place is in a critical state. It is in urgent need of help to prevent its collapse and begin conservation works, but lack of funds prevents an immediate start.

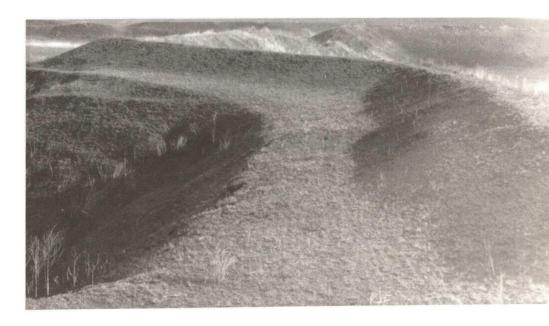
The extension of the Ukrainian frontier spanning the watershed between the Dnipro and Siversky Donets rivers is some 285 km long. This border represents a continuous moated rampart with 16 fortresses and two hundred redoubts and blockhouses mounted along it. The area of each fortress' inner court is about 1.2 ha, the perimeter of its ramparts 980 m. The fortifications were designed and their construction supervised by French fortification engineers G M de Brigny and D I de Bosquet, under the guidance of Kyiv Governor General A I Tarakanov. In building the borderline, 20,000 Cossacks and 10,000 peasants were employed under Cossack Colonel Halahan.

Today this line of border is in critical state. Saving this unique monument to the art of fortification and town-planning is one of the most urgent tasks, and presents serious organisational as well as methodological problems.

Ukrainian frontier
