ARMENIA

The Little Church of Saint Astvatsatsin (Virgin) of Artik

ICOMOS Armenia

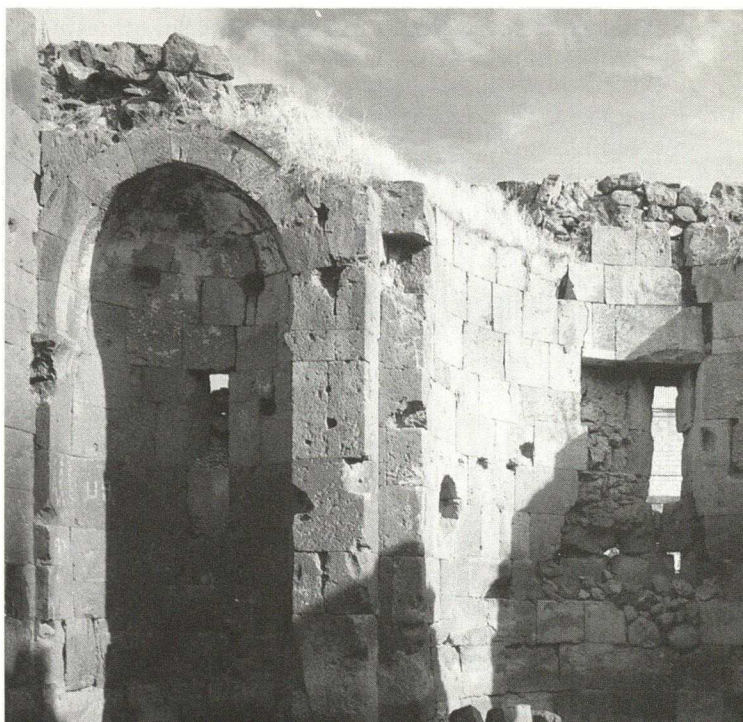
Arthik. St. Miriam's Church, interior view

Because of the above mentioned reasons the monument is in a decayed situation with numerous and expanding cracks, bent walls, stones fallen from mortar, settling of basements, and deformation of the structural system.

If the monument continues to decay without any urgent stabilisation, in some years it will be lost forever from the history of Armenian architecture.

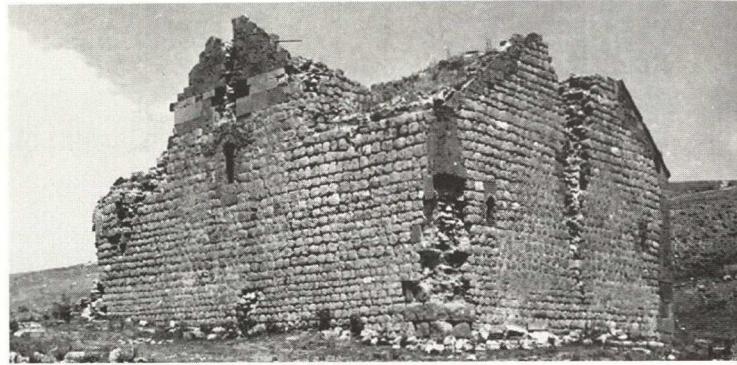
Surp Astvatsatsin church

The dome and coverings of the church were demolished after the earthquake. There are multiple cracks on the walls. Among the remaining structural elements are the whole barrel vault on the northern side and all the sacristy vaults.

Severe damage to the monument can be observed. The problems are mainly of a structural nature – it is in a condition of failure due to the fractures and lack of roofs. The external coat of the lime mortar has not been preserved due to the atmospheric humidity. It requires important consolidation support and a full programme of restoration works.
