BULGARIA

The Bulgarian national committee of ICOMOS has presented an analysis of the causes for deterioration and the list of most endangered monuments in the years 2000 and 2001.

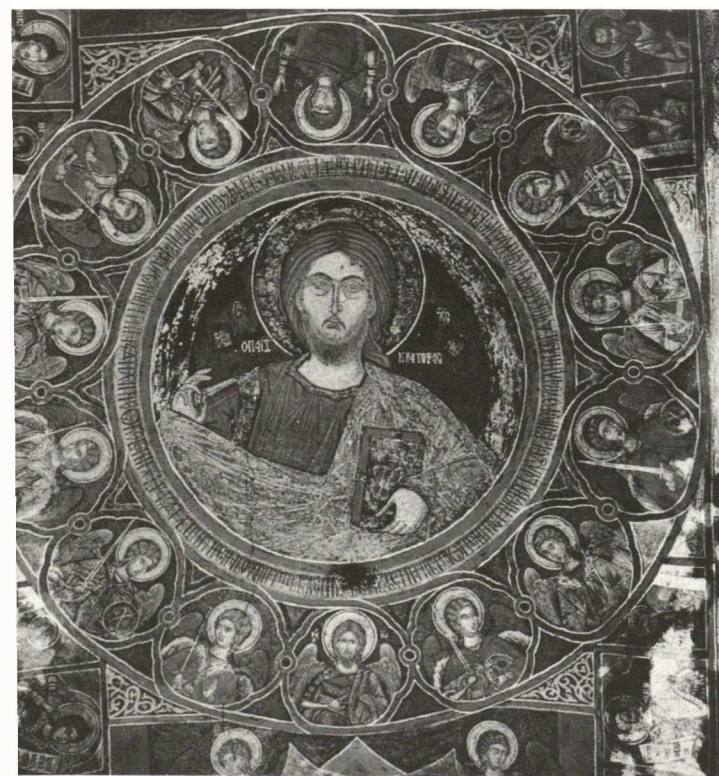
Severe damage is obvious at present – throughout the years the church has been seriously affected, as a result of slides of the terrain. Part of the murals in the naos were covered by whitewash, and the iconostasis was stolen. The church requires urgent consolidation measures, starting with strengthening and stabilisation of the terrain. Partial reconstruction of the destroyed parts must also be carried out as soon as possible. The next step should be restoration of both the immovable decoration of the monument – the wall paintings – and of the moveable decoration – for example, iconostasis and icons. The site is of national importance.

Case study C: Church 'St. Nickola' in Soslavtzi Monastery, wall paintings

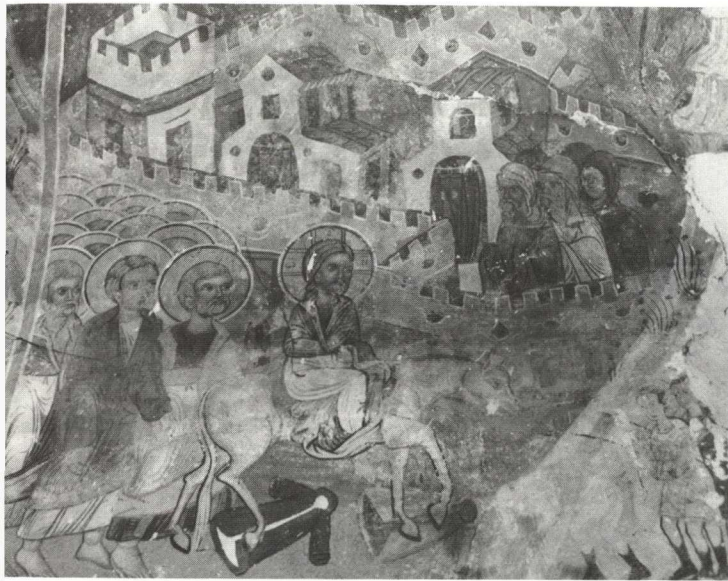
Case study E: Church St. Arhangel and Michail in Bilintzi monastery, wall paintings in the interior

Throughout the ages, the ensemble has suffered continuous damage under the destructive effect of the environment, and the mural paintings are falling down. The monument needs urgent measures to halt the destructive processes: consolidation of the terrain around the church, structural reinforcement, consolidation of the erected structure, roofing and window replacement, and restoration of all moveable and immoveable features.
