## CZECH REPUBLIC

### Endangered 20th-Century Historic Monuments

## Monuments Damaged by Floods in August 2002

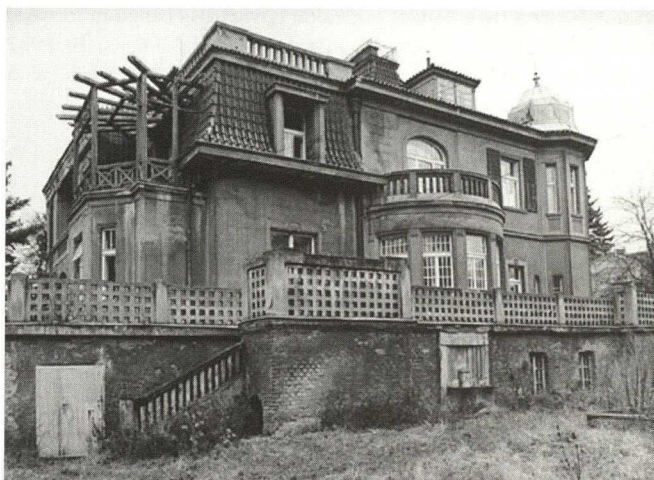
An example of Cubist architecture by Josef Gočár, it was built in 1912–14. Its present-day new owner is considering the reconstruction of the building as smaller flats.

Libodřice Villa, Central Bohemian Region

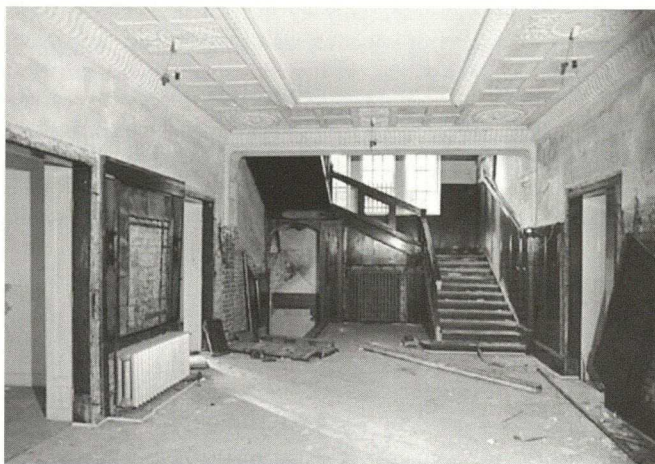
Built by architect František Beneš in 1921–2 as his family home, the villa is an example of exceptionally successful architecture,

Villa in Plzeň – Lochotín Region showing devastated interior

preserved until today almost in the original condition. The present owners are considering demolishing the structure to basement level and building a modern family house, referring to the bad structural and technical condition of the villa.

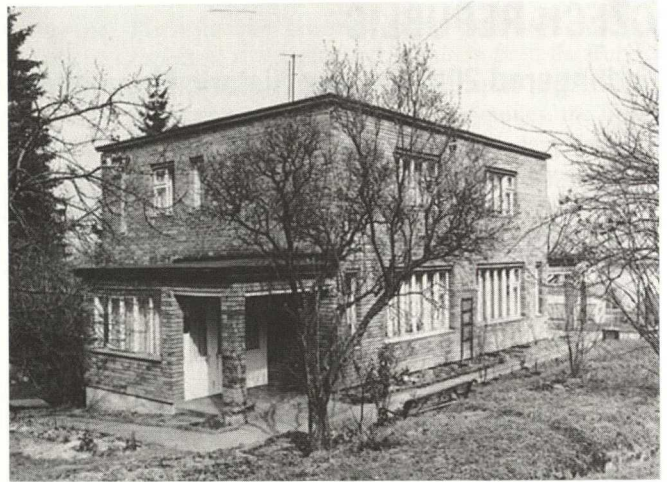
The threats to the small houses include inappropriate alterations by the owners, especially by thermal insulation of their exteriors; replacement of windows with plastic ones; superstructures, extensions by adding bathrooms, small rooms, garages; building different sheds and shelters in the gardens; by casting concrete in the terraces and garage places; and replacement of hedges with unsuitable fencing. So, gradually, not only is the characteristic appearance of the houses changing, but also the total appearance and atmosphere of the various settlements. The interest of the town in co-operating with monument protection is limited – on the contrary, the intention is to cancel the declared municipal zone of ancient monuments.

Settlement of Bat'a's houses, Zlín

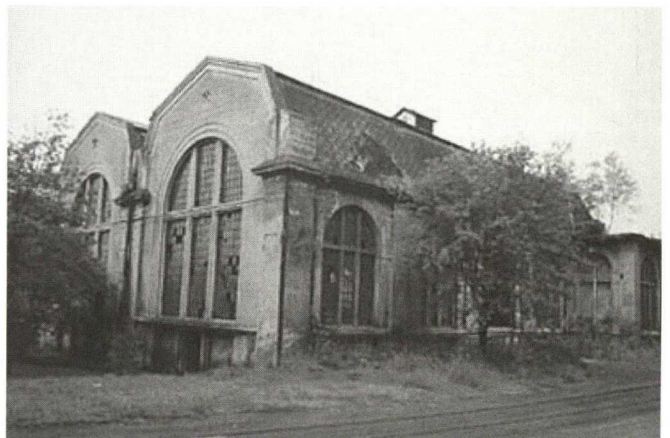
Operating buildings of the František Josef Mine Kladno – Dubí, Central Bohemian Region

abandoned mining areas, and especially the operating buildings. Some of them represent quality architecture built in the style of Art Nouveau and the individualist Modern Movement, with perfect hand-made details. We have discussed this problem previously in the two earlier *Heritage at Risk* reports. Particular examples (the original names of the mines are given) include:

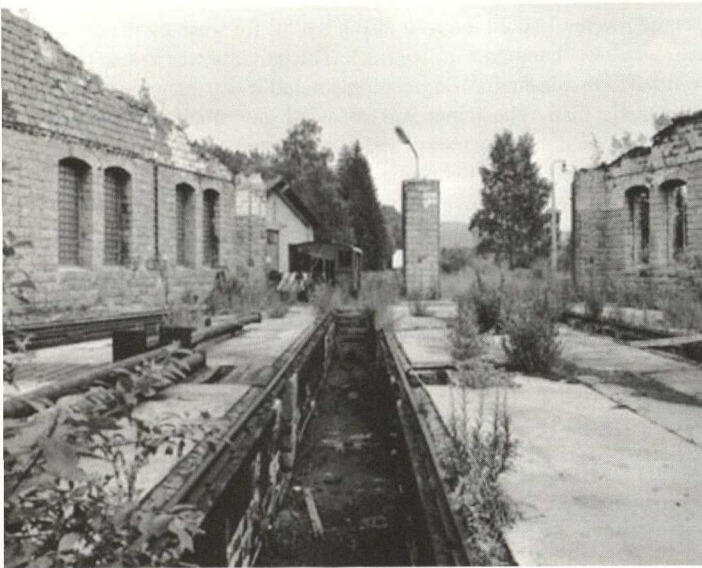
Kořenov, Region of Liberec, the locomotive shed in the area of the station – interior (without roofs)

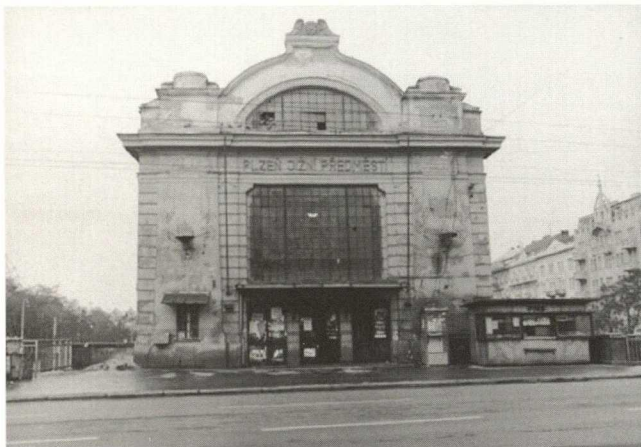
The main building of the railway stop, Plzeň – southern outskirts

The old departure (western) building of the railway stop Plzeň–Jižní předměstí (the Southern outskirts) in Plzeň was built in 1904 in the historicizing style with elements of Art Nouveau. It has been closed since the reconstruction of the eastern building in 1980; without utilisation it falls into disrepair and České dráhy (the Czech Railways) considered its demolition. In the second half of the 1990s, with a contribution from the preservation of historic monuments, its membrane roofing was repaired. However, there are no financial means for the total restoration. Occasionally, exhibitions and theatre performances are organised on the site.

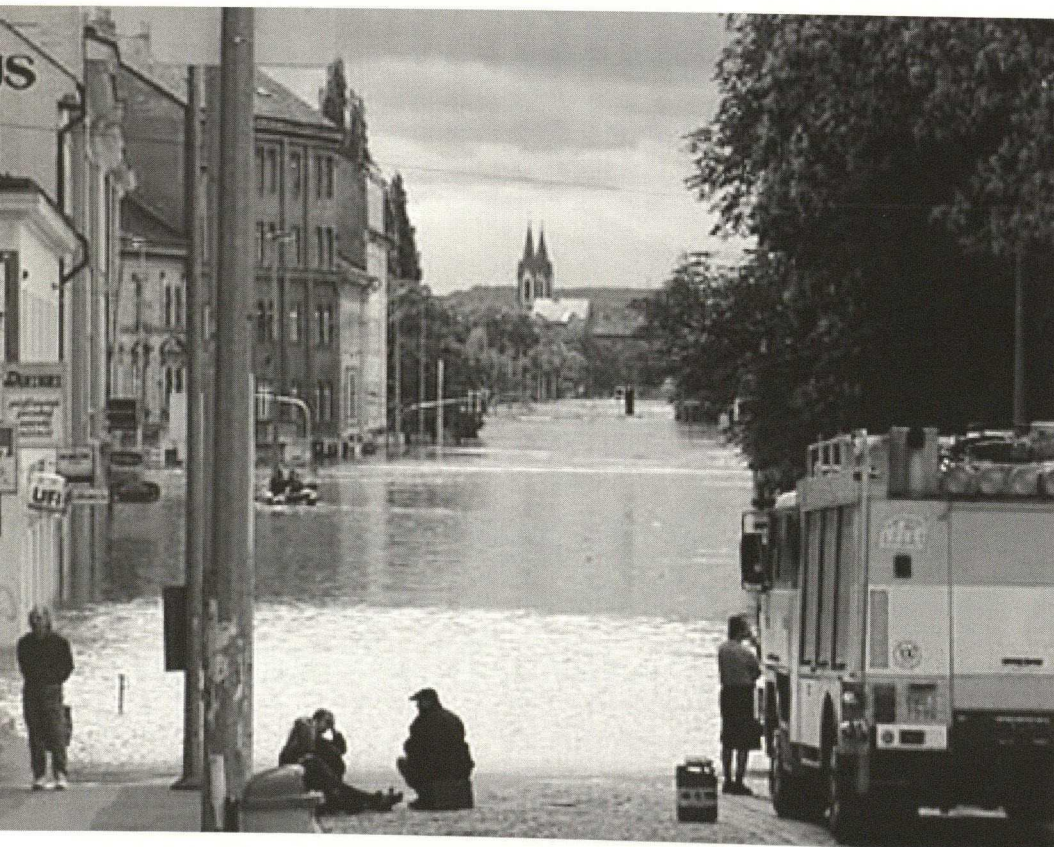
Prague, Karlín, St. Cyril and Methodius Church

In the historical quarter, the St. Cyril and Methodius Church, an important work of the neo-Romanesque architecture by Ignacius Ullmann, was flooded. Water rose to the height of 1.6 metres and the wall paintings and all moveable objects were damaged.

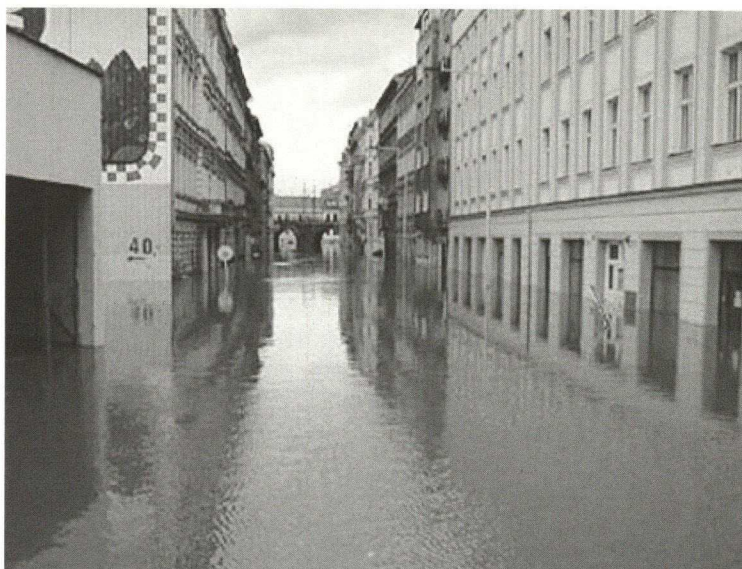
Prague, Karlín

big cities: real-estate speculation. At best it can be demonstrated in the case of Prague's quarter called Karlín. It is a valuable town-planning unit – the oldest historical suburb of the city, founded at the very beginning of the industrial revolution in the 1830s. The built-up area of the quarter was formed partly in the neo-classic genre, partly in the revival and Art Nouveau styles. The quarter was flooded completely and a couple of its buildings, originally built of cheap materials, collapsed. Because the quarter is situated in the very centre of the city, its building lots are in most cases much more valuable, in commercial terms, than the buildings standing on them. Many owners and developers, who wish to invest in the region, are now trying to put their houses into the category of so called 'irreparably damaged structures'. It would result in the situation that the inhabitants of the houses will be transferred into compensatory municipal flats and the owners will be allowed to pull the houses down and replace them with bigger ones, serving no more as residential housing (with State-regulated rents), but as more-lucrative offices, commercial buildings and parking.

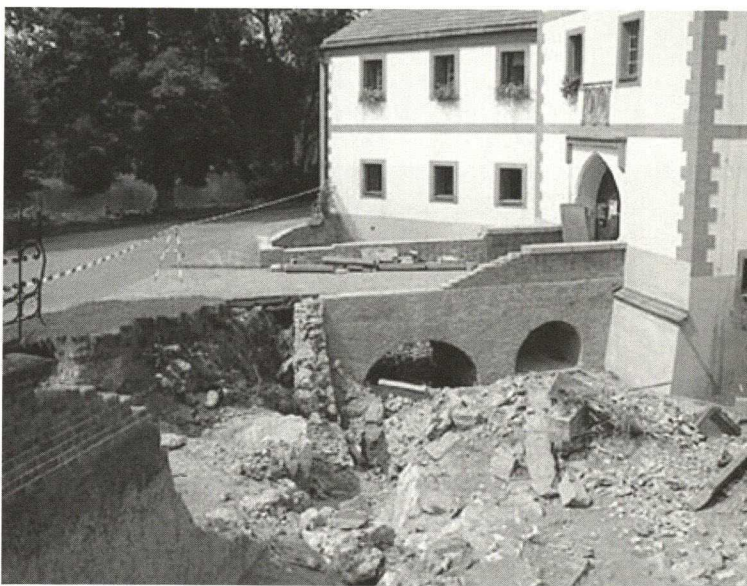
This early Baroque historic country house from the period after 1650 includes excellent stucco and fresco decorations and a Renaissance palace, originally from the 16th century. The enclosure walls, which have Baroque sculptural decorations, at the entrance of the country house were completely destroyed. The cellars, ground floors and chapel with wall paintings were flooded. Walls in the *sala terrena* are endangered by moisture. Some trees in the park were uprooted. Expected cost of renovation: EUR 120,000.

Lnáře Country House

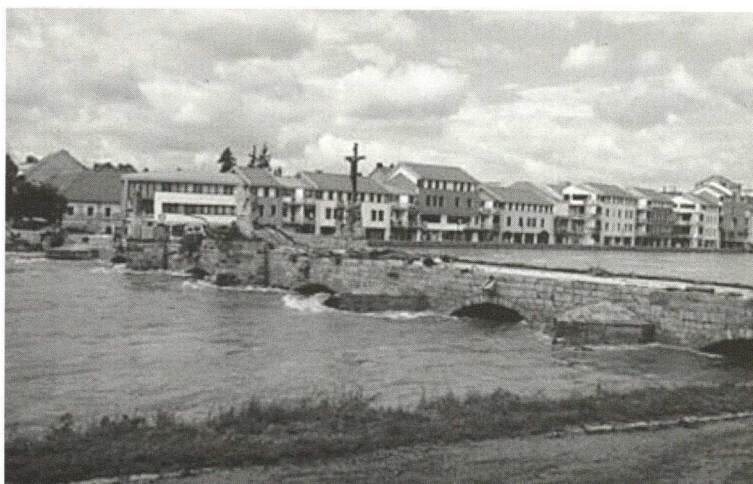
The bridge at Písek is the oldest mediaeval Gothic stone bridge in Bohemia with Baroque sculptural decorations from the period after 1250. The bridge was completely under water, the breastwork walls made of square granite stones and one of the Baroque statues collapsed due to the flood. About 250 square stones and the damaged statue have already been retrieved by divers. Expected cost of renovation: EUR 240,000.

Písek, Gothic Bridge
