GEORGIA

Natural Disaster and Heritage

Case Study 1: Tbilisi Historic District

Case Study 2: Kanchaeti Kabeni Church

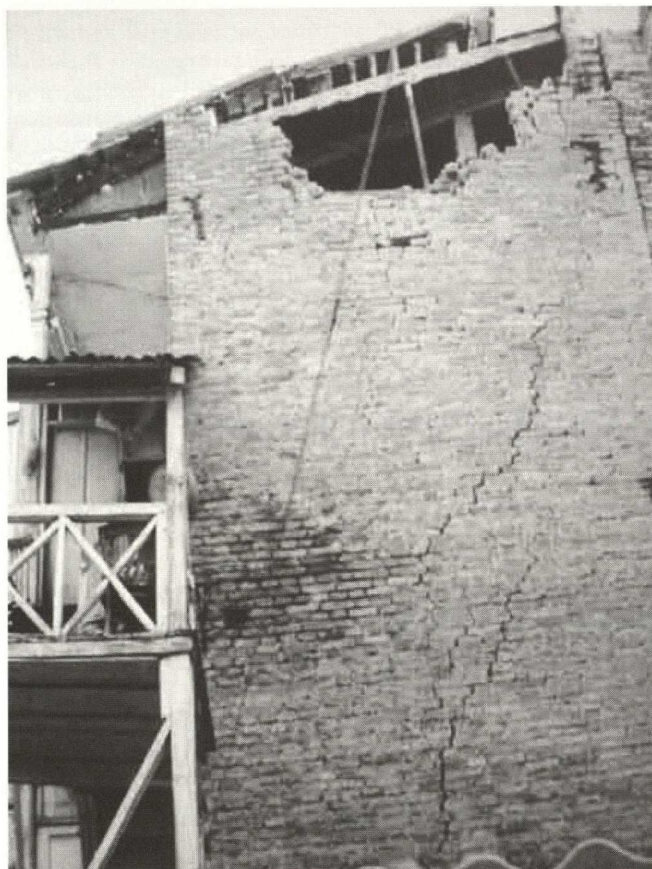
Earthquake damage in Tbilisi Historic district
Residential house in Kvemo Kala micro-quarter after the earthquake

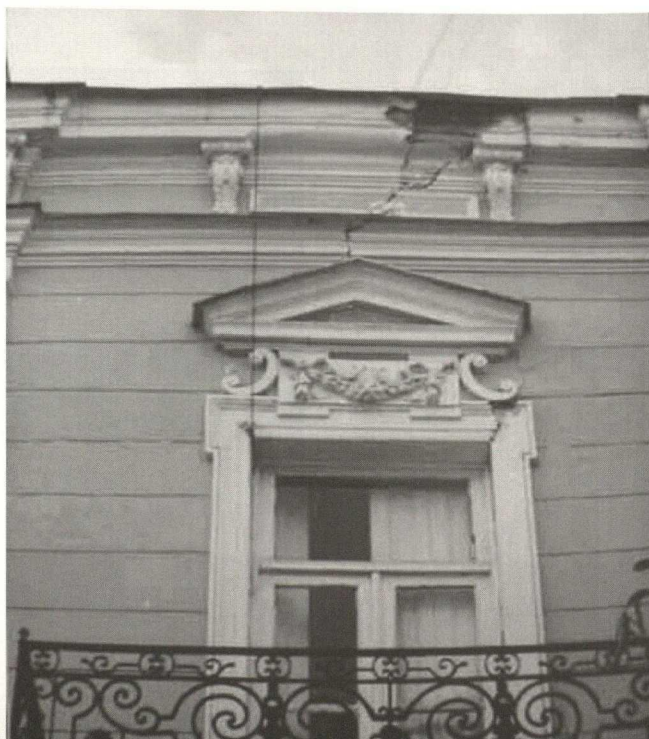
Parapet of a residential house (in Sololaki quarter) damaged by the earthquake

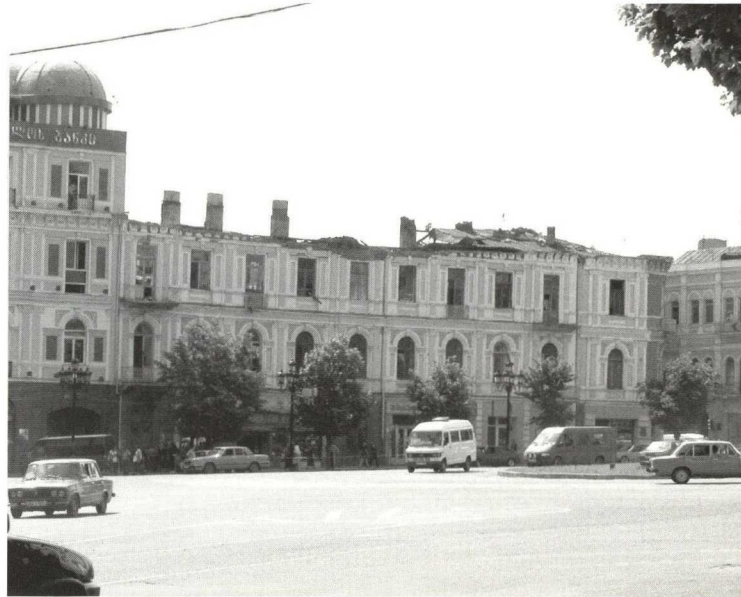
Damaged listed building on the Liberty Square destined for demolition by the city authorities

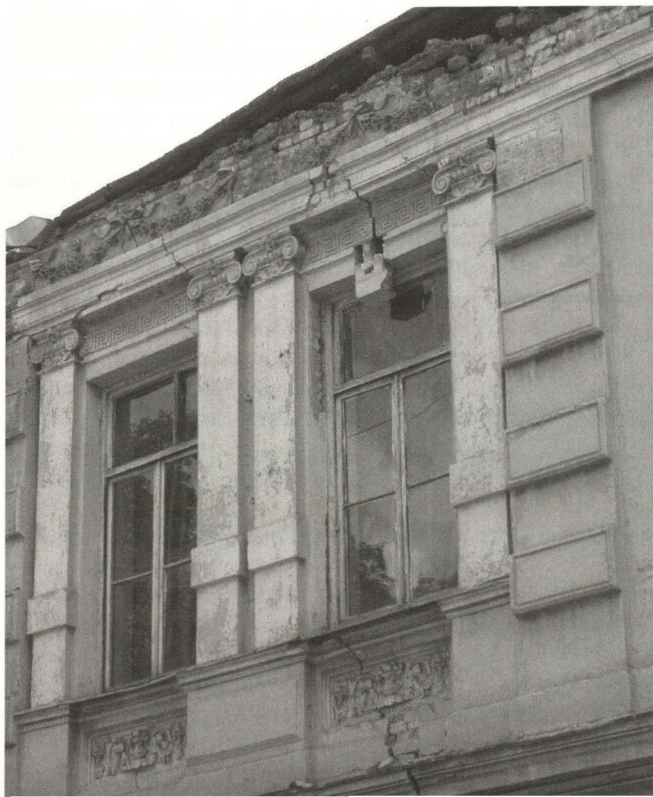
Exterior decoration of residential house (in Sololaki quarter) damaged by the earthquake.

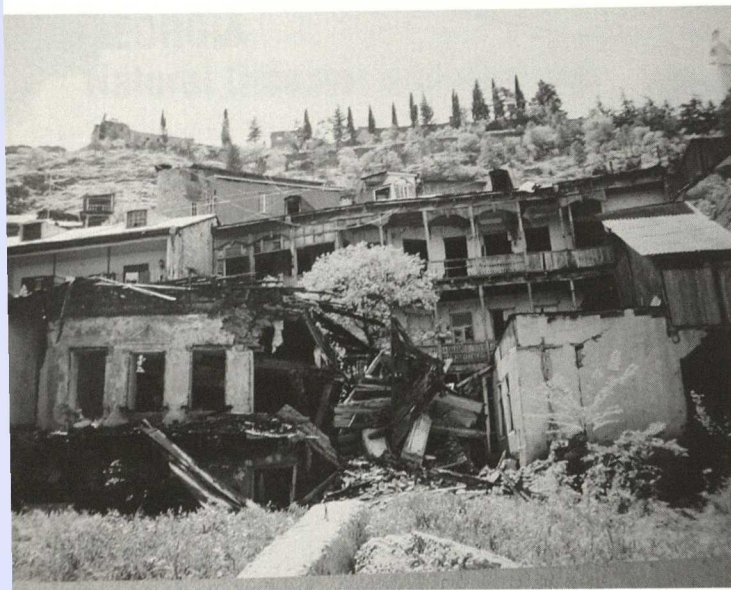
Residential buildings after the earthquake

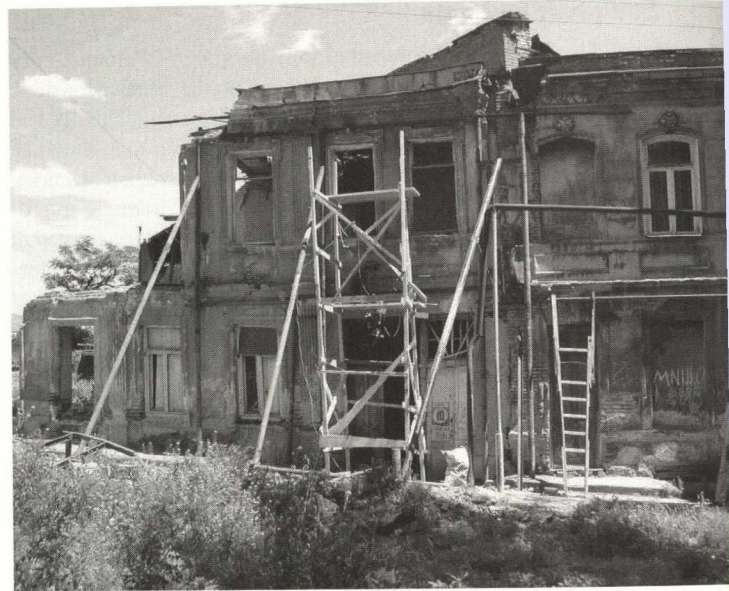
Residential house in Kvemo Kala micro-quarter. Emergency stabilisation after the earthquake

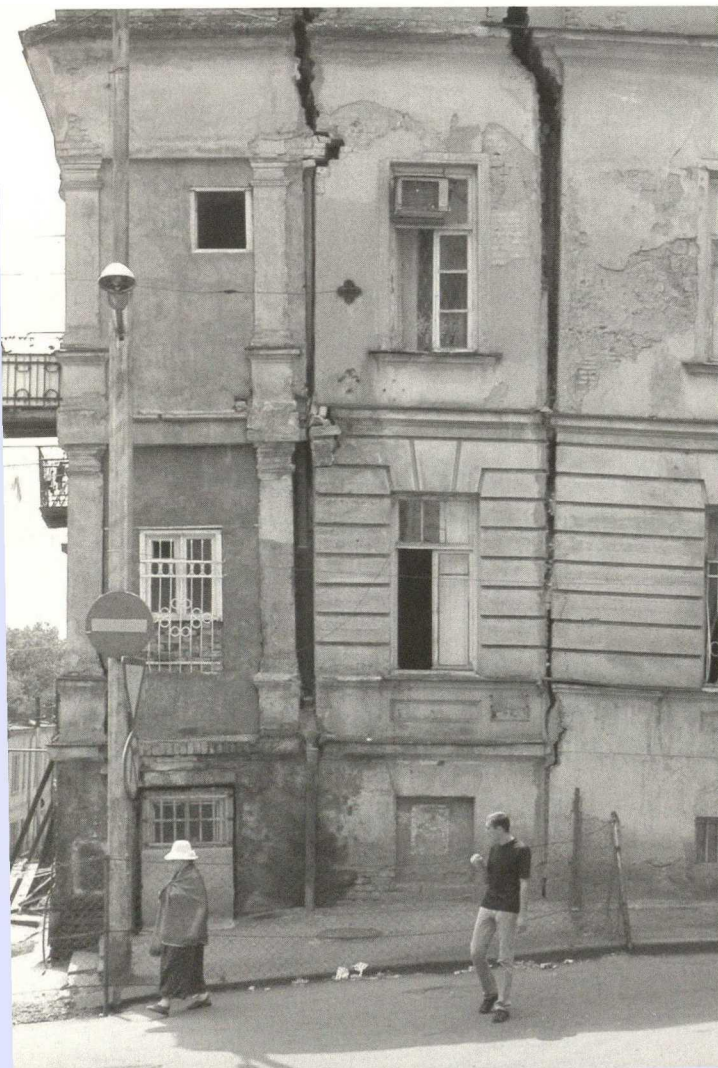
Residential house in Mtatsminad after the earthquake

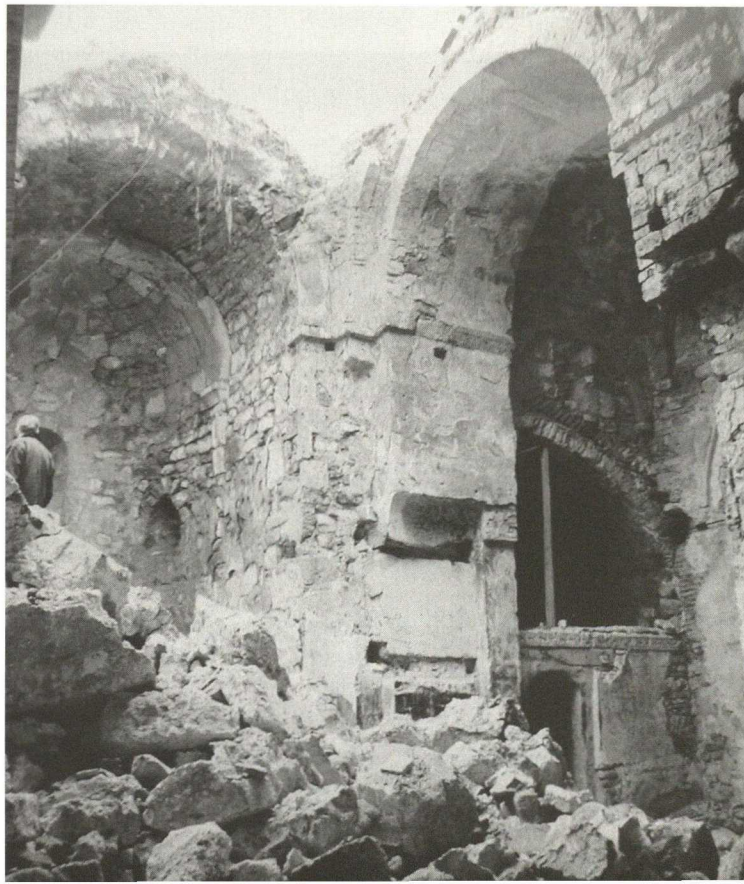
Kanchaeti Kabeni Church, general view of the church interior after the Earthquake

The north cross-arm of the church was extremely damaged: its vault and roofing constructions collapsed. As a result, the 13th-century north wall was left without an adjusted wall. The site, left unmaintained for decades, was progressively deteriorating and heavy rainfalls preceding the earthquake caused the total collapse of its dome, which, in its own turn, caused destruction of the north wall. Fragments of the mural painting (13th century) in the dome vanished. At present the situation is as follows: the structural integrity of the site is violated; roofing is damaged; due to penetration of sediments, the south cross-arm is seriously endangered; fragments of the 13th-century murals still preserved in this part of the church are in danger of vanishing.

As an emergency response, the Cultural Heritage Protection Department of Georgia has allocated US\$8,500 for immediate actions on the site – cleaning, sorting fallen stones, and arrangement of temporary wooden scaffolding in the preserved parts of the building (cross arms).

The Patriarchate of Georgia has allocated US\$4,000 for the safeguarding of mural painting fragments, which was directed towards cleaning and recording the fallen parts of murals, and cleaning and stabilisation of the fragments preserved on the walls.

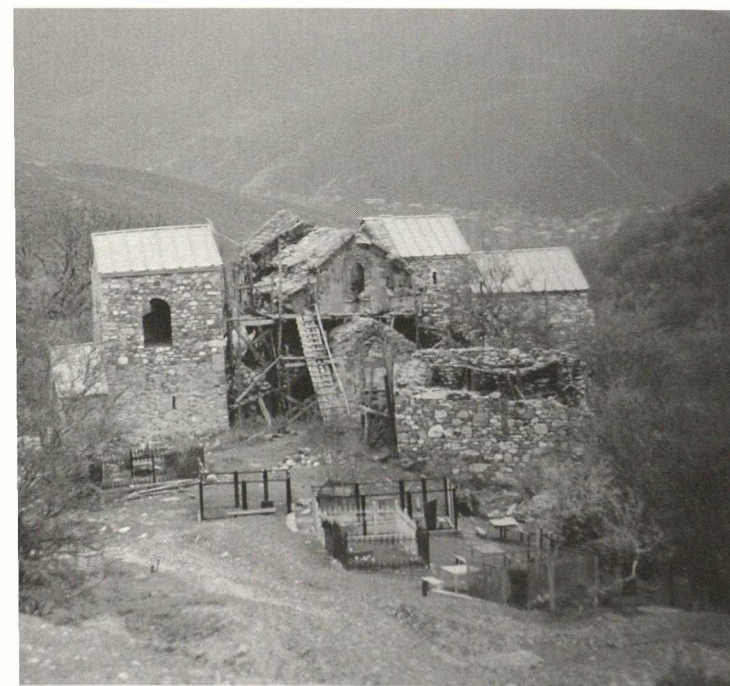
Kanchaeti Kabeni Church, general view after the earthquake
