## HUNGARY

### Façadism

## Flood at the Upper-Tisza River Region

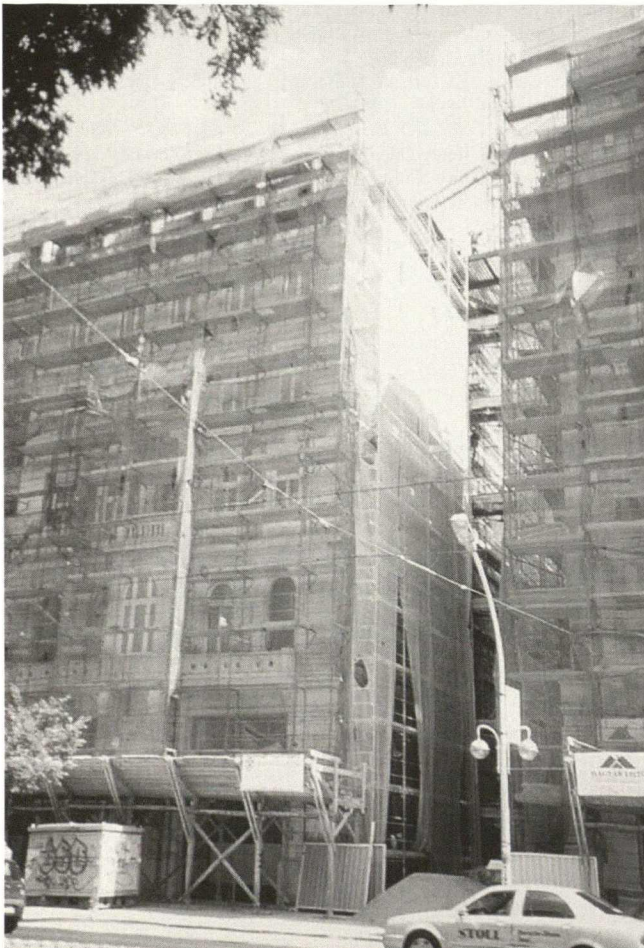
Façadism of another Budapest hotel under construction

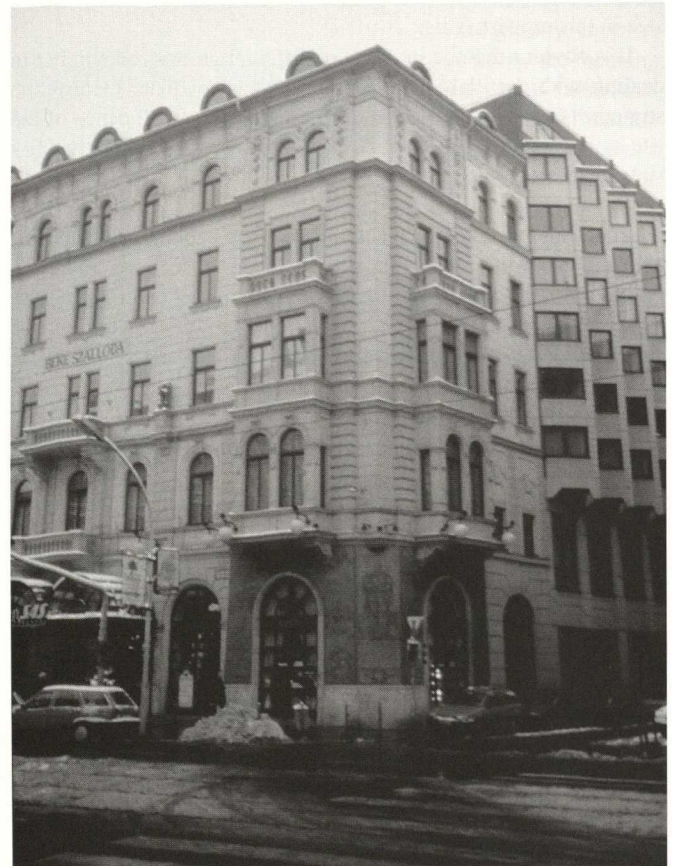
An accomplished façadism of a Budapest hotel

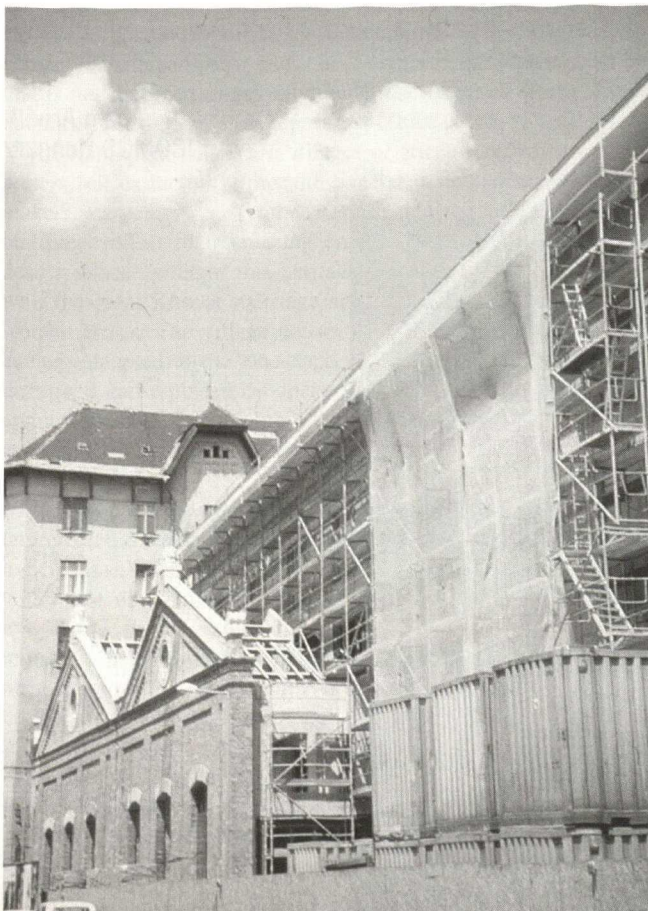
The worst form of façadism: even the façade was pulled down and now façadism is allowing its 'recreation'; the new building is towering over the left-behind façade of an industrial building.

The newest trend is that façadism is used as a 'fig leaf'. In architecture the result is that the new building gushes out from behind the old façade, the new and old structures visually mingle with and intrude on each other. It happens mostly in the case of former industrial buildings and sites. Similar to other large cities, we have this problem in Budapest. Industrial sites, which were built at the perimeters of the town in the 19th century, now find themselves in the inner districts. There are other industrial and transport sites, for example transformers or tram sheds that were built within the town borders, but they have lost their function. These sites are mainly targeted for the construction of malls or office blocks, where the 21st-century demands do not really need a 19th-century look and façade. In addition, these new developments often need bigger and higher volume. At the same time it is chic to preserve the fabric of old buildings, and this attitude may be welcome by a cautious authority. The result is a new building growing out of façadism that only partially keeps the original fabric.

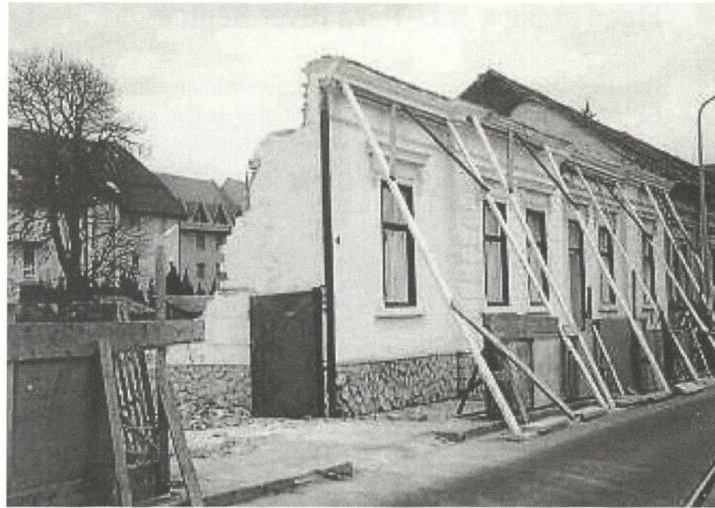
The mistaken regulation results in façadism in Zalaegerszeg, a little town

Similar solutions may be encouraged by the faults of even well-intentioned local authorities. A middle-size Hungarian town, Zalaegerszeg, has set out in its local building regulations that the locally characteristic 19th-century residential buildings must be preserved. These buildings are commonly single-storey structures. But the new demands at such a developing, lively town need investments into new office blocks, banks and shops, and these buildings need more floor-space. The fault in the regulation is that it only prescribes the retention of the façade of the old buildings, or at least that they are built into the newly constructed façades. The result is the loss of the characteristic single-storey townscape, and sometimes ridiculous or misshapen architecture, characterised by a formerly single-storied facade standing in front of the separated wall of a new two-storey building.

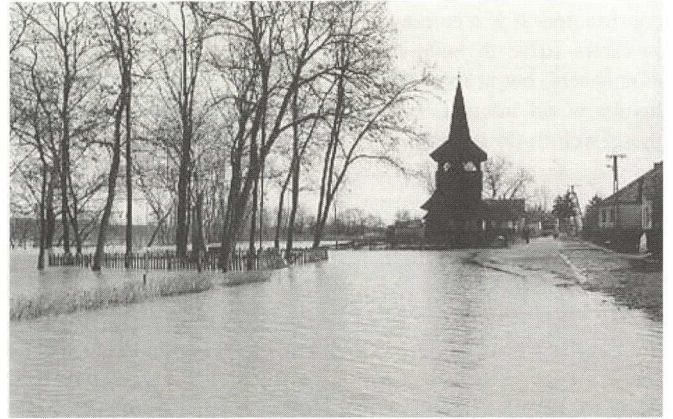
In addition, the flood has affected historic buildings. Mainly vernacular heritage was damaged, encompassing some 55 buildings. The walls of these houses were made of adobe, so they had little resistance to water. The National Office of Cultural Heritage has taken part in the reconstruction work, mainly in the preliminary arrangements, design and supervision, and partly in organisation and completion.

Tákos is flooded (Photo: István Szatmári)

Problems also occurred after the flood had receded, as the condition of the buildings continued to deteriorate because of the dampness of the ground. Unfortunately the available grants only covered the reconstruction costs of the residential buildings, although the outbuildings, stables or barns were of nearly the same value. Nevertheless, many of the refurbished residential buildings provide a higher level of comfort than before. Instead of being used as residences, some of them will serve for rural tourism in the future.

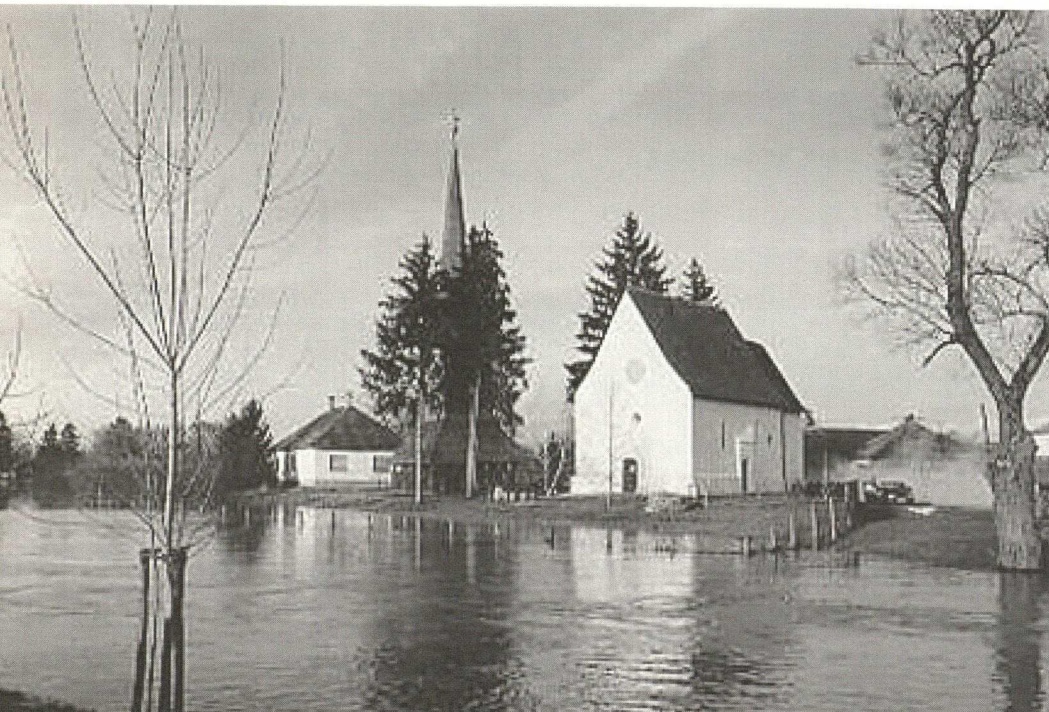
Vámosatya at the time of the flood  
(Photo: István Szatmári)
