PALESTINE

Destruction in the West Bank, April 2002

Old City of Nablus

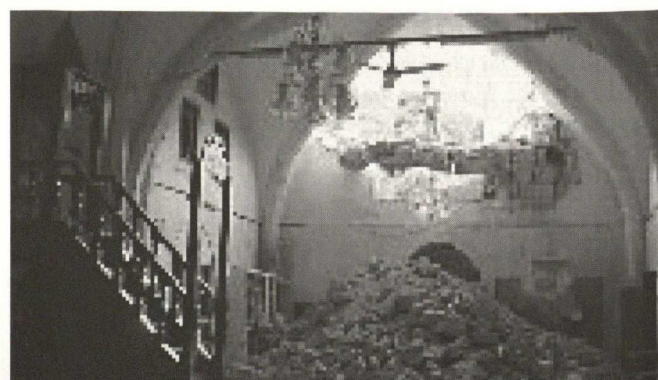
Al-Khadra Mosque

The oldest mosque in Nablus, Grade 4 damage. Originally a mosque that was converted into a church by Crusaders, it was converted back into a mosque in 1187. The mosque served the residential communities of Yasmeeeni and Qaryoun quarters in the Old City. Its features were a Mamluk minaret, simple but rich layout, intricate stone detailing and handmade wooden doors. The squared minaret built by the Mamluks was located near the original building, one of only two such monumental minarets existing in Palestine. Large parts of the mosque, including the main prayer hall of 150 square metres, were destroyed by Israeli tank fire followed by

a bulldozer that demolished the main façade, two-metre thick walls and caused partial roof collapse at the western side, affecting the stability of the building and threatening the safety of nearby residential structures.

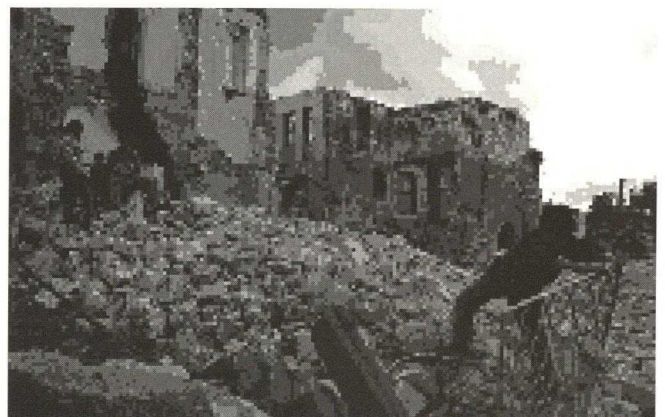
Al-Kannan soap factory site

Ottoman-era building, Grade 5 total destruction. Located near the main western entry to the old city, the site contained two olive-oil soap factories (al-Kannan and al-Nabulsi) and a group of houses belonging to eight families. The Kannan factory was hit by helicopter 'smart' bombs and totally burnt. The destroyed factories were two of the city's 30 famous 18th-century soap factories. The destruction affected 3500 square metres of built-up area in adjacent buildings and affects the structural stability of the residential blocks around the site. Two other soap factories were partially demolished: the Abu Shamat family factory was hit by tank shells that damaged the external walls, and the free-standing Masri family factory (built in 1890) was totally burnt from tank shells. Explosives were also placed inside the buildings.

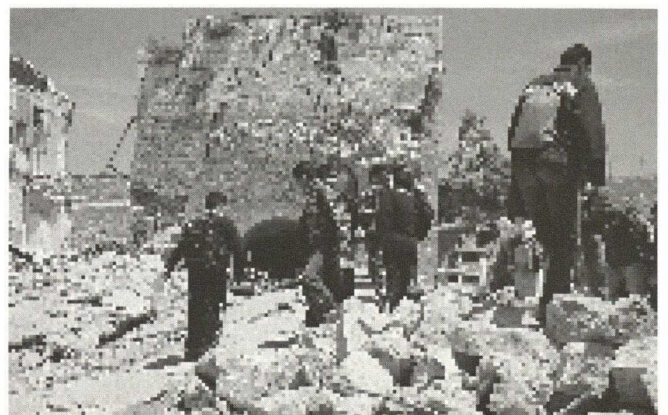
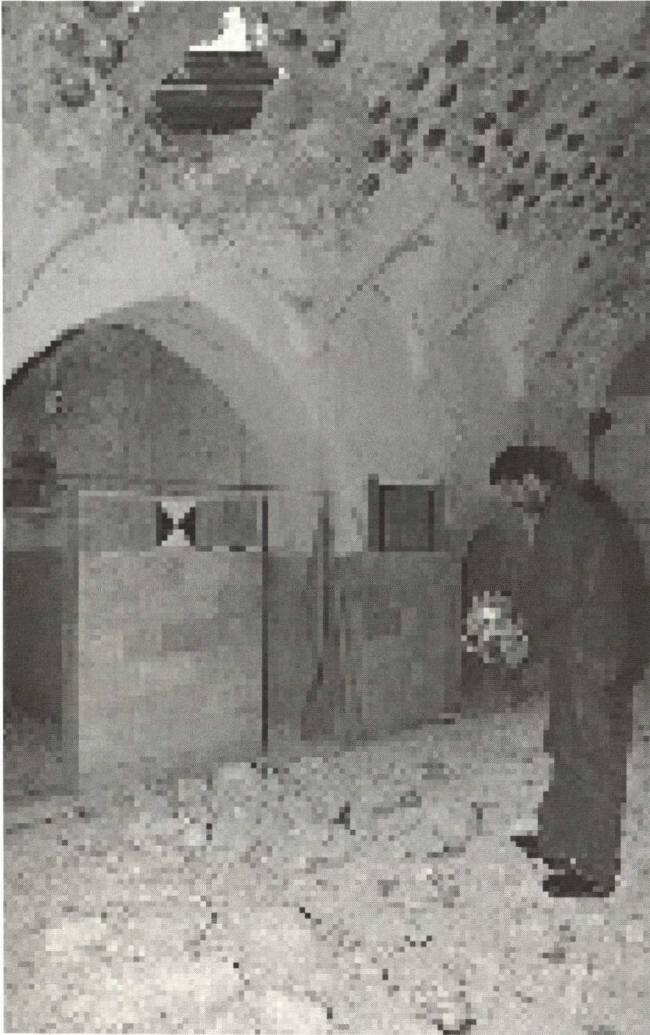
Al-Jadedeh (al-Shifa) Hammam

Ottoman-era Turkish bathhouse (built in 1720), Grade 3, partial damage. The structure, which is of historical and architectural value (built in 1790), was restored in 1992 and is one of only two baths that continues to function in the old city for social gatherings. Two helicopter 'smart' bombs hit the main hot bathing room of the hammam, creating large holes in the vaulted roof. The damage has seriously affected the stability of the historical structure and its unique architectural design.

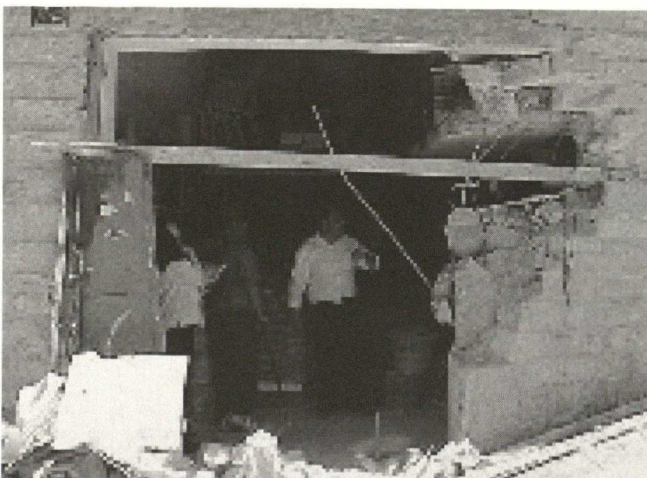
Bethlehem, the Church of the Nativity

The Church of the Nativity complex, where Palestinians had sought refuge from the attacks, was damaged by bullets, fire and one missile, but was probably saved from more serious damage by the widespread interest and appeals made by the international community. Within the church itself, wall mosaics, the roof and the external upper façade of the central nave suffered bullet hits that caused holes of up to 3 x 10 centimetres in diameter. In the Franciscan convent within the complex, damage was confined to pavement, plaster, frames, doors, electrical system, lighting system and walls. The external stone façade was blackened by smoke. A marble statue in the Church of St. Catherine and St. Jerome's cloister courtyard was damaged by bullets.

In the Greek convent within the complex, a missile hit a double cross vaulted room, damaged window frames and the base of the arch in the cross vault, causing a 20-centimetre hole. On the upper floor, three rooms and a staircase were seriously damaged by fire; there was also fire damage to wooden doors, handrails, plaster, pavement, windows, and walls in the rest of the structure. In one room an ancient painting and furniture were damaged. Bullets gouged holes (10 x 5 centimetres) in the external southern and eastern façades of the tower.
