TURKEY

Recent publications about Heritage at Risk in Turkey

Early Christian and Byzantine Sites in coastal South Western Anatolia at Risk

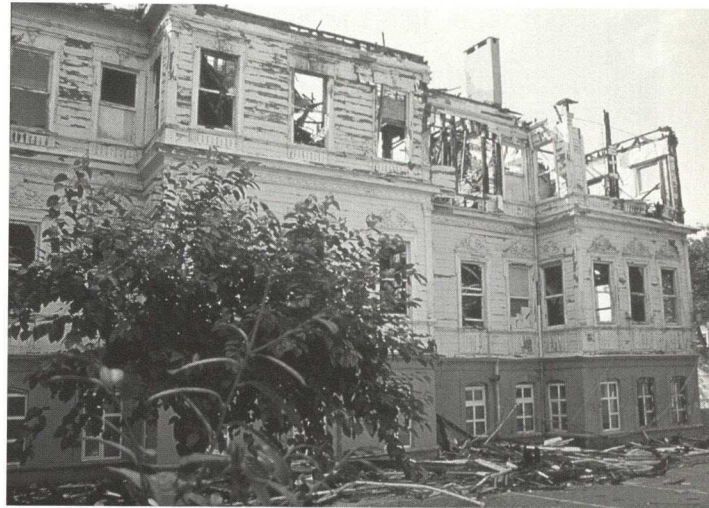
Late 19th-century timber palace on the Bosphorus, Istanbul, devastated by fire. Electrical installations in historic buildings are often the cause of such losses. Used as a public school, the building was suffering from lack of funds for its maintenance.

Timber is the traditional material for houses in many parts of Turkey. If they are not maintained properly, timber structures become very fragile. Many are suffering from neglect and misuse. Several fires – some intentional, some due to old and badly maintained electrical installations – ruin historic timber houses. Recently a 19th-century Bosphorus mansion that was being used as a primary school burned due to badly maintained electrical installation. The improvement of old electrical systems is essential for old timber buildings.

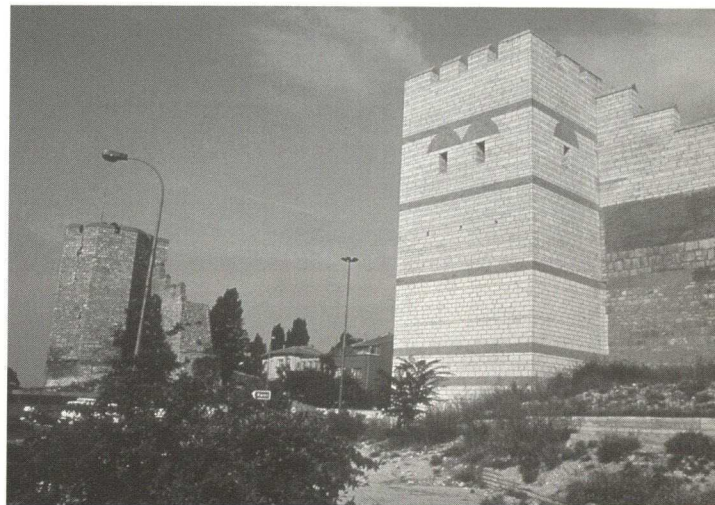
Tower 89 of the Theodosian Wall had suffered from the earthquake in 1999 (see *Heritage at Risk 2000* for a photo of the damaged state). The vestiges were not enough for a proper reconstruction. A new tower has been recreated, reducing the significance and legibility of the ancient remains.

Several towers and wall sections of the Theodosian Wall in Istanbul were damaged during the 1999 earthquake. The restoration of Tower 89, which was taken up by the Municipality of Istanbul, is another example of bad restoration practice. The problems of authenticity and preservation of historic evidence need to be discussed, because the tower was reconstructed to its full height with a completely new façade.

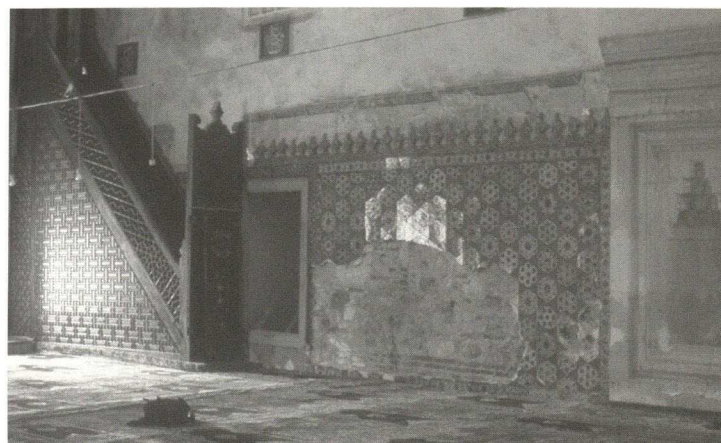
The mosque of Murat II in Edirne is a 15th-century monument, famous for the beautiful glazed tiles on its walls. The artistic impact of the mosque had been greatly damaged by the looting of its beautiful tiles. (Photo: Dr. Yegan Kashya)

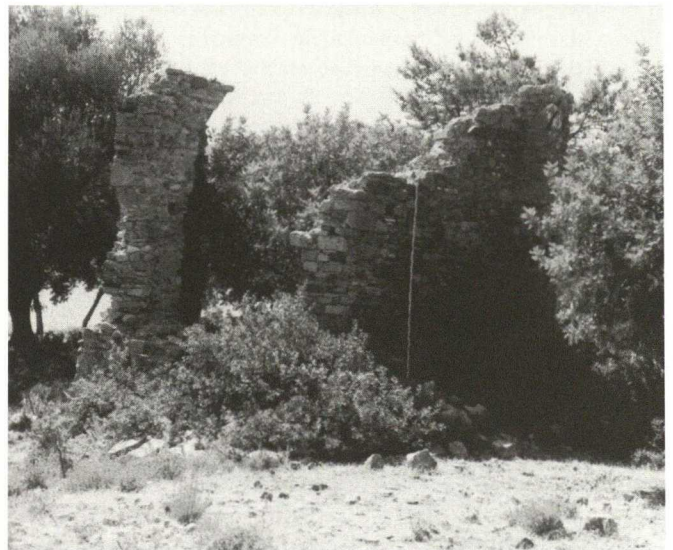
Ala Kilise II, basilica – polygonal apse, view from the east

The ruins of the second big church of the city are situated in the eastern part of the bay, also directly behind the shore. The building must also once have been a three-aisled basilica – appearing outside with a polygonal apse – in the west it still possesses a tiny annexed building with a square plan, which is still covered by its original dome and a fragmentary cover of frescoed wall paintings of the late 5th or the 6th century. Here we find remains of a circle of saints, and at other parts of the walls we find the fragmental paintings of Jesus and the apostles, Emperor Constantine's mother Helena and others. Apart from the baptistery of Gököy (north of Bodrum), this small building is one of the earliest early Christian domed buildings preserved and known in this part of Anatolia. It was probably used as a funeral chapel. However, on the near island of Kös we find exactly this small building type, which here was often used as a baptistery. Eastward of the church a group of small, barrel-vaulted tombs can be found. At the much smaller neighbourhood bay of Şeytan Bükü, some kilometres to the east, a small monastery basilica, a tomb and another bath ruin can be found, belonging to the same period of construction. The whole site is in great danger of being built-over as a holiday resort village by a European hotel group. Additionally uncontrolled tourist activities are causing destruction of the masonry of the buildings and the late ancient wall-paintings still preserved in the churches and their annexed buildings of this site. Also, a hotel

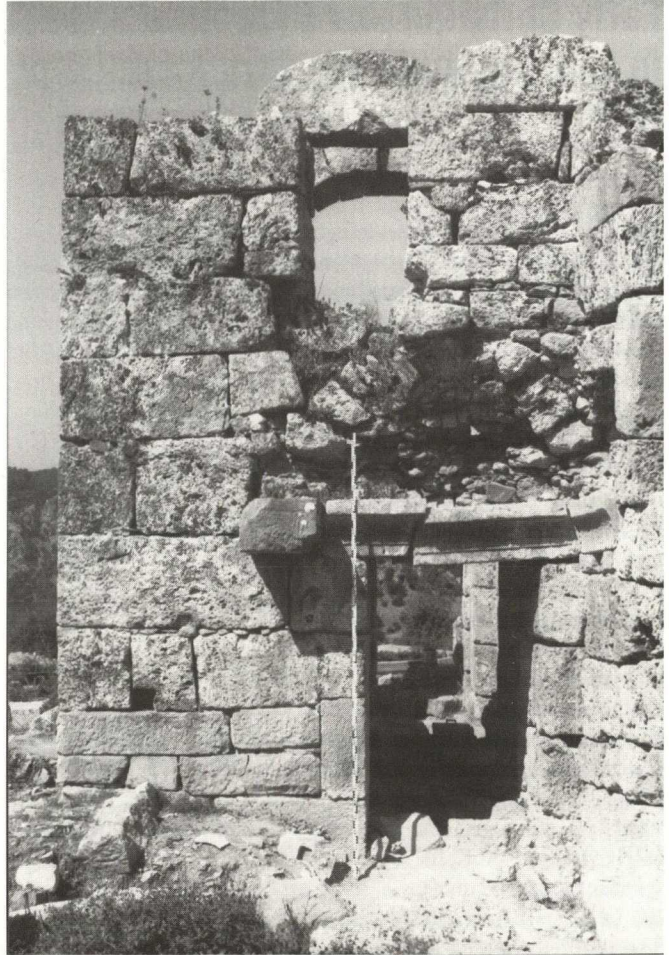
Kaunos (Hagia), domed basilica, southern aisle, eastern door – cracked lintel

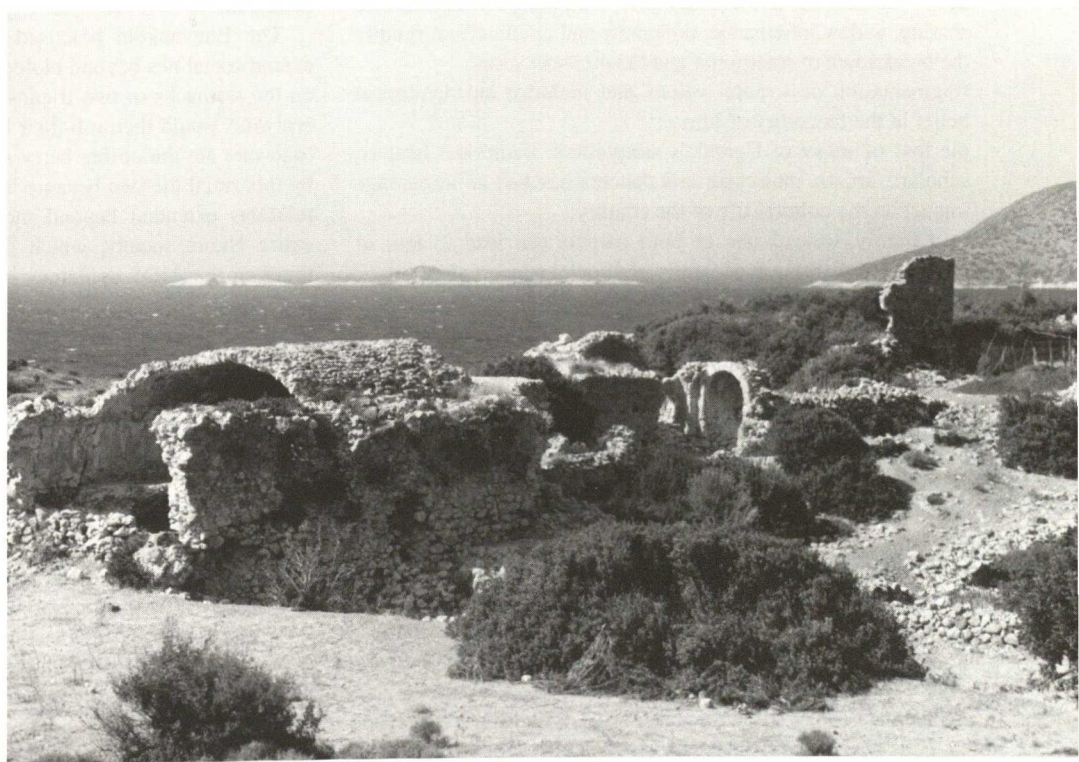
Değirmen Bükü, middle Byzantine settlement with church ruin – view towards the east

A Middle Age Byzantine church ruin is found at Değirmen Bükü, located on the far western peninsula of Stadia (Datça) in the territory of the polis of Knidos, at the harbour of the village of Yazı Köyü. The church was most probably erected in the 11th or 12th century, and is preserved at the western part of the bay on a narrow hill behind the shore. It is still partly closed with cloister-vaults,

which are in great danger of collapsing. In addition, a large Byzantine barrel-vaulted building is situated westward of the church, which may have belonged to a contemporary settlement. The site is dominated by the ruin of a large Roman bath, which was erected in the direct neighbourhood of the site of the ancient harbour city Knidos.
