BULGARIA

Thracian Tomb in the 'Shishmanets' Sepulchral Tumulus

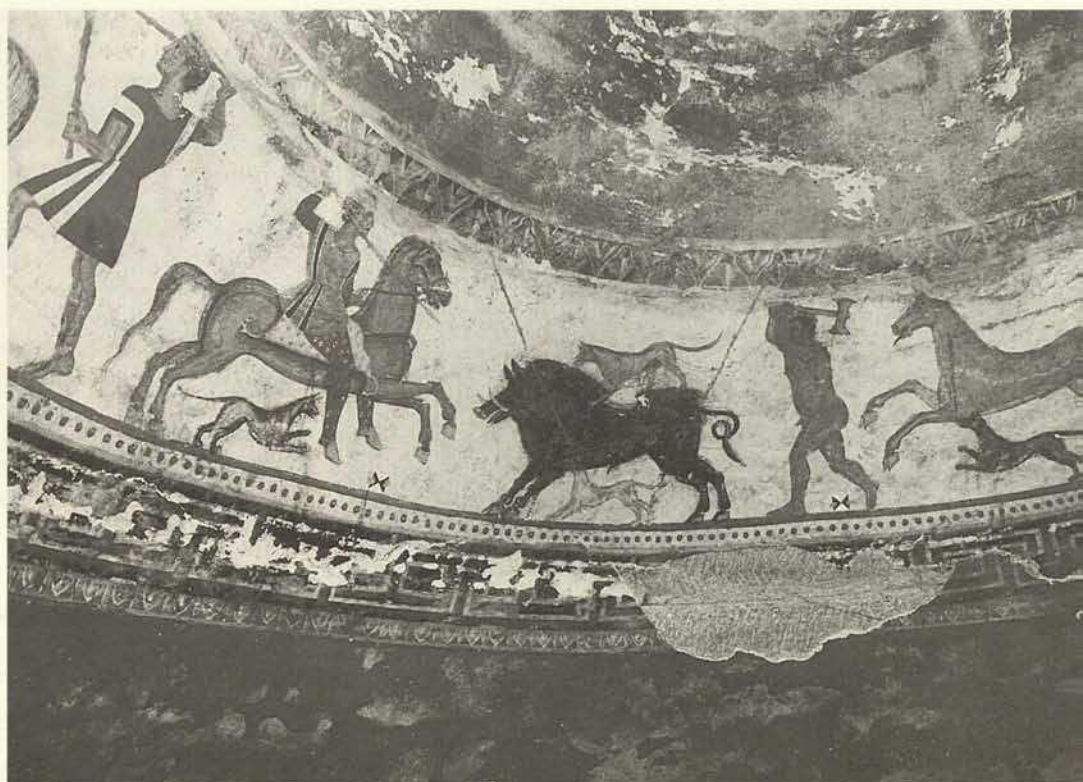
Thracian cemetery near the village of Alexandrovo

The portal and the round chamber are constructed of precisely processed quadras with dry joints, with carefully polished and fitted stone-fronts. Despite some deformities, the structure is in a stable condition. On the floor, pieces of stone doors to the two premises can be seen. The dromos is built of roughly processed stones bearing traces of paint and is covered with large stone tiles, which are preserved. The small portal is shaped as a rectangular chamber covered with a false arch, which is coated and painted entirely. The round cemetery chamber is covered with a false dome and is also entirely painted.

The initial survey suggests that the murals are of exceptionally high quality in terms of their stylistic, iconographic and artistic character. Murals are preserved in the three premises, though in various degrees. In the dromos (in its preserved end) scarce remains of the coating and painting are preserved. The walls of the portal are covered with decoration of multiple colours (about 50% preserved), whereas the two lunettes under the vault have human and animal-figure compositions with the western one preserved in full: a fight between an equestrian and a foot soldier. The round chamber bears the richest decoration, which is structured in layers of various height from bottom to top: a figural frieze in a very poor condition (about 15% preserved) and an almost illegible monochromatic layer; a comparatively well preserved high footing in Pompeian red; a three-division eave; a second, almost fully pre-

As a first step, urgent measures are required to stop the destructive processes observable in the painting layer at its base, and to implement a reliable and permanent protection for the cemetery from harmful atmospheric influences and ill-minded visitors (for the time being only provisory protection/security is provided). This needs to be followed by a programme of systematic activities for research, preservation and exposure of the cemetery.

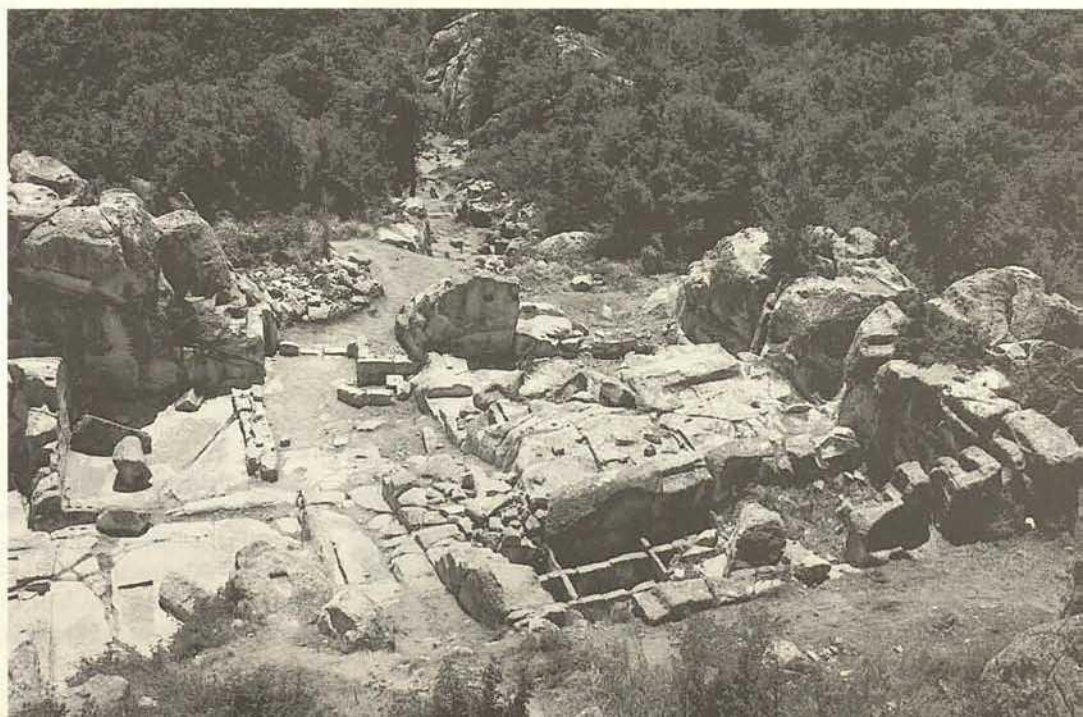
The ancient medieval fortress of Perpericon

The Fortress is located on a broad and not very high rocky hill, with the citadel erected on the summit. The site of the castle is immediately below, and the substructure is located on the lower flat terrace. In the valley, beneath the Fortress, the remains of a mediaeval monastery were discovered, which, according to existing data, had been an important religious-worship and military centre.

- completion of exploration, and documentation and publication of results;
- emergency preservation works and the installation of protective covers;
- preparation of a preservation and restoration plan to restore and stabilise the gate approach and the surrounding area to facilitate exposure and public visitation.

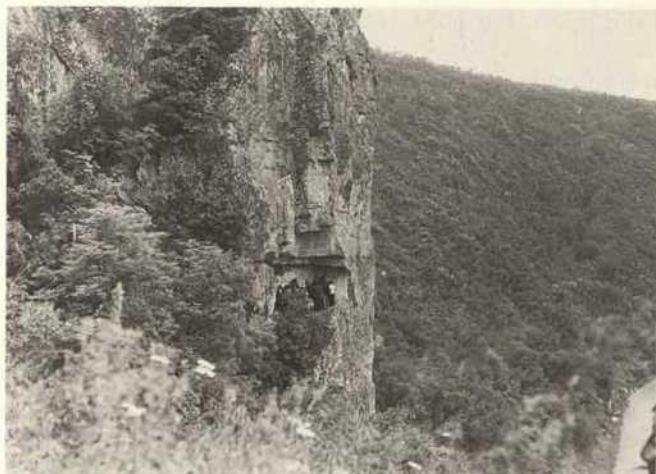
The Madara Horseman (Madarski Konnik)

Severe damage is evident, partly as a result of the continuous

process of natural destruction. The site requires measures for consolidation of the rock massif on which the relief has been cut, as well as consolidation of the relief itself and the adjacent inscriptions. An important problem to be resolved involves finding the best possible technical solution to provide maximum protection of the relief from the direct influence of destructive agents.

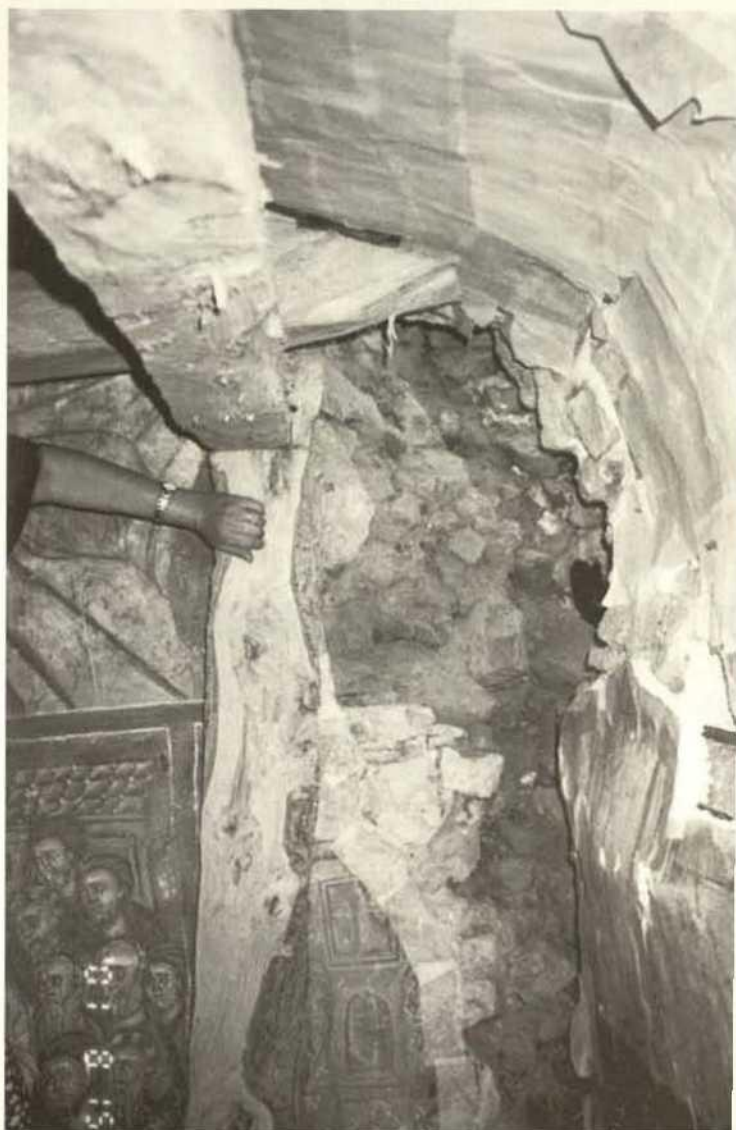
St. Dimitar Church in Boboshevo

The physical state of the monument today is desperate, which is the reason the spiritual and cultural values have been inaccessible to pilgrims and tourists for a long period of time. Although some attempts at consolidation were completed about 50 years ago, a late and inauthentic narthex and façades were added. The building is listed by the Bulgarian Ministry of Culture as a monument in a threatened state. Just a few months ago urgent work to support the vault was undertaken.

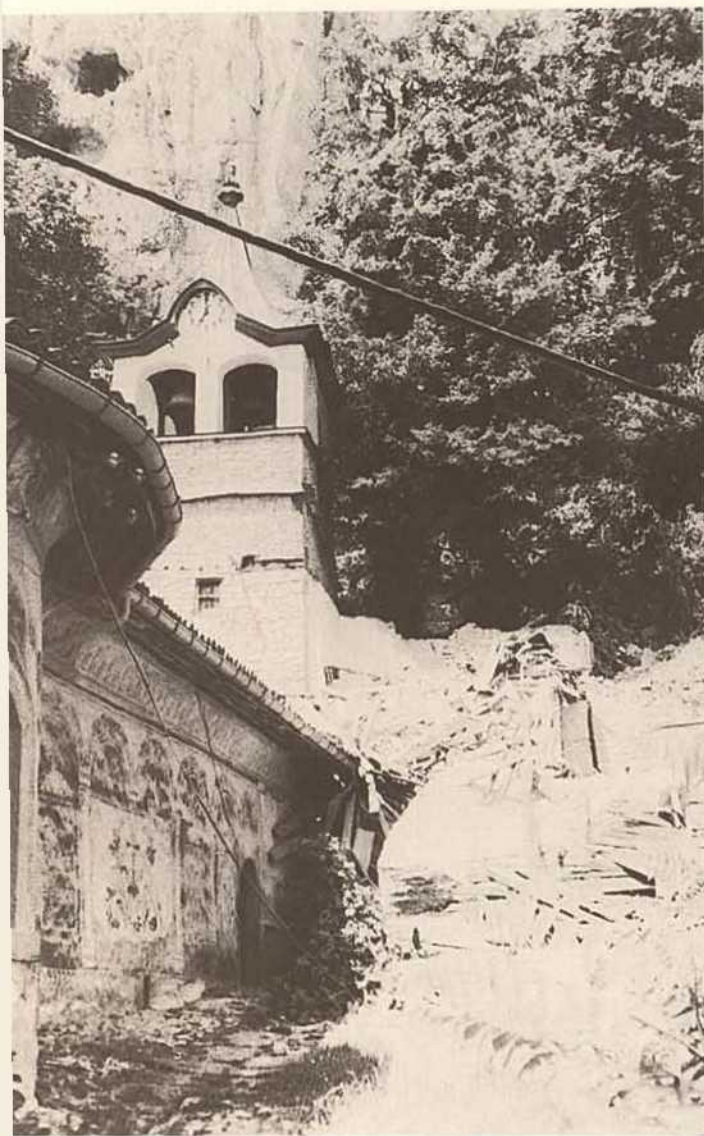
The Probrszenski monastery

The site has suffered severe damage – throughout the years the

church has been partially destroyed, as a result of slides of the terrain over the Monastery in the 1970s and of rock-caving in the terrain below the monastery in 1992. It requires urgent consolidation measures, commencing with a need to strengthen and stabilise the terrain. Partial reconstruction of the destroyed features should also be carried out as soon as possible. The next step should be the total reconstruction of the church – architectural-construction as well as restoration of both the immovable decoration of the monument (the wall paintings) and the movable decoration (such as iconostasis and icons).

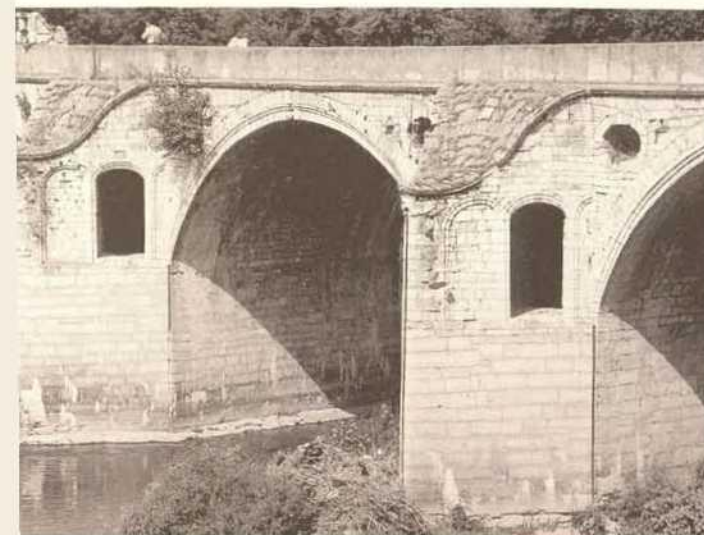
Bridge over the Yantra River

Severe damage has occurred throughout the years – in 1897 there was a flood and eight domes in the middle part of the bridge (about 130 metres) were destroyed. In 1922/23 the bridge was reconstructed with steel concrete pillars and domes, but its original design was changed; the new part is of low aesthetic value. When a new bridge was constructed nearby, the track of the main road was diverted and the old bridge was closed to cars and is now used only by pedestrians. The preserved original parts – the eastern section with a length of 78 metres and the western section as long as 64 metres – are severely damaged; the stone coating and the plastic decoration of the original parts of the bridge are severely eroded.

It requires urgent measures for consolidation of the construction. The project design includes constructional strengthening and hydro-insulation protection of the original parts. In addition, the part of the bridge that was reconstructed in 1922/23 (a length of around 130 metres) has to be dismantled and reconstructed following the original design of the monument. The following stage should incorporate complete restoration work on the frontage and the sculpture elements forming the stone plastic of the original parts.

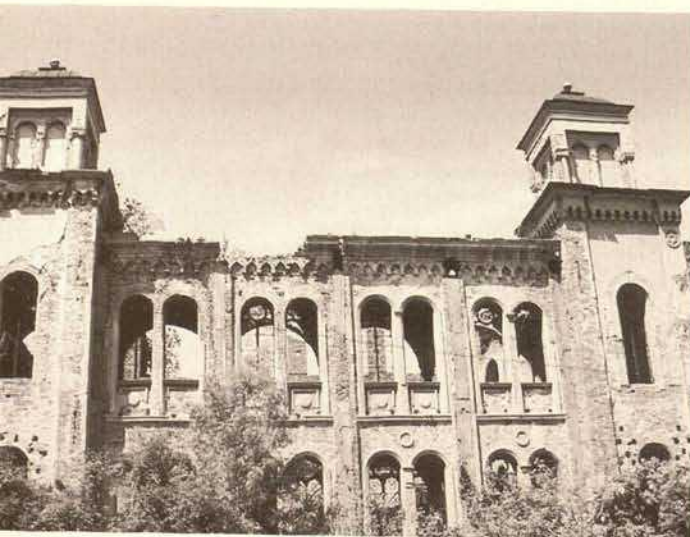
The Synagogue in Vidin

The building is in an exceptionally deplorable condition: without roof or windows and with progressive erosion processes affecting the brickwork. The monument needs urgent measures to prevent the ongoing destructive processes: structural reinforcement, consolidation of the erected structure, roofing and window

replacement (pending the reconstruction of the missing leaded panels). Following this, it will be necessary to draw and implement plans for the overall preservation, restoration and socialisation of the building (possibly as a multifunctional cultural centre) in order for this remarkable monument to be actively integrated in the most prestigious part of the Danube city.
