GEORGIA

The case studies that follow have been selected to highlight different risk categories:

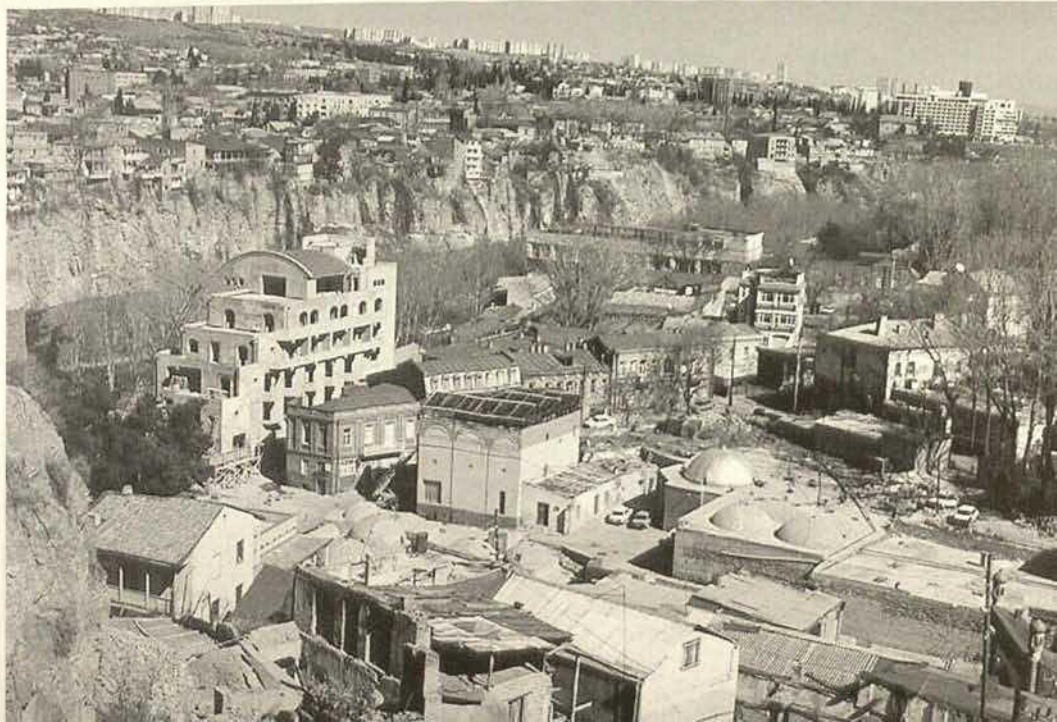
Brutal interventions in the historic urban fabric of Tbilisi

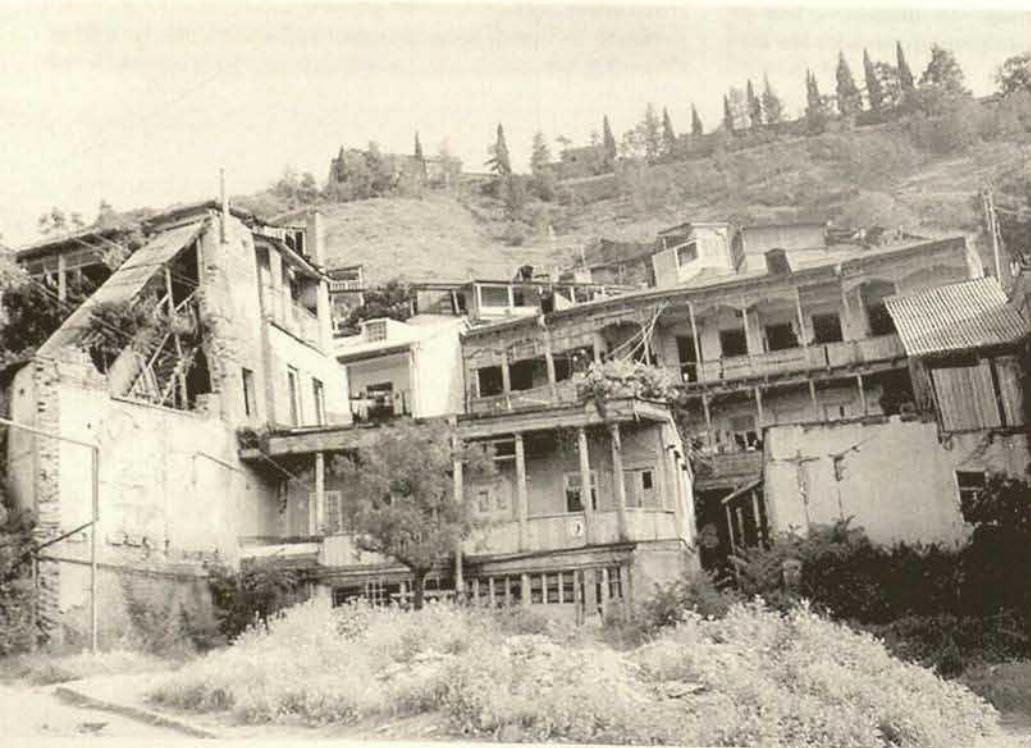
State of listed historic buildings in one part of Tbilisi historic district

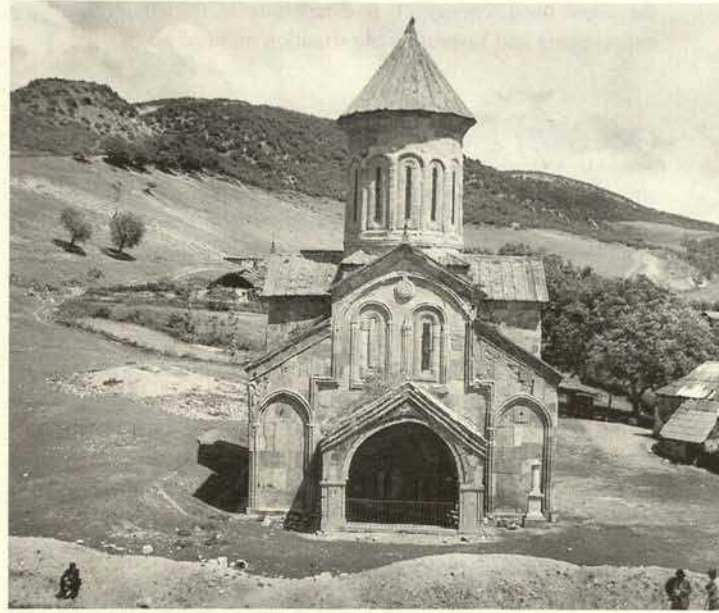
Ikorta church of the Archangel before the earthquake

Ikorta church of the Archangel after the earthquake

The 1991 earthquake in Georgia greatly damaged the church: the walls were deformed, perforating cracks have emerged, facing masonry has fallen off and is weakened in many places; due to great deformation, fragments of the vault, pendants and supporting piers have collapsed; vaults of the southern and western cross-arms were severely damaged; the structural stability of the church interior had decreased to a great extent; a large portion of the dome (approximately one-quarter) had collapsed in its western part, damaging roofs and roofing constructions of the western and southern cross-arms. In the following years, preparatory conservation works conducted by the Main Board for the Protection and Utilisation of the Monuments of History and Culture of Georgia and supported by the local authorities were initiated on the site – metal scaffolds were arranged in the western and eastern parts of the church. The situation was aggravated by the repeated subsoil tremors, due to which another large part of the preserved dome collapsed and deep vertical cracks emerged on the extant dome. Collapsed dome fragments damaged metal scaffolds and the roofing of western and southern cross-arms; the pediment of the southern cross-arm was completely destroyed, and interior construction details and architectural fragments were damaged.

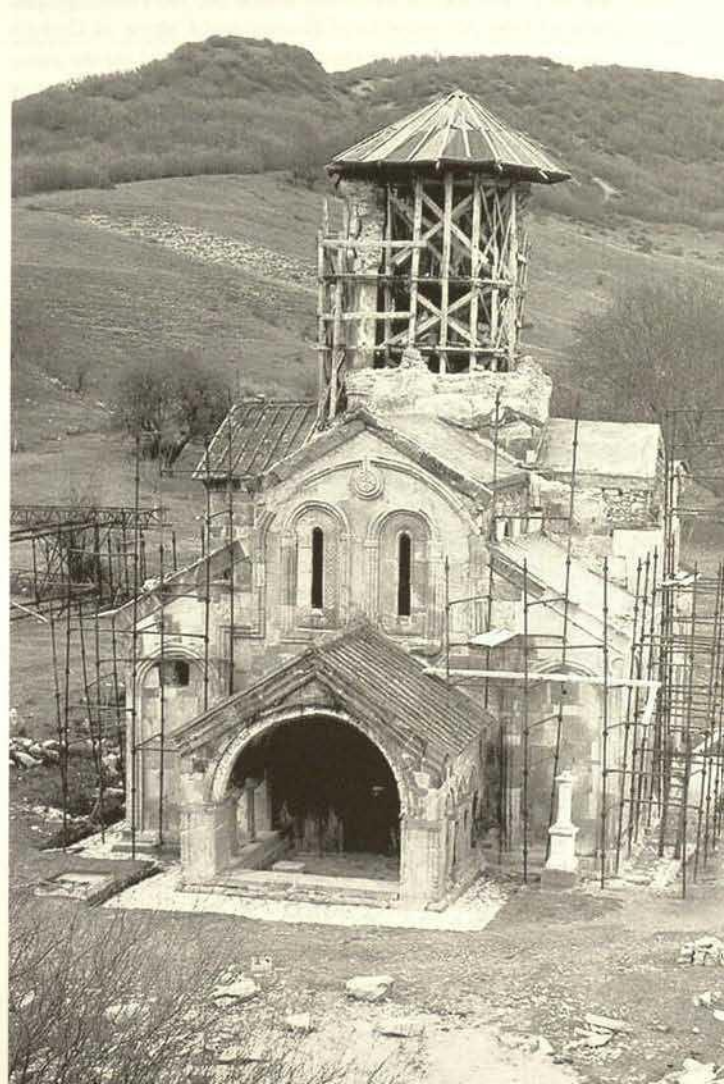
Ikorta church of the Archangel during restoration

site. In 1999 with financial support from the Open Society Georgia Foundation (Soros Foundation – US \$9,500 grant) protecting wooden-scaffoldings were arranged in the interior, deformed exterior metal-scaffoldings damaging the site were removed, the interior and roofs were cleaned of fallen stones, and a temporary roofing ('umbrella') was arranged in order to safeguard interior mural paintings.

In 2000 a grant of US \$65,080 was allocated through the Emergency Rehabilitation Programme of the Fund for Protection of Cultural Heritage of Georgia for works to reinforce the main body of the church (up to the dome), based on the prepared conservation project.

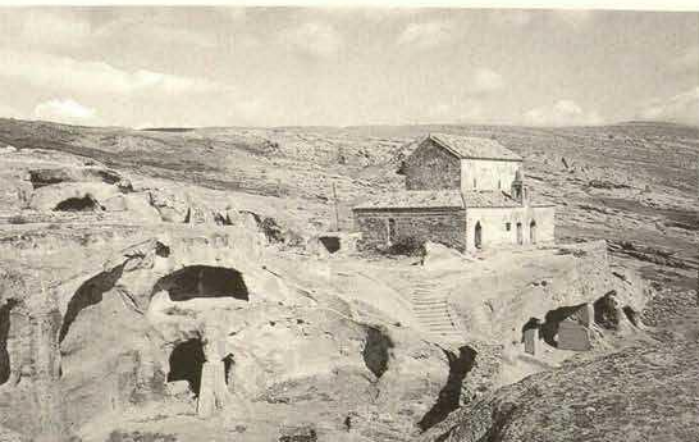
Uplistsikhe rock-cut complex

The physical state of the site is under substantial threat: cracks resulting from intensive physical, chemical and biological deterioration have disintegrated rock massifs. Disintegration processes are of varied intensity in different areas of the site. Several parts of the most vulnerable areas were completely destroyed by an earthquake in 2000.

Because the physical stabilisation of the site is linked with complicated technical and technological problems, in 2000 the Fund for Preservation of Cultural Heritage of Georgia (a joint programme of the World Bank and Government of Georgia) financed the development of a concept plan to safeguard and consolidate the Uplistsikhe complex. Based on the geo-physical study, a pilot project was prepared, which envisages the use of a method of anchor joints and crack cementation. In order to ensure hydro-insulation of the caves, 'eco-friendly' materials were identified.
