ITALY

Case Study 1: Reconstruction of Towns and Villages in Umbria, Destroyed or Damaged by the Earthquake of 1997

Case Study 2: Paestum

Case Study 3: Herculaneum

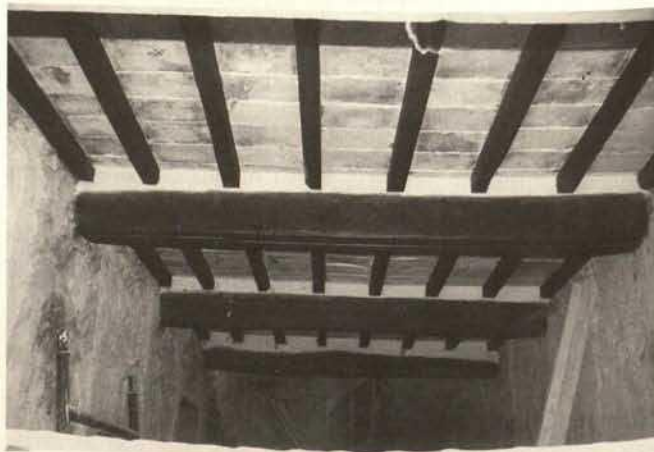
Massa Martama: Despite strict earthquake protection measures this historic wooden ceiling with brick elements could remain in situ

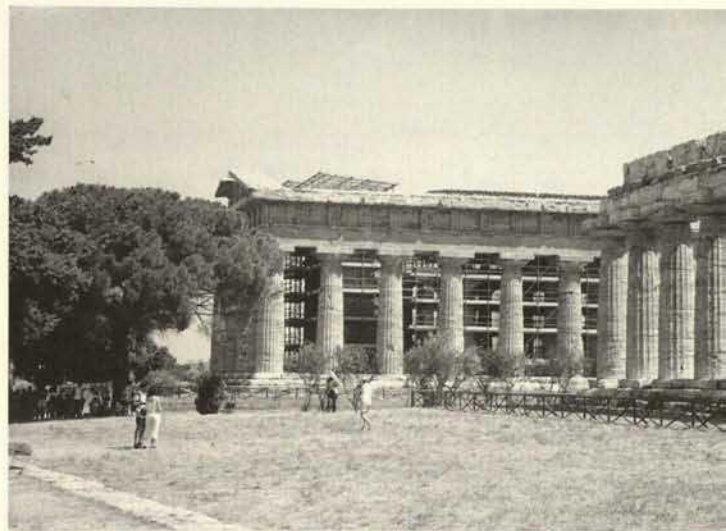
Paestum, "Tempio di Nettuno", interior still in scaffolding, and Basilica with protective fence

Temple of Poseidon (tempio di Nettuno), built around 450 BC and originally consecrated to Hera, is still in scaffolding inside – the building site (including the scaffolds) making a positive impression.

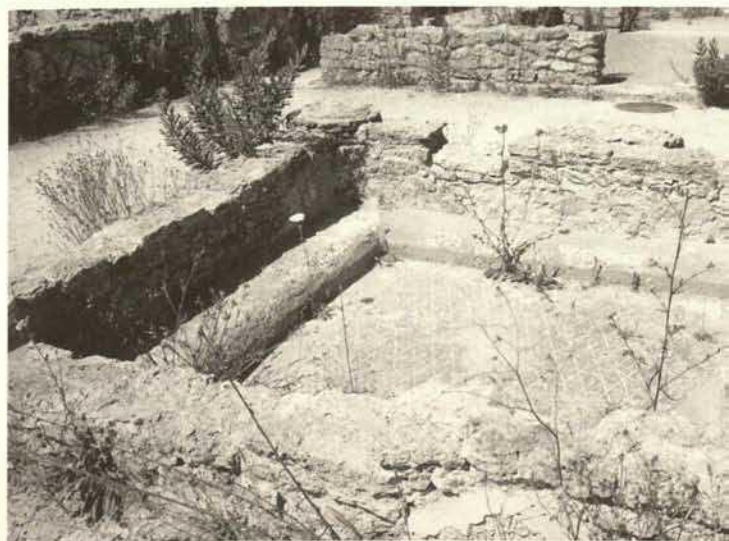
Paestum, water basin in the former atrium of a Roman house: damaged covering of the wall crests, destroyed antique plaster, broken mosaic floor, extensive plant growth

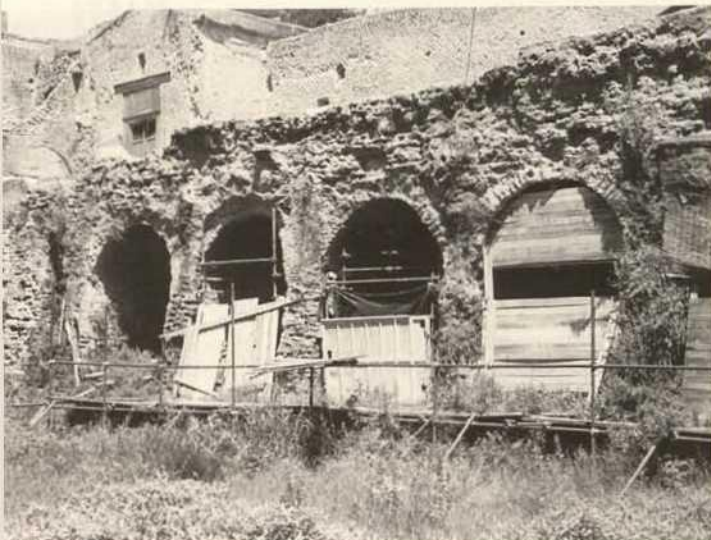
Herculaneum, former shore front underneath the "Area Sacra" (entrance to the excavation)

Immediately, at the beginning of a visit, one is shocked by the state of the substructure in the 'area sacra' and of the terrace with the altar of M. Nonio Balbo, considering that in 1981 well-preserved remains of more than 250 people were discovered here at what is the former coastline of the Mediterranean. These people died of hot gases when they sought shelter from the eruptions of Vesuvius in the vaults open to the sea.

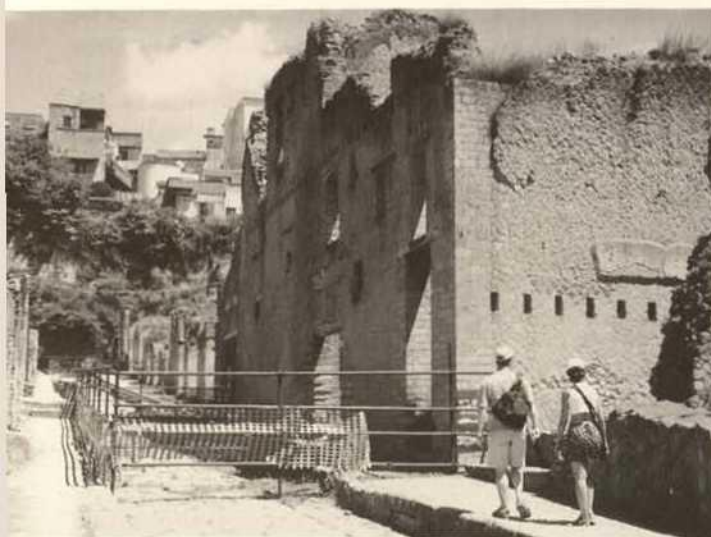
Herculaneum, 5th Cardo with street front of the vestibule of the Palestra in danger of collapse

restored; on the opposite, south-east side of the street is the large complex of the 'palestra' and the 'sala absidiata', with shops and workshops in front. Here, the decay caused by growth and damp walls is particularly severe. Pictures in the *Itinerario* of 1997 show buildings that are intact and rooms that are accessible; today the 5th Cardo is blocked off, the two-storey front of the buildings is threatened by collapse, at the rear most of the modern roofs have already collapsed or are badly damaged, the plant growth continuing unhindered. Apart from street barriers for the protection of visitors, no emergency measures can be seen.

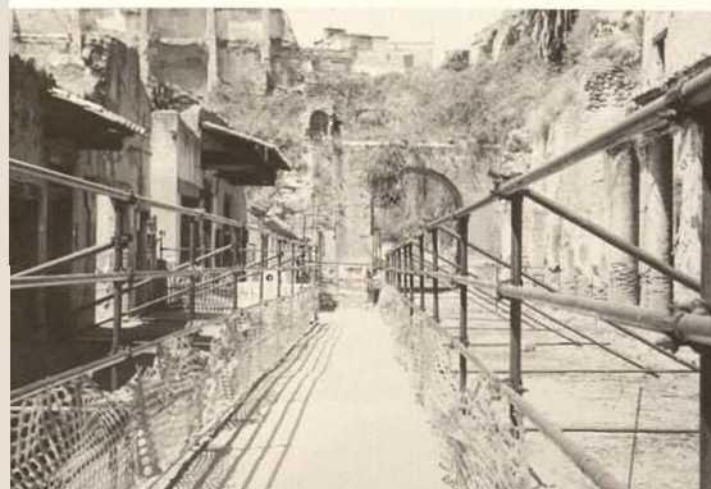
Both sides of the building fronts of the Decumano Massimo blocked off

are still intact and particularly impressive for the many (sometimes even wooden) details in the shops and entrances to the houses. Today both rows of buildings are blocked off by steel scaffolds, with only a narrow lane for tourists kept open in the middle of the wide 'decumano'. The buildings on the north-eastern side are not accessible, those on the south-western side only partly.

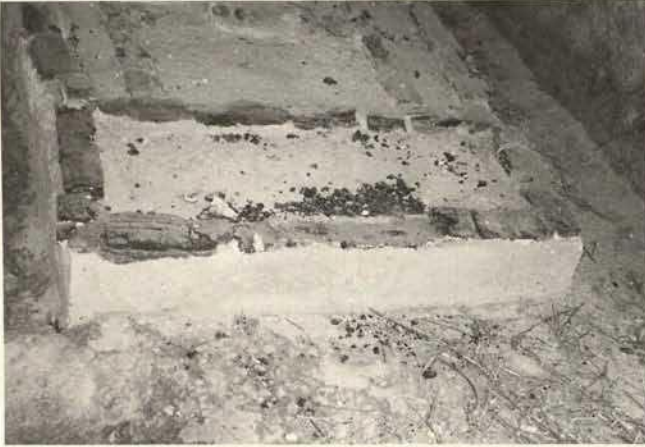
Casa del tramezzo di legno, crumbling wooden bed frame

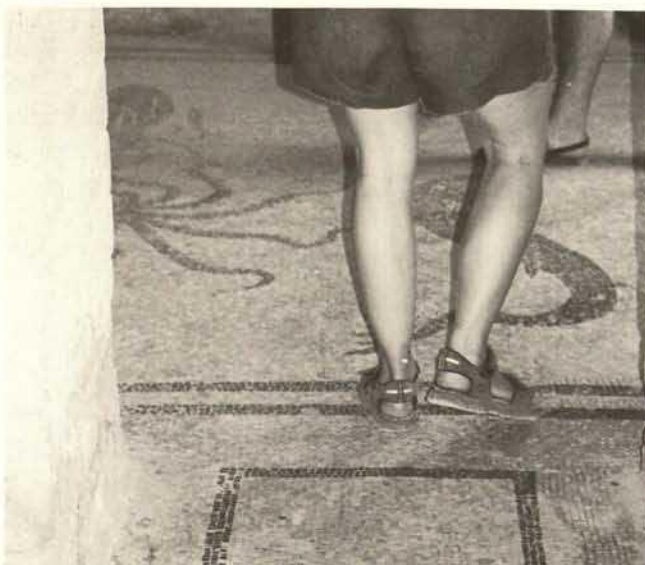
Women's changing room in the municipal bath: tourists are allowed to walk on the antique mosaic floors

A positive regulation in the 'Collegio' is that the central, richly painted room is not open to visitors, which is, however, an exception in Herculaneum. The standard is that tourists are allowed to walk on the antique floors – either composition or mosaic floors. Consequently, these floors suffer, especially since parts that are beginning to break off are not immediately repaired. An efficient and complete protection of the floors would not be easy to implement; some of the lavishly designed mosaics would not be entirely visible anymore, also the appearance and visual character of the rooms would be affected. But in many cases – at least where rooms are not passageways to others – a simple barrier at the entrance would be very effective, without impairing the visibility and appearance of the rooms. Of the 'first room on the real side' of the 'Casa del Atrio Corinzio' (House of the Corinthian Atrium) Mario Pagano writes in his *Itinerario*: 'beautiful mosaic floor with geometrical pattern'. With a barrier similar to that in the 'Collegio degli Augustali' this room could be viewed from the atrium and would have long-lasting protection.

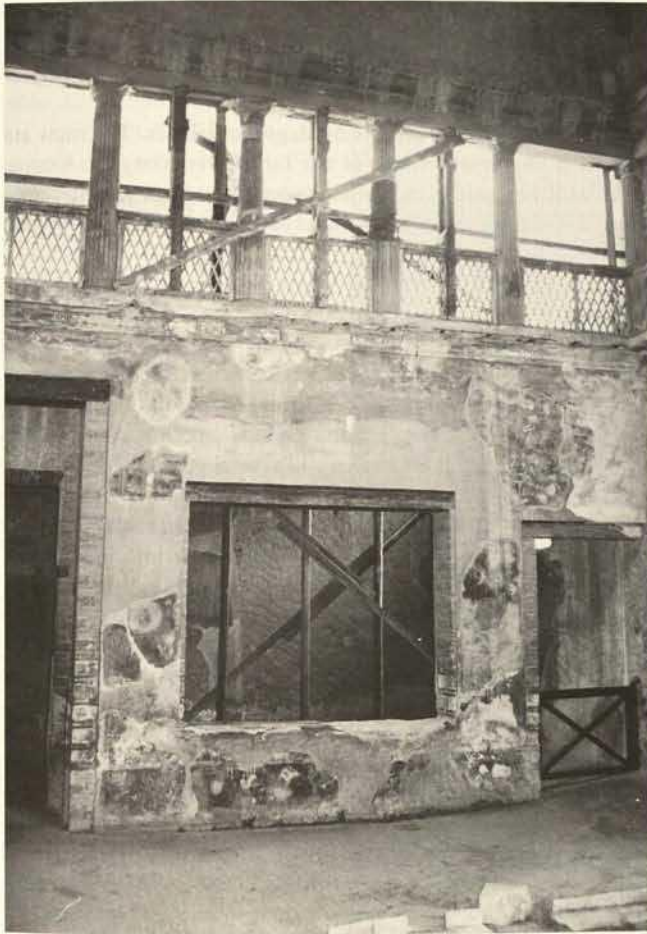
Casa sannitica: provisionally supported ceilings and severe water damages due to leaking roof

Among the particularly lamentable buildings is the 'Casa Sanitica' in the 4th Cardo, characterised by Mario Pagano as 'one of the best preserved and oldest (2nd century BC) houses in Herculaneum'. Today we see the most primitive supports for the modern ceiling above the ground floor and for the architrave of the loggia on the east side of the building. The walls show clear signs of water damage caused by leaking roofs and considerable damage to the plasters and paintings.

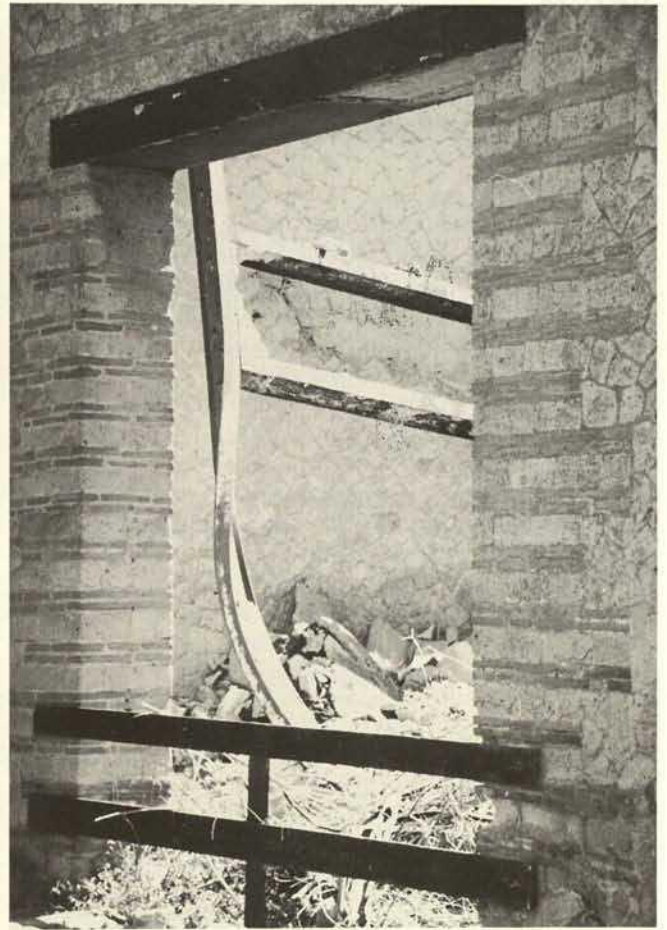
Casa dell'atrio a mosaico, salon facing the sea, collapsed modern ceiling

Regrettably, this negative picture could be extended. We would just like to mention the 'Casa del Atrio a Mosaico', described in the *Itinerario* as 'one of the most luxurious houses of Herculaneum'. The richly ornamented mosaic and marble floors are particularly remarkable, as is the wooden frame construction of the glassed-in veranda. Even in 1997 Mario Pagano wrote that it was only partly accessible because of danger of collapse. In the meantime, it has been closed entirely for visitors. The wooden frames are supported, otherwise no stabilising measures are noticeable. The modern steel ceiling above the big salons, which used to be open to the sea, has fallen down; the rich marble floor mentioned in the *Itinerario* is covered by rubble, and one can only guess as to the current state of the marvellous wall paintings. In view of this situation, the elaborately painted and durable sign warning people of the unsafe building seems a mockery.
