NICARAGUA

Cailagua, El Muerto and Montelimar: Nicaraguan Millenary Rock Art at Risk

ICOMOS Nicaragua

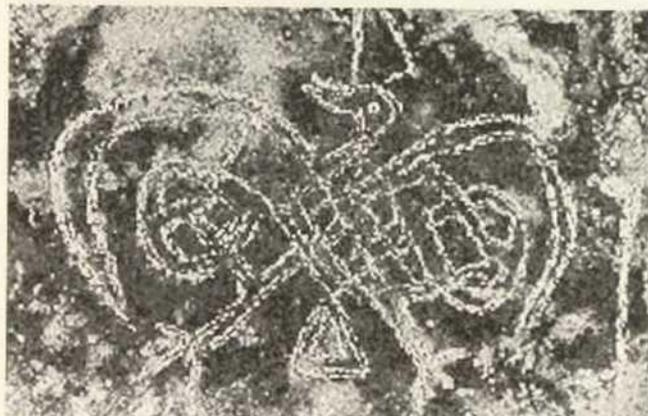
One of the Montelimar petroglyphs, with chalk

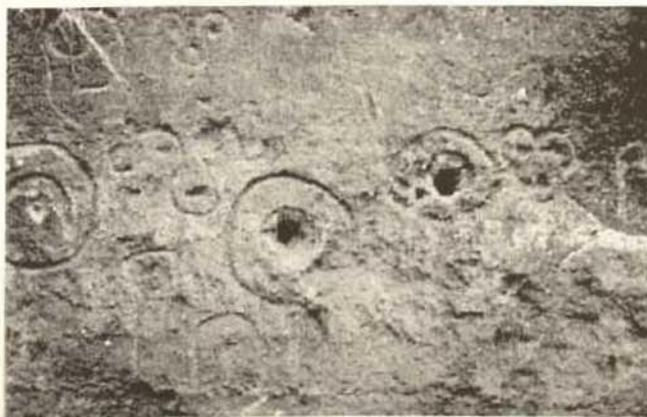
Evidence of vandalism and spalling on the Cailagua petroglyphs.

As early as 1852, Ephraim G. Squier, then United States of America's Chargé de Affaires for Central America, documented the Cailagua petroglyphs. They are distributed over more than 100 metres of tuff wall surfaces and are located along the Cailagua drainage creek. The designs are thought to have been made in several episodes, and may have served to record, commemorate or depict actual or mythical events. Sadly, there are two instances where modern day names have been carved alongside ancient petroglyphs.

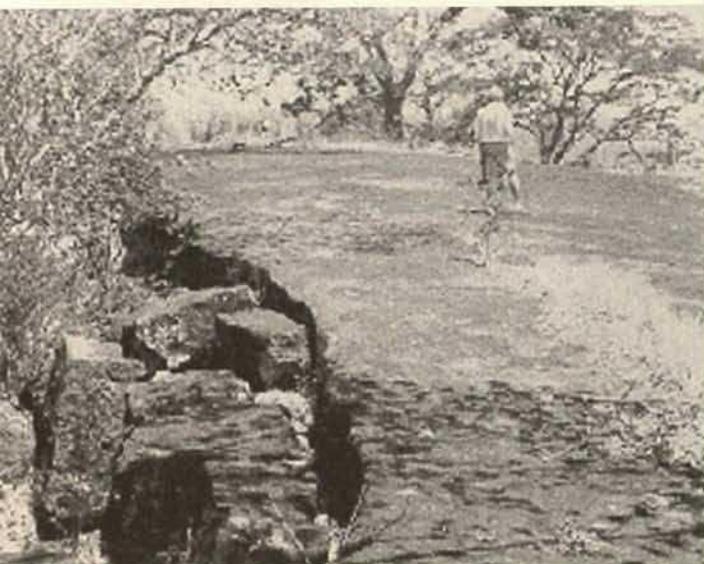
Blocks of tuffaceous layer breaking off as a result of erosion in the underlying soil layer at El Muerto

El Muerto Island is part of the Zapatera Archipelago near Granada. The island is located in Lake Nicaragua and is part of the Zapatera National Park. Ideally, national parks should be allocated the highest level of protection available. In reality, there are not enough resources available to closely supervise and protect the site, as the designation would require. The petroglyphs extend over a volcanic-tuff shelf that measures slightly more than 350 square metres (35 metres wide by 10 metres high). In the last few years, tourist traffic has increased substantially. As a result, the numerous visitors that walk on the petroglyph surface and trace the contours with chalk are adding to their degradation. In recent years the Pacific region of Nicaragua has experienced episodes of above-average precipitation. Because the tuff was deposited as ash atop a hill, differential erosion of the underlying soil matrix is undermining the integrity of the tuff layer, by allowing the more easily displaced organic soil to evacuate the area immediately underneath the tuff. The process results in the fracture and detachment of large blocks of tuff. Although the known petroglyphs have not yet been affected by the erosion of the underlying soil, within the next three to five seasons it is very likely that we would be witness to the irreversible destruction of these ancient wonders.

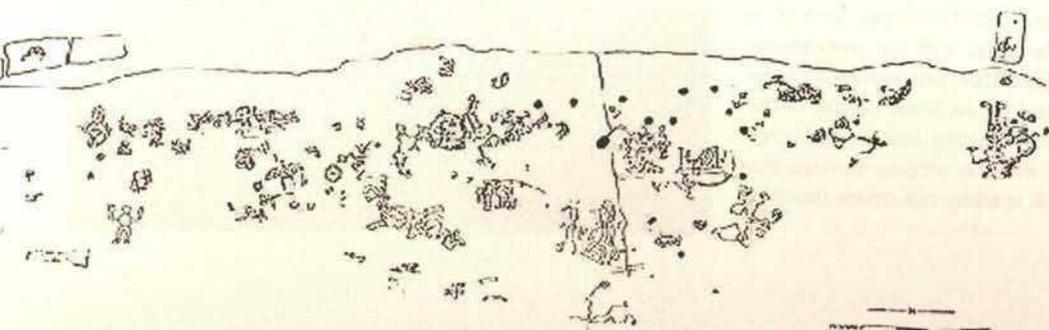
Isla El Muerto petroglyph ensemble. The engravings are all on the surface shown in the figure above.
