## PALESTINE

### Case Study: The Church of the Nativity in Bethlehem

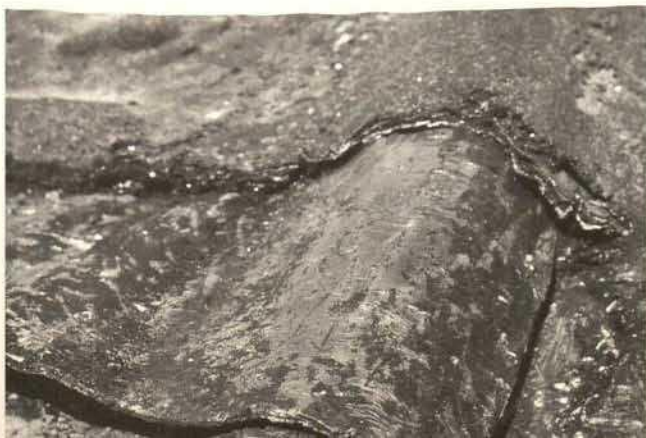
In the 15<sup>th</sup> century, timber for the repair and probably lead for covering the roof structure were shipped from Venice to the Holy Land. In the course of time the lead plates were covered with bituminous felt and recently with a white plastic coating.

Lead plates covered with bituminous felt

We recommended removing and cleaning the old lead plates, after which they be melted and, in a sand bed, new ones be re-cast out of the melted lead. We found out that parts of the loosened plaster can be fixed back to the walls and other parts are to be replaced. Further recommendations concern a roof and ground drainage system, lightning protection and the repair of the windows.

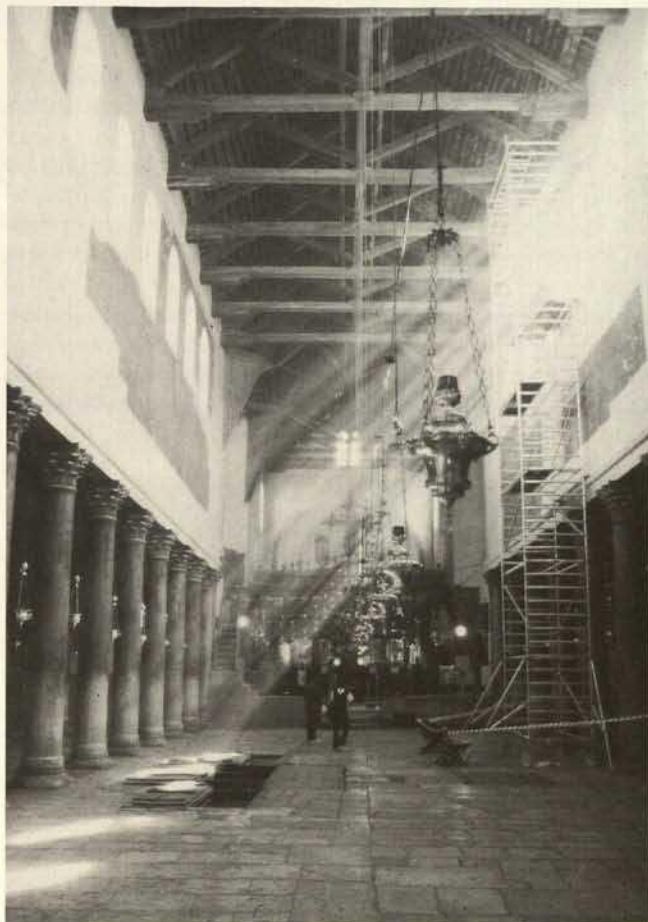
Wall plaster damaged by penetrating rainwater and condensation

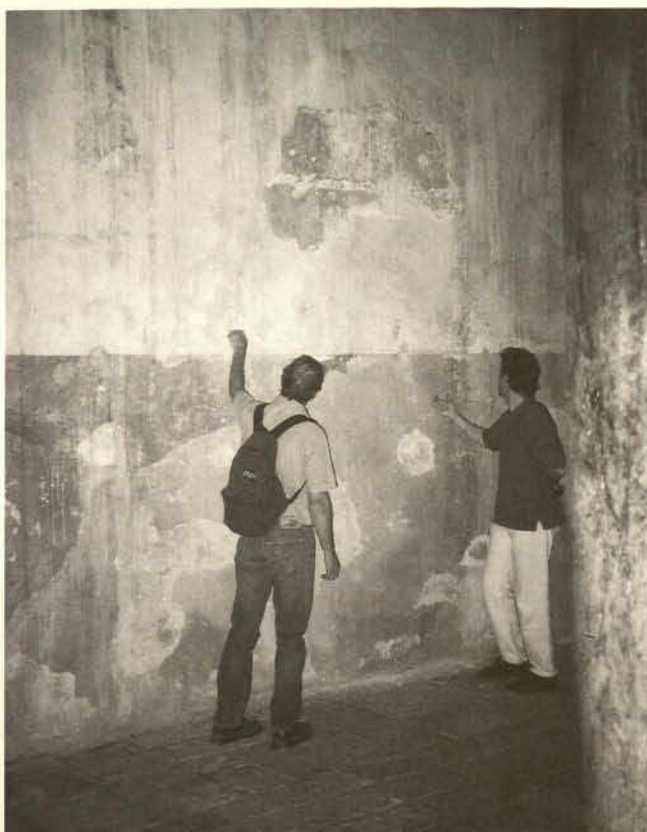
Today the Church of the Nativity still suffers from penetrating rainwater and from condensation caused by the interior humidity. The timber construction is partially rotten; some of the structural members are about to collapse. The rainwater flows down from the roof, washes out the walls, disfigures their mosaics and loosens the tesserae. It also detaches large areas of the wall plaster. Rain puddles on the floor damage remains of mosaics even here.
