TANZANIA

Case Study: Kilwa Kisiwani & Songo Mnara

Case Study: Bagamoyo

D.M.K. Kamamba & U. Malisius
ICOMOS Tanzania

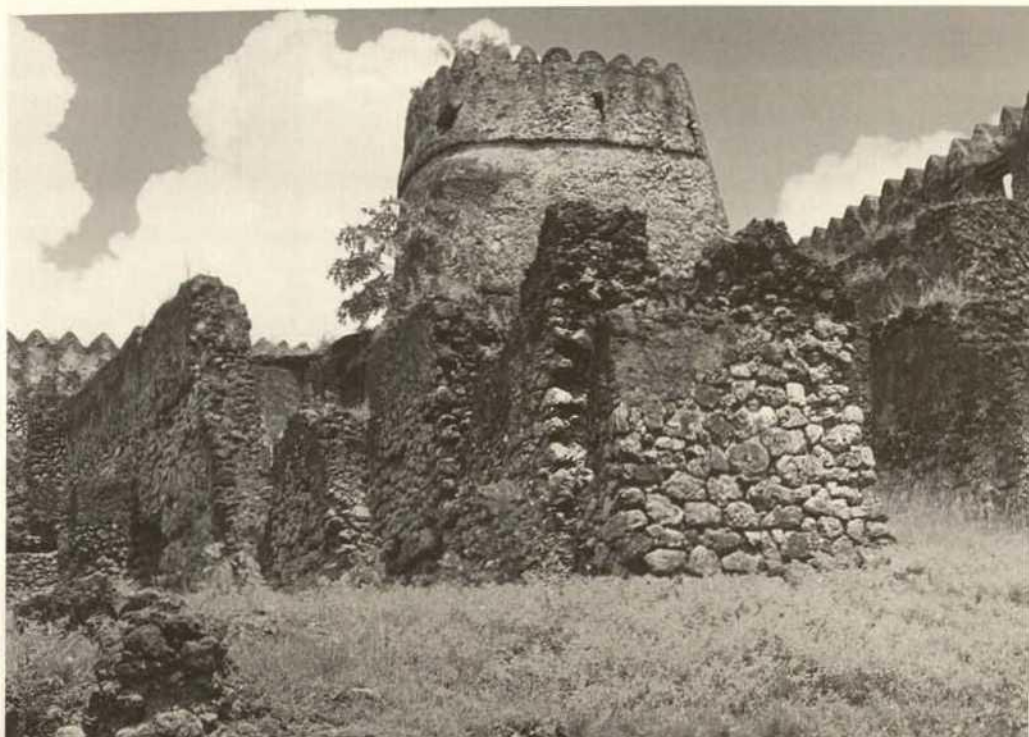
Kilwa Kisiwani, Portuguese fortress

The erosion due to the sea is the first sign that strikes the visitor who arrives on the island of Kilwa Kisiwani. Ninety-nine percent of the city walls have been lost, Gereza Fort has lost the north wall and the massive tower that flanks it on the north-east is severely threatened. Stabilisation work was done in this area during the restoration project undertaken by Neville Chittick, but since then this work has largely been eroded. All the vestiges situated on the sea front on the northern side of Kilwa Kisiwani have been greatly altered, and certain more are threatened with collapse. At the Husuni Kubwa Palace, the damage to the soil caused by rainwater wash is accentuating the risks of collapse of the remaining structures on the edge of the cliff. The eastern section of the palace is progressively disappearing.

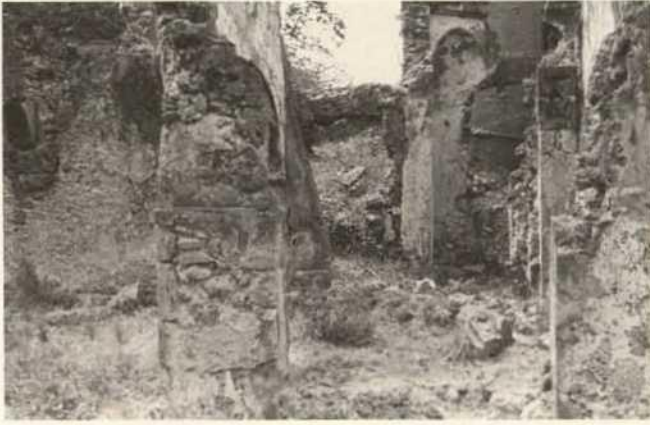
Ruins of Songo Mnara

However, the size and geographical layout of the monuments do not always permit systematic maintenance. Husuni Ndogo, situated to the east of the Husuni Kubwa Palace, and the urban complex situated on Songo Mnara Island have been invaded by trees that have become so intertwined with the stonework that it would be extremely difficult to remove them without destroying part of the structures.

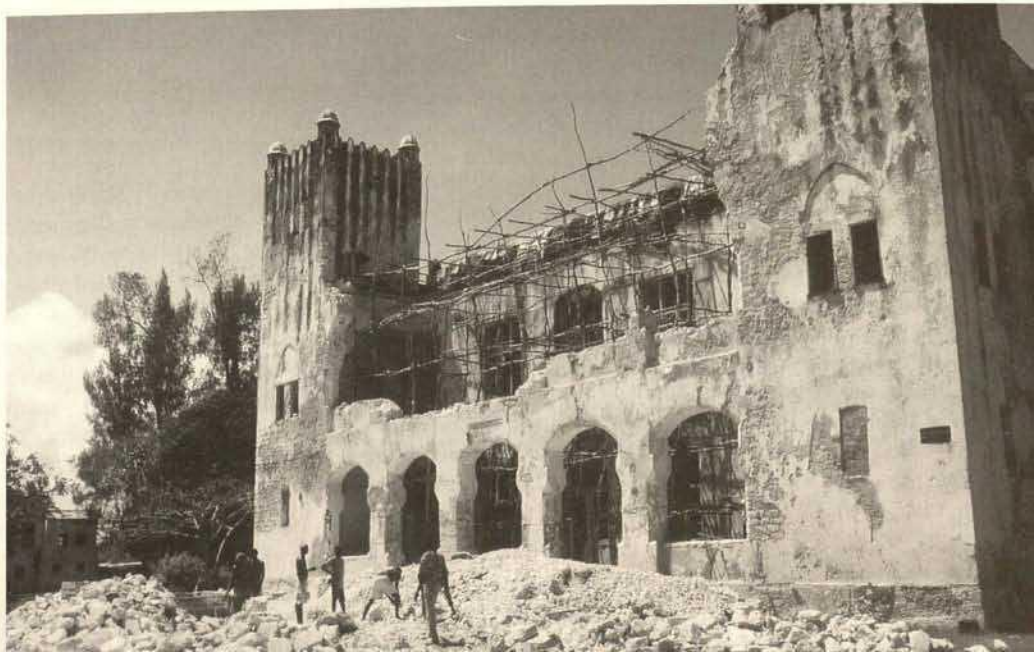
The Boma after December 2000: dangerous parts of the façade had to be taken down. Will it be possible to reconstruct it soon?

Due to neglected maintenance, part of the slab collapsed in 1998 and the building has been abandoned since then. Several attempts to save the structure were initiated by the Department of Antiquities, but have not shown any positive results so far – the building is too big, complicated and costly for the Tanzanian Government. Foreign assistance is needed, but foreign donors are very reluctant to assist in financing the project, most of them giving priority to programmes such as health, education or infrastructure. Additionally it takes time to establish a well-organised project concept with the government. Also private investors may be reluctant to be involved in such a big investment. It is an open question as to whether or not the building can be saved before it is too late, the speed of deterioration being so fast.
